RATTLE/BUZZ/VIBRATION—TRANSMISSION CROSS-MEMBER EXHAUST MOUNT—BUILT BEFORE 12/3/2007

TSB 08-3-4

FORD:
2005-2008 Mustang

This article supersedes TSB 06-4-1 to update the vehicle model years and Service Procedure.

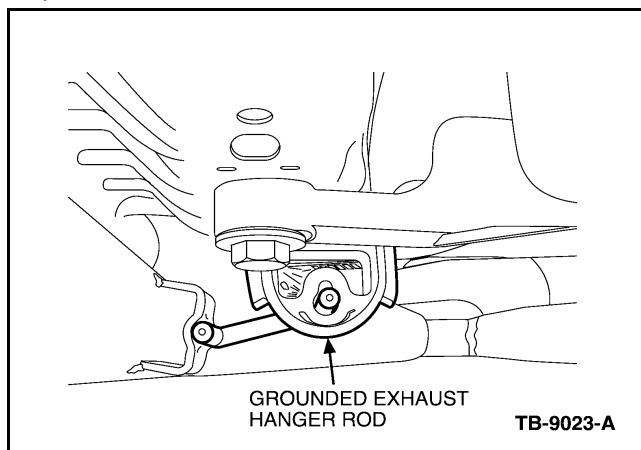
Figure 1 - Article 08-3-4

The rattle/buzz/vibration may be caused by one or both of the exhaust hanger isolators on the transmission cross member number 3 being loose in the bracket and/or compressed by misaligned exhaust hanger rod. If the voids in the isolator are compressed by the exhaust hanger rod, then it may allow the hanger rod to ground through the number 3 transmission cross member exhaust mount bracket (Figure1). Follow the Service Procedure steps to correct the condition.
