GRUNT/CREAK/CHIRP/SQUEAK NOISE FROM THE FRONT LOWER CONTROL ARM OVER BUMPS

TSB 13-9-3

FORD:
2011-2014 Mustang

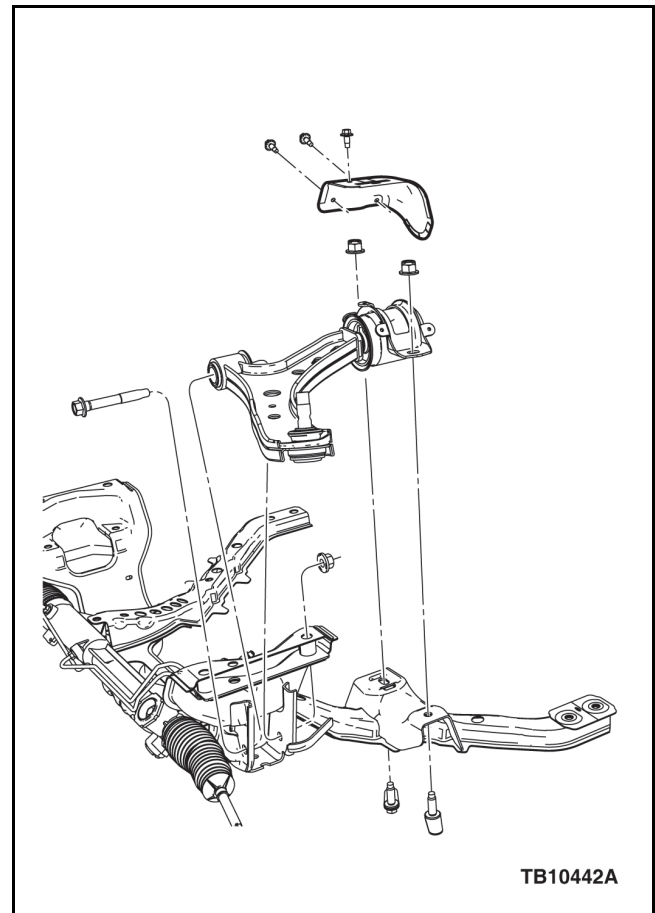
Figure 1 - Article 13-9-3

Some 2011-2014 Mustangs vehicles may exhibit a grunt/creak/chirp/squeak noise from the front lower control arm hydro bushing. These noises may occur over large vertical bumps like speed bumps, pot holes, rough roads and driveway approaches.

1. Attach Rotunda wireless chassis ears (JSP97202) or equivalent on both lower control arm hydro bushing bracket tabs to verify noise is coming from the hydro bushing.
 - a. The hydro bushing is the large diameter bushing at the rear of the control arm. Due to hydraulic fluid flow some noise from the bushing is normal. There would typically be some difference from side to side on a unit with a noisy control arm.
2. If the noise is not confirmed as coming from the hydro bushing, this article does not apply, refer to Workshop Manual (WSM), Section 204-00 for normal diagnostics.
3. If the noise is confirmed as coming from the hydro bushing, replace the affected lower control arm with the new lower control arm with shield and three (3) screws. Tighten the three (3) shield screws to 7 N•m (62 lb-in.) Refer to WSM, Section 204-01. (Figure 1)
