GENERAL SERVICE BULLETIN

Various Vehicles – Manual Transmission Clutch System Concern Analysis

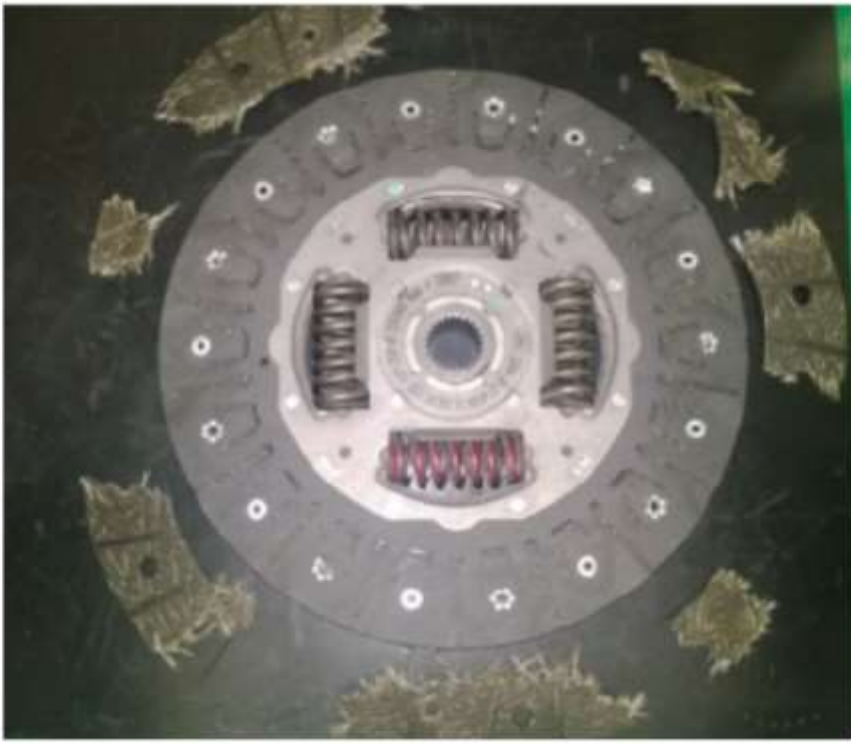
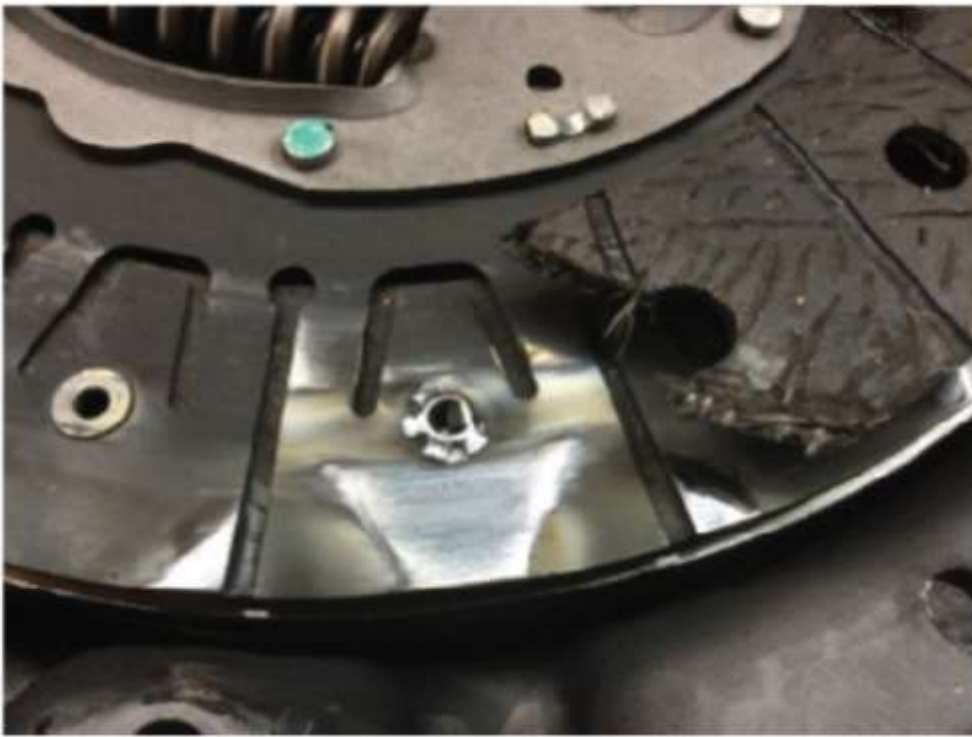
Clutch disc burst due to overspeed / inadvertent downshift to 1st or 2nd gear at high vehicle speed. (Figures 1-2)

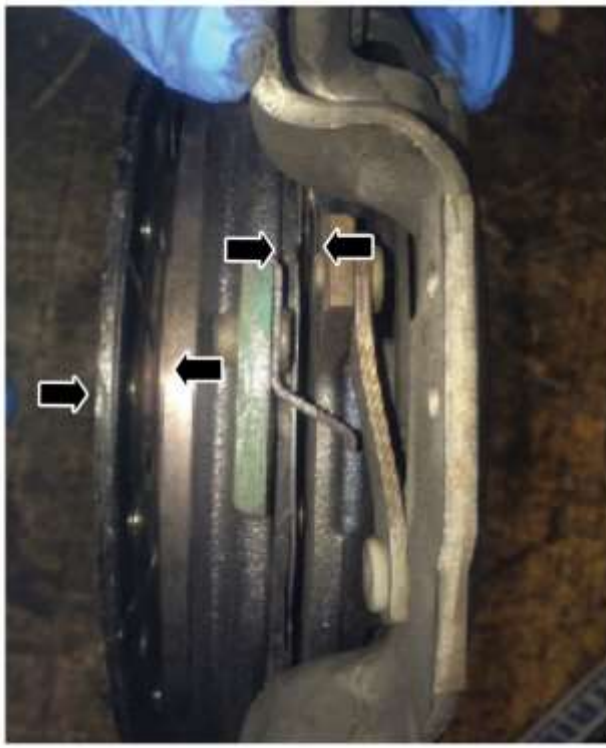
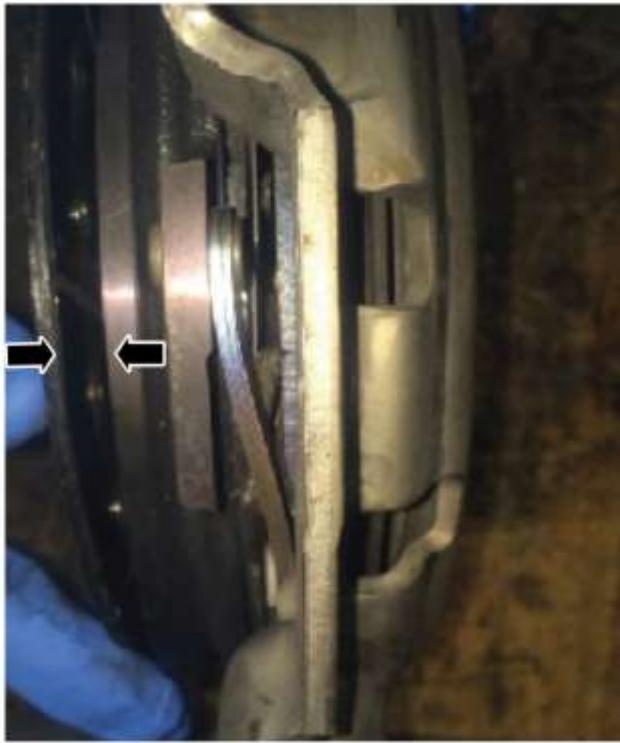
One side facing lost from each disc of a twin disc clutch due to overspeed / inadvertent downshift into 1st or 2nd gear at high vehicle speed. (Figures 3-4)

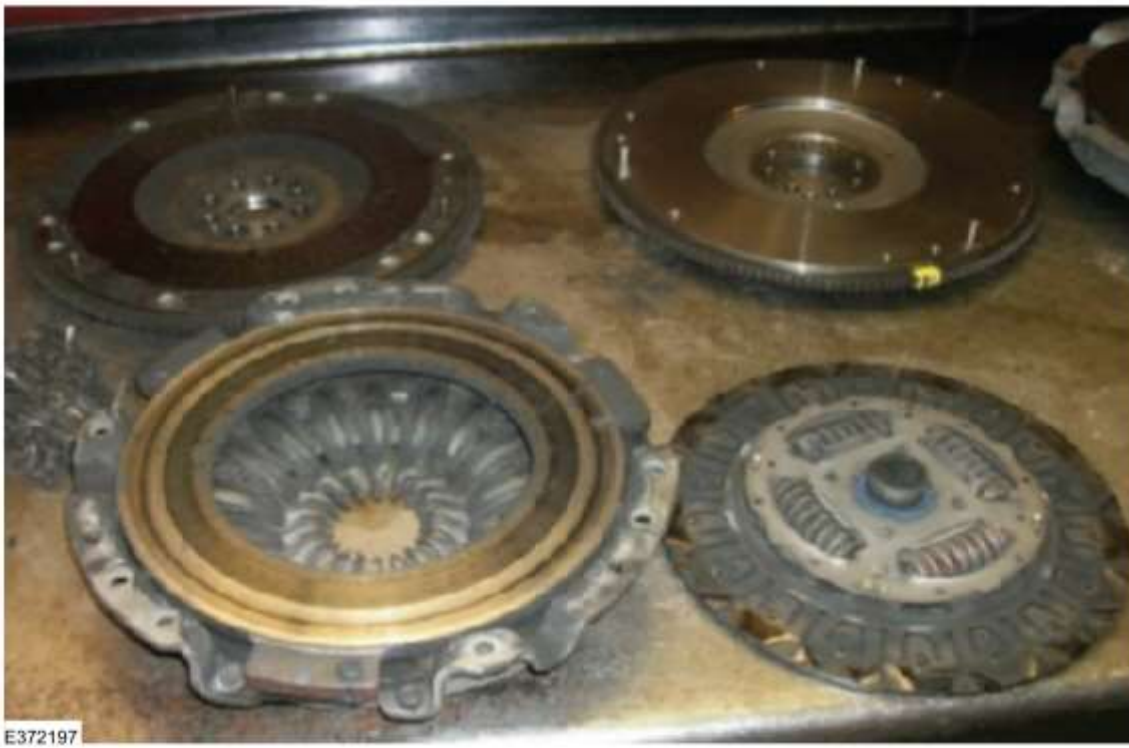
Figure 5

Clutch assembly is overheated due to excessive slip, with overspeed burst/'birds-nested' friction material fibers, overheated flywheel, overheated and scored pressure plate. (Figure 5)

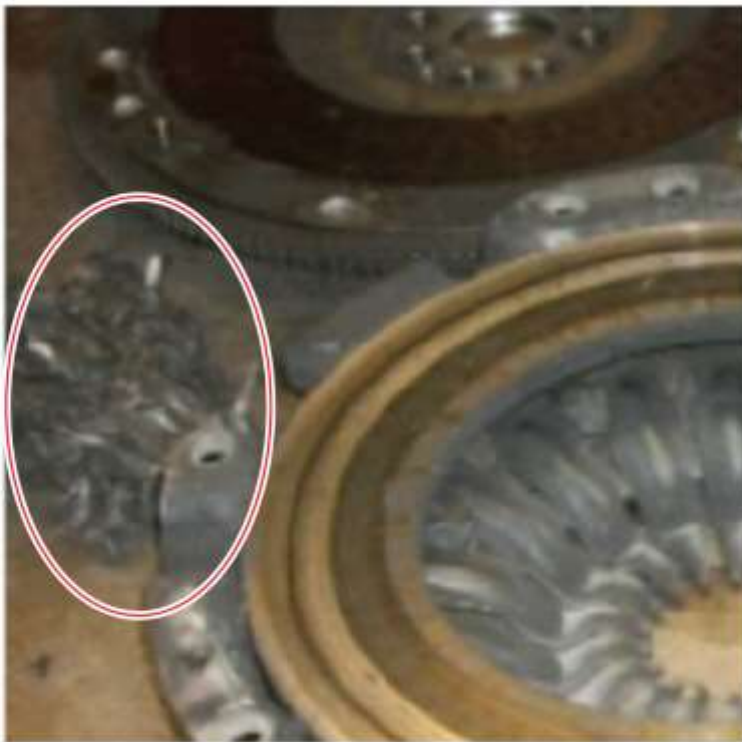
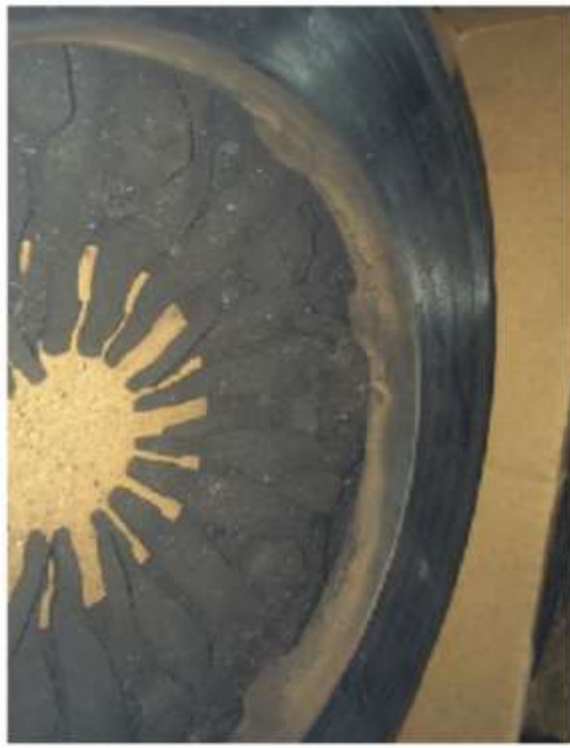
Clutch disc burst due to overspeed and excessive slip/heat. Figures show clutch lining material overheated, clutch binding agents burned off, clutch fibers loose in the clutch housing, jammed in pressure plate assembly. (Figure 6-7)

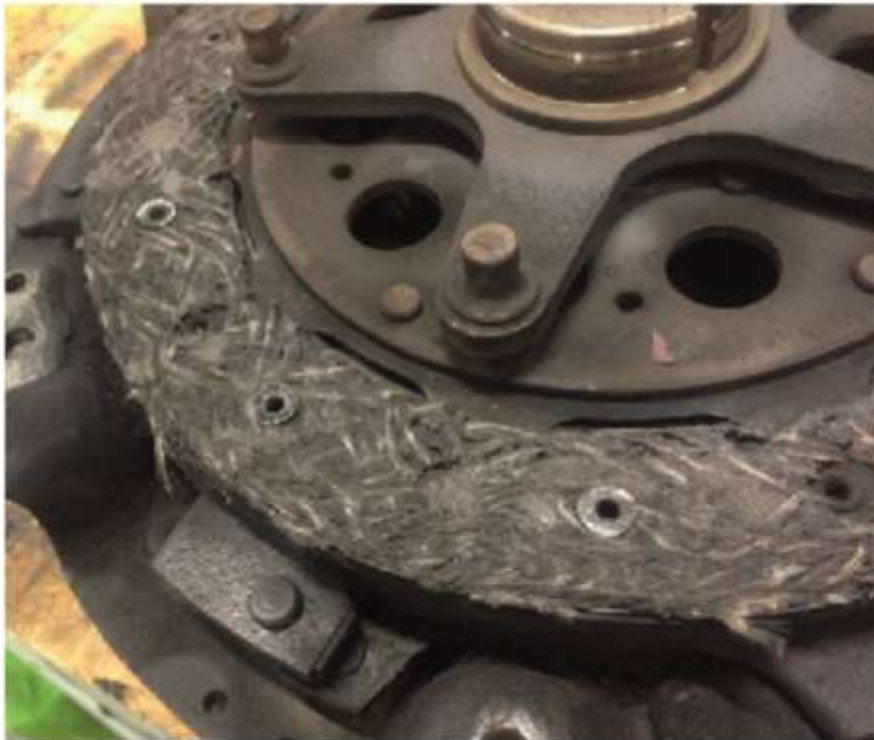
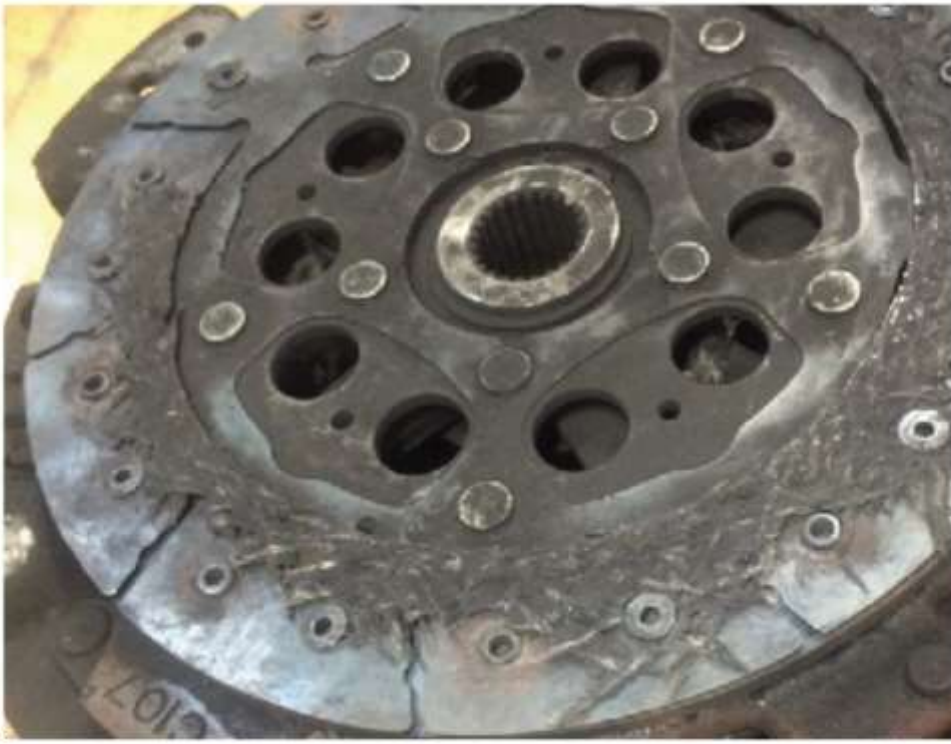
Clutch disc heat damage/wear due to excessive slip. Figures show clutch lining material overheated, binding agents burned off. (Figure 8-9)

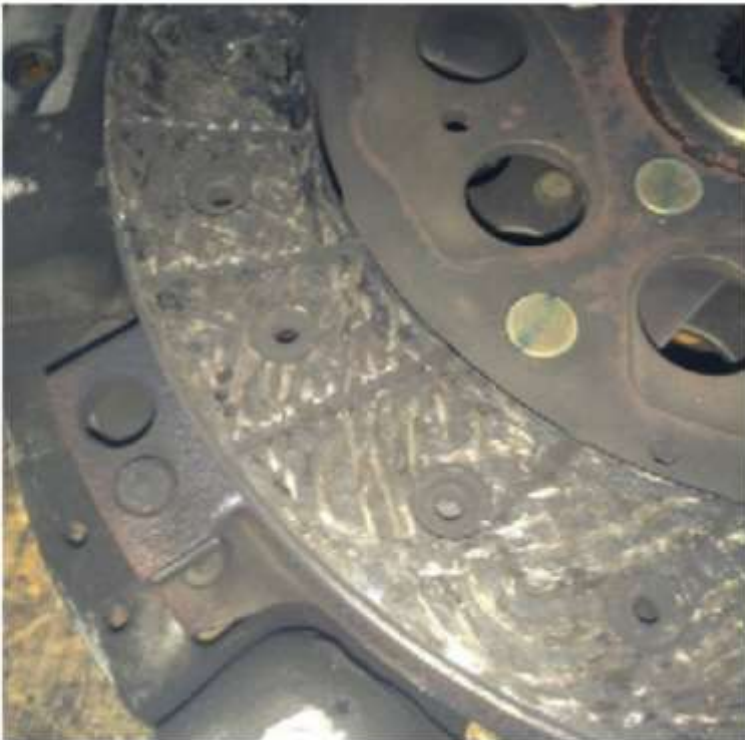
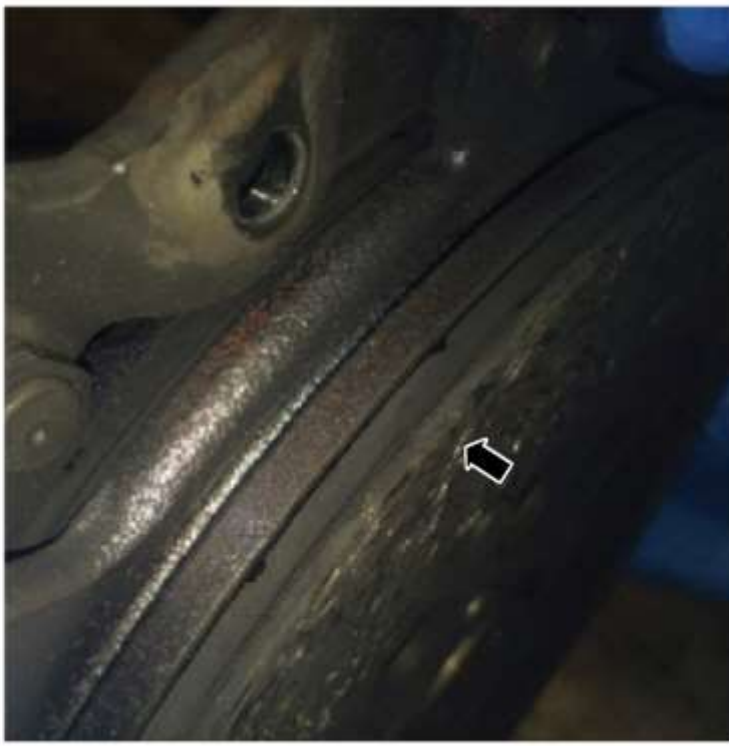
Clutch disc lining heat damage due to excessive slip. Figures show face and edge appearance of heat-damaged lining. (Figure 10-11)

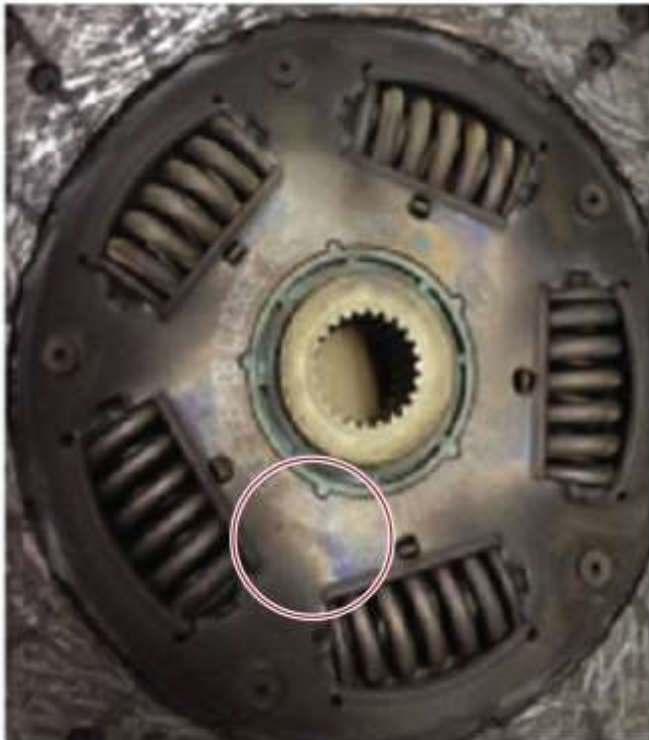
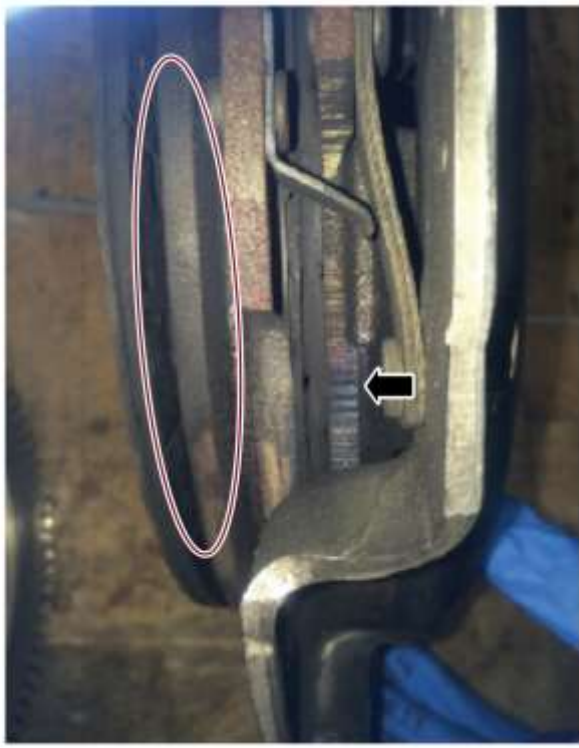
Clutch disc steel hub, pressure plate edge overheated / discolored due to excessive engagement modulation/slip. Figures show broad uniform dark/gray coloring or blue/violet coloring from excessive heat. (Figure 12-13)

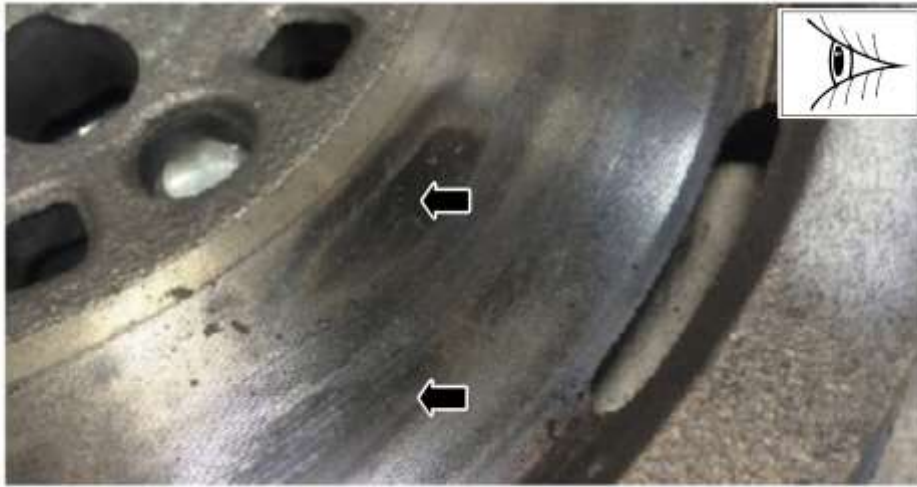
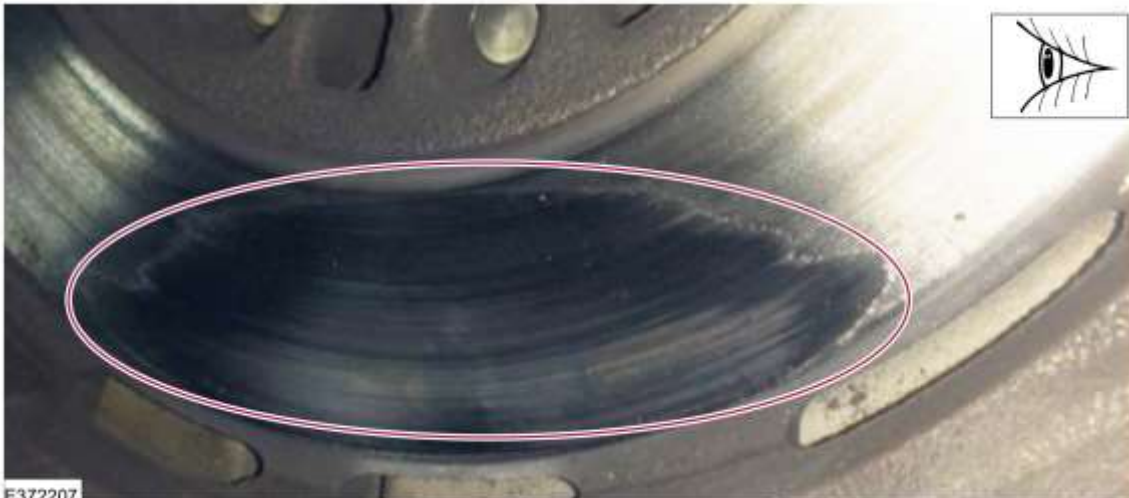
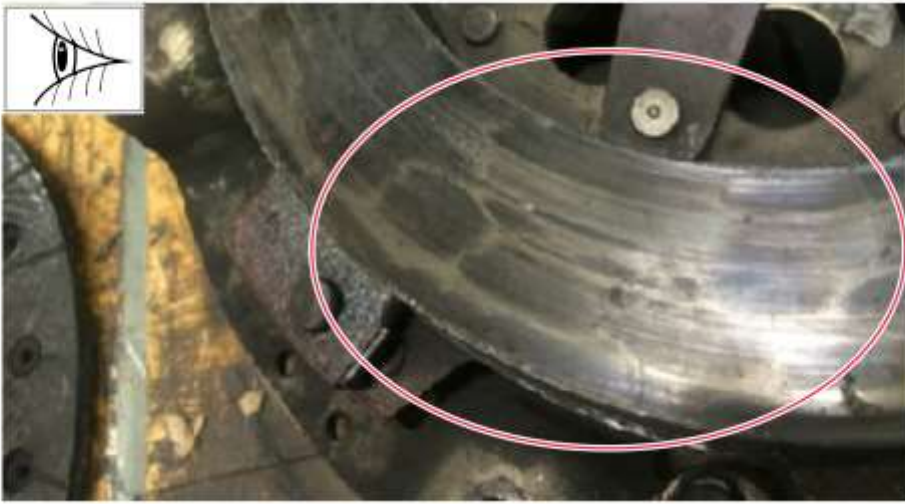
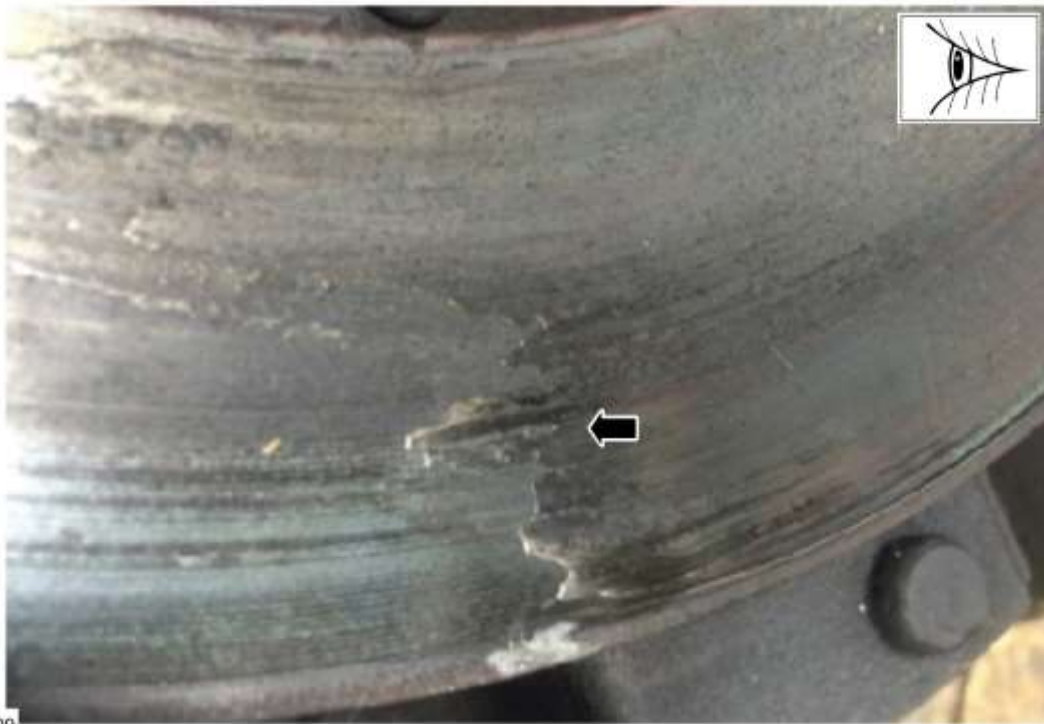
Clutch pressure plate or flywheel overheated/discolored due to excessive engagement modulation/slip. Broad dark/gray coloring or blue/violet coloring, appearance of material smeared from excessive heat. (Figure 14-17)

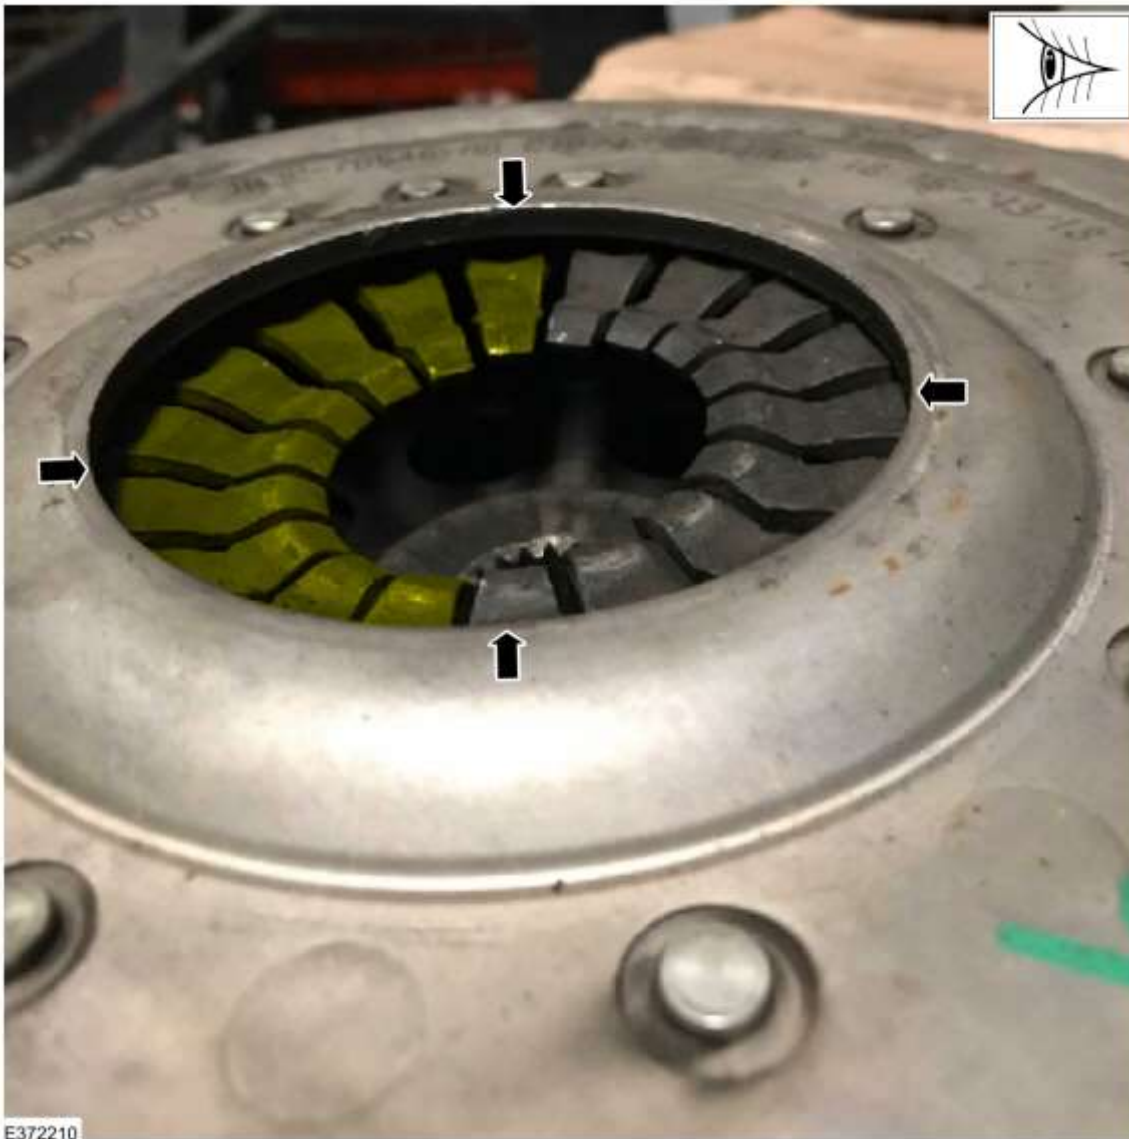
Figure 18

Clutch pressure plate diaphragm fingers low/uneven due to burst lining material jammed lodged in cover assembly. (Figure 18)

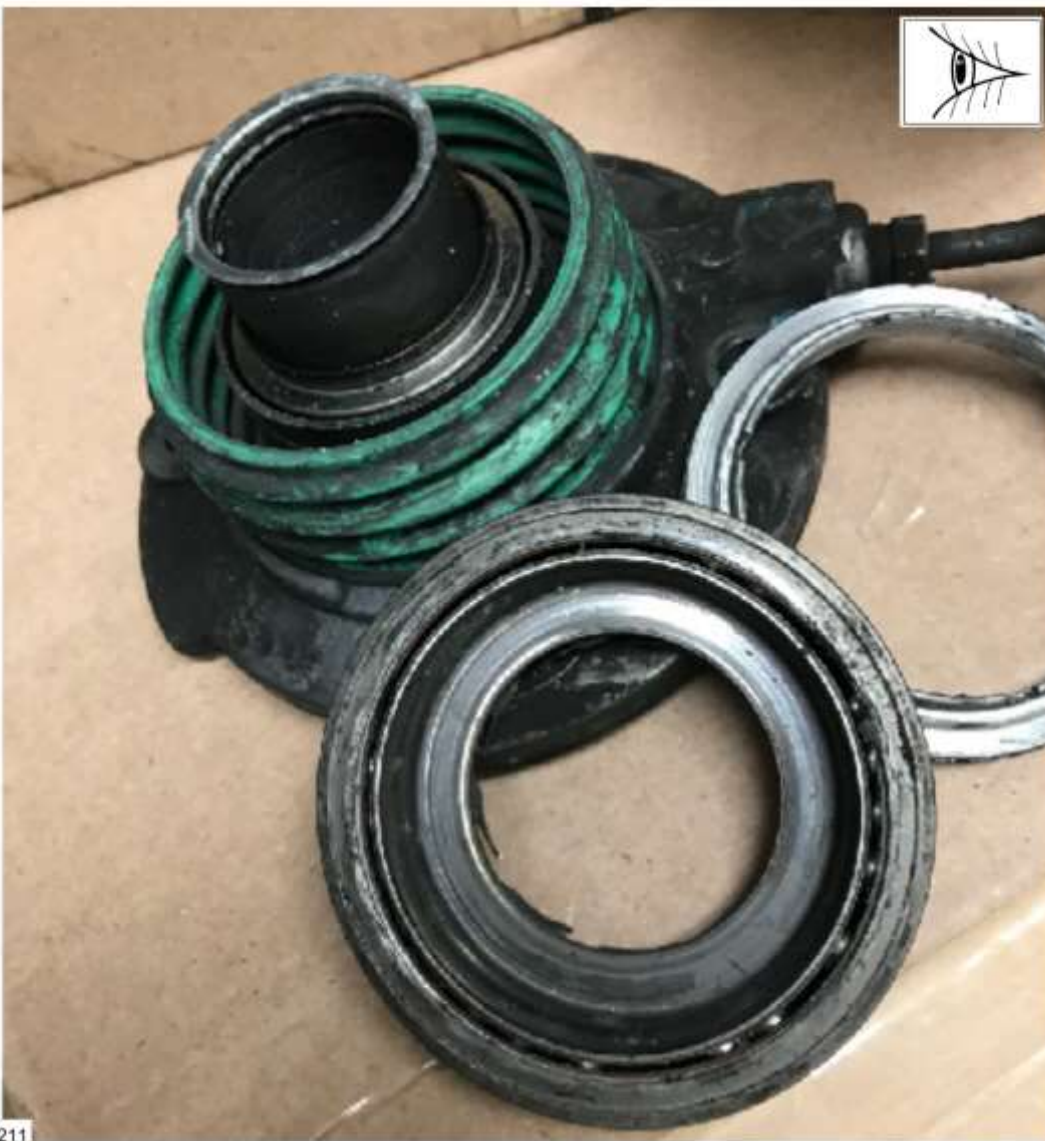
Figure 19

Clutch slave cylinder overheat/overstroke failure – bearing/grease failure due to overheat from clutch slippage; bearing carrier/retention failed due to overheat; cylinder leak due to overtravel/failed bearing retention resulting from low pressure plate diaphragm finger height associated with burst lining. (Figure 19)

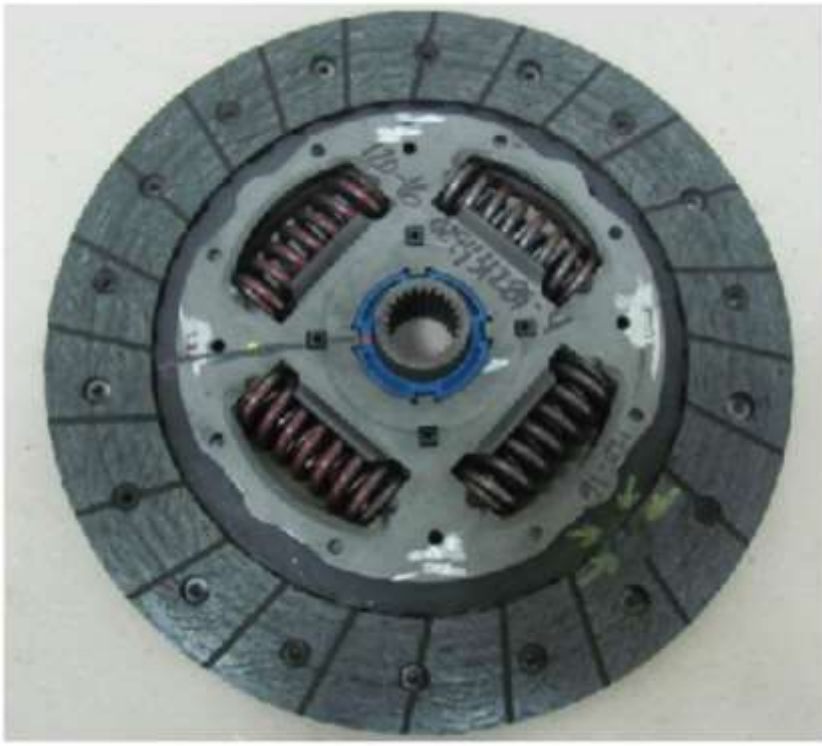
Figure 20 – Clutch Disc Assembly

Structural failure of the clutch disc assembly (Figure 20) and its components parts (Figures 21-26) are covered.

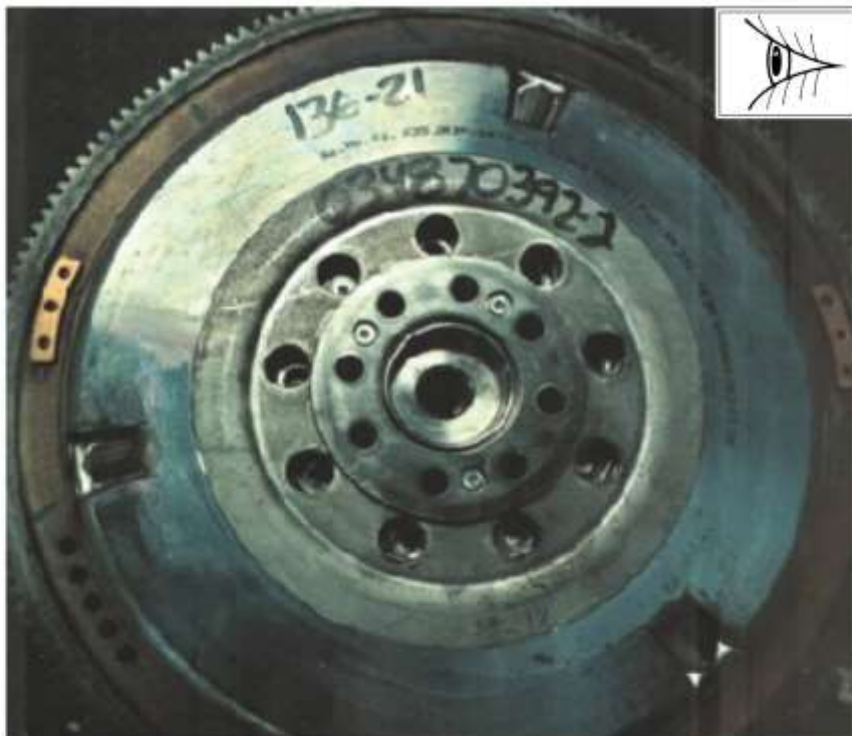
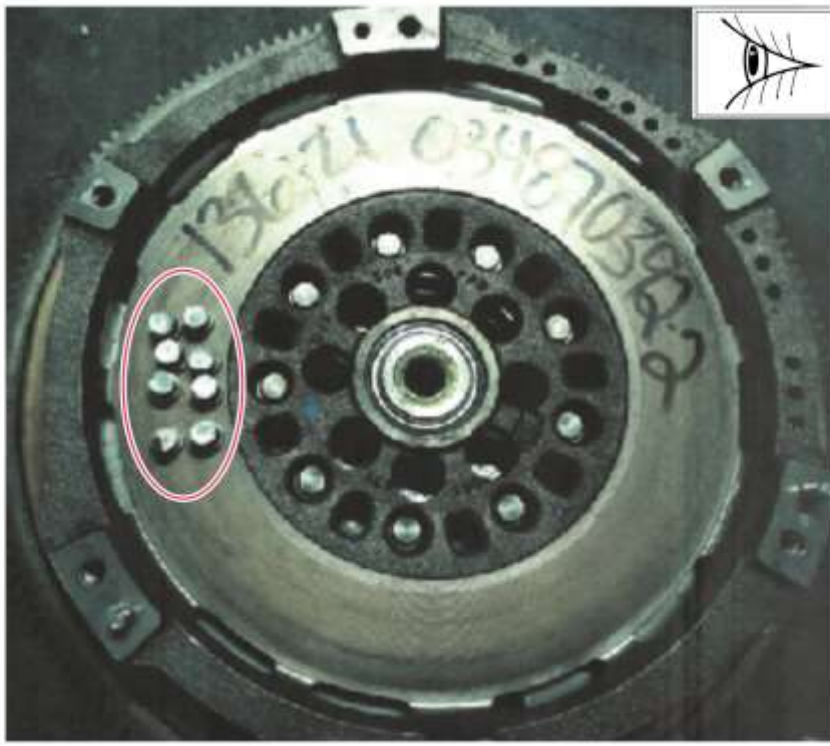
Failed dual mass flywheel rivets. (Figure 27-28)

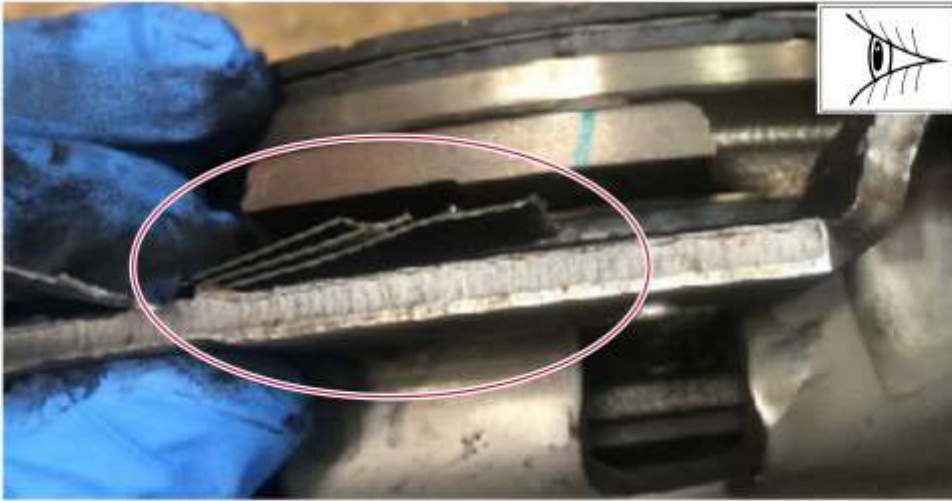
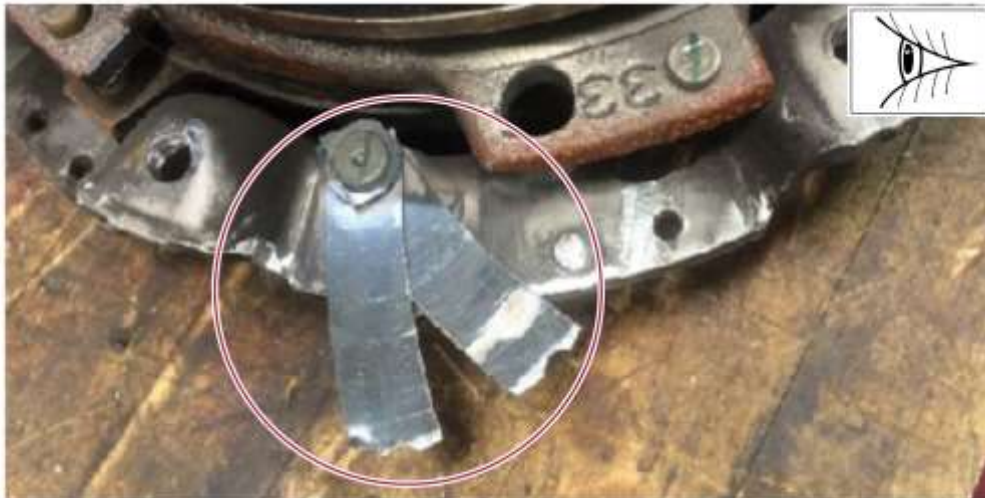
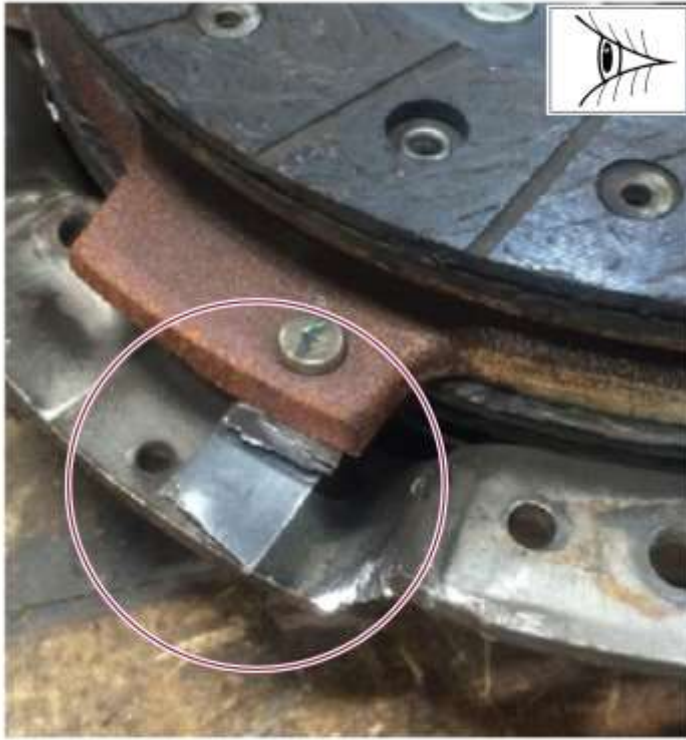
Structural damage to pressure plate assembly components is warrantable. Figures show broken drive straps, failed or missing drive strap rivets. Refer to Figure 13 for reference of a properly attached drive strap. (Figure 29-31)

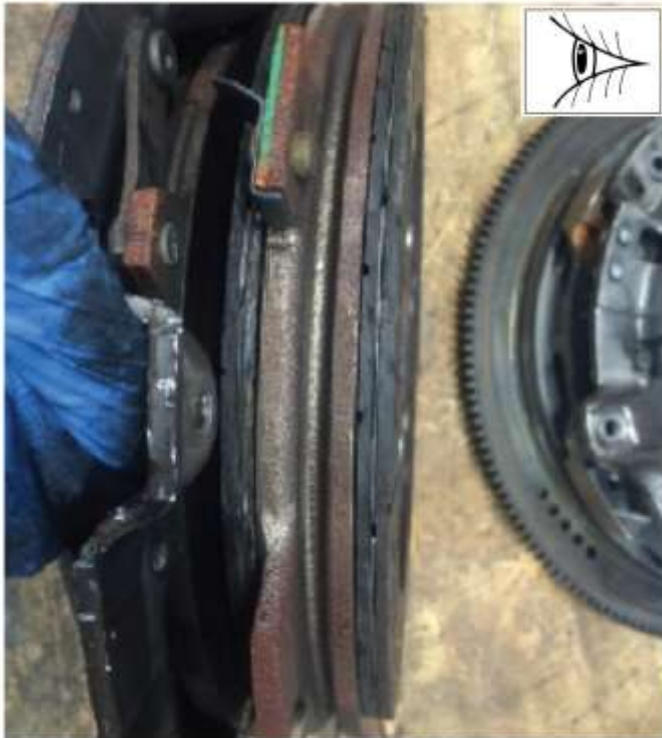
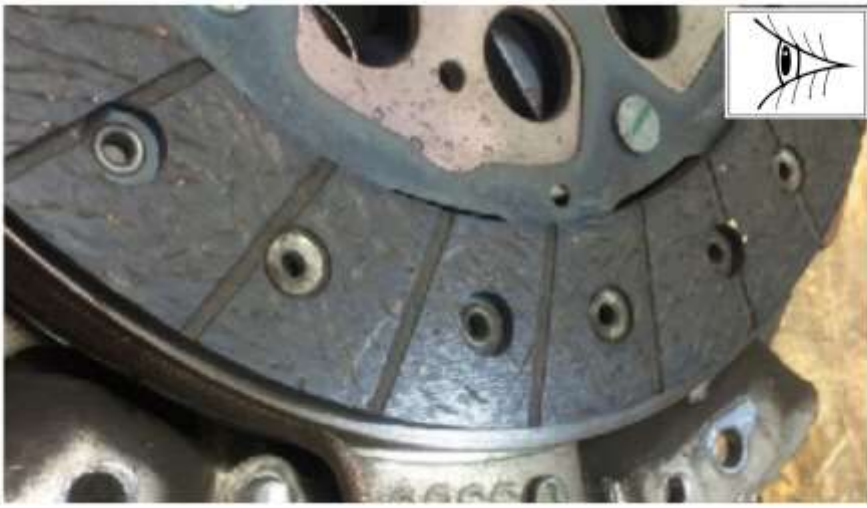
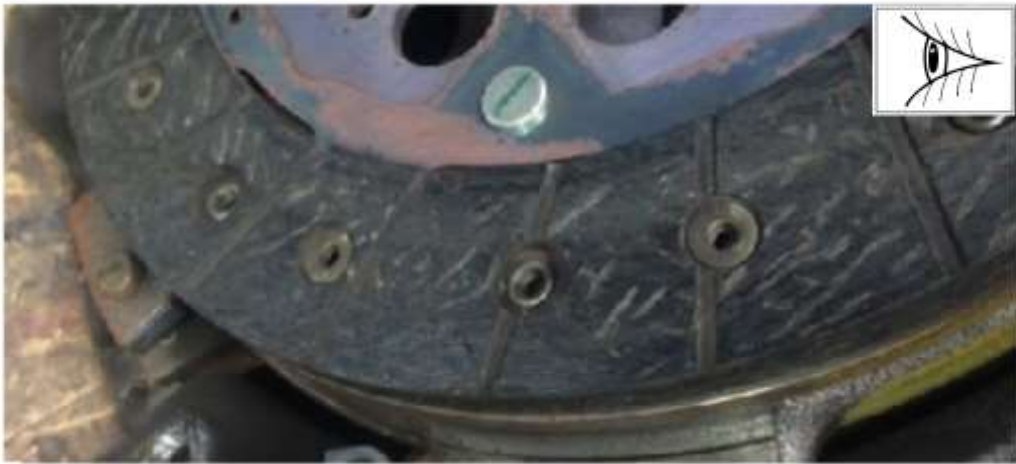
Reuse - Figures 32-34 show clutch disc with sound lining, no overheat and no excessive wear.

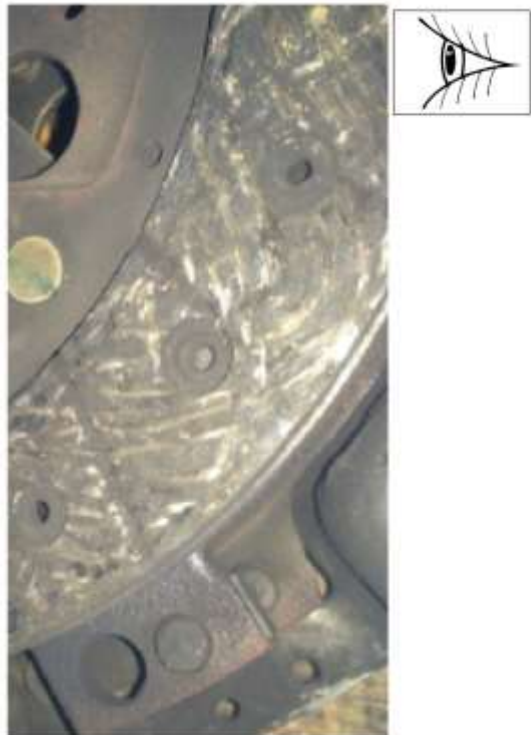
Figure 35

Not Reusable - Clutch lining showing heat damage (Figure 35), high wear on one or both sides of the disc (Figure 36-37).

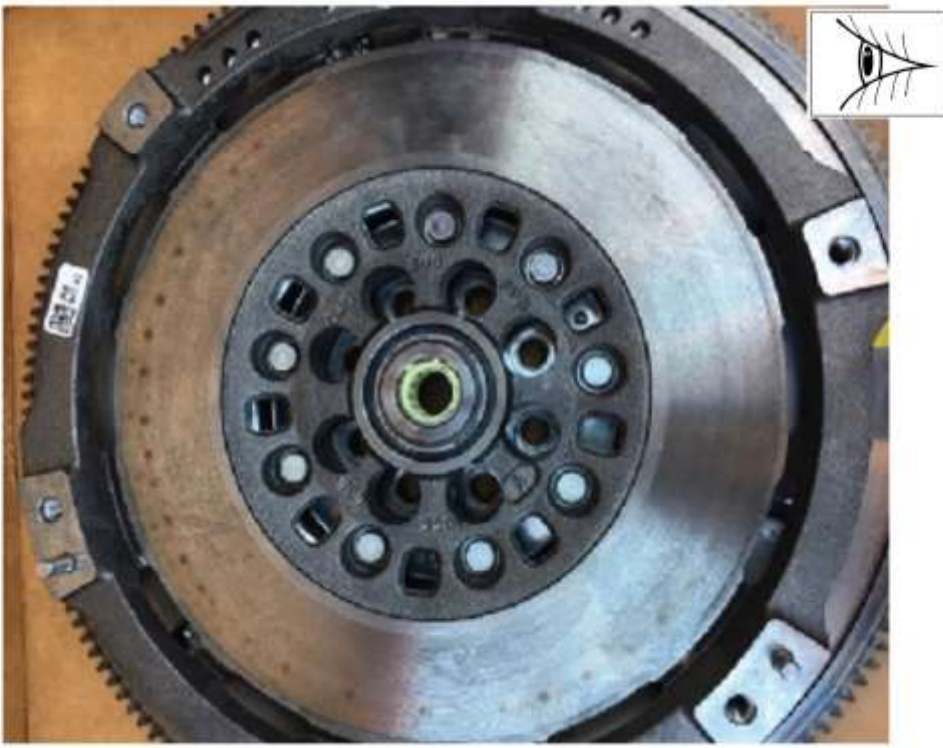
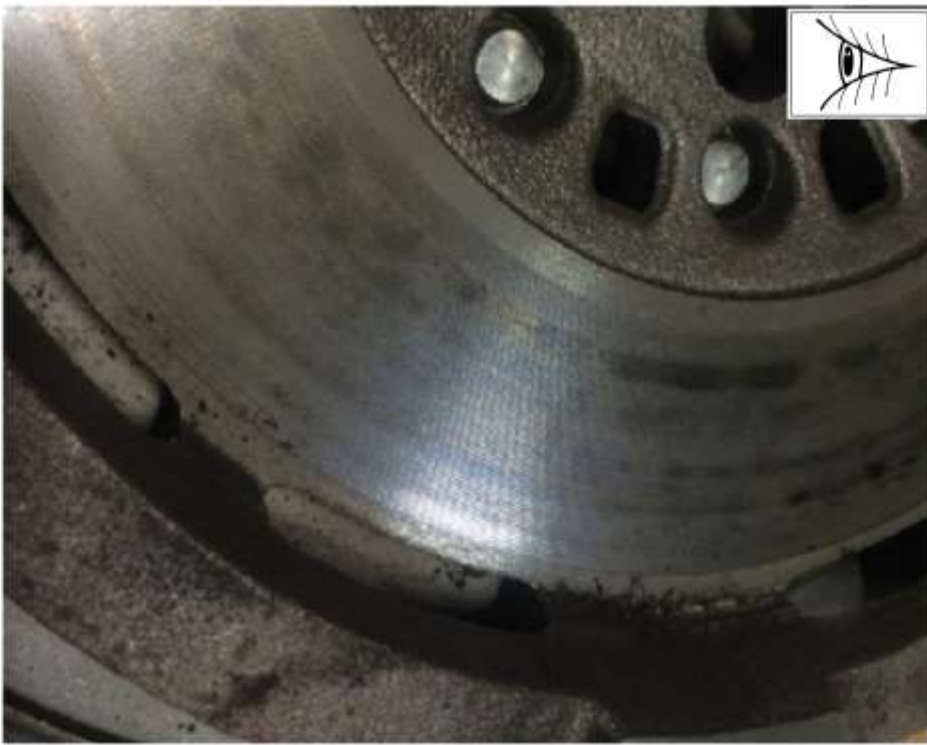
Reuse - Clutch flywheel showing normal heat-spotting marks that occur during break-in and normal use, with no adverse effect on function. (Figure 38-39)

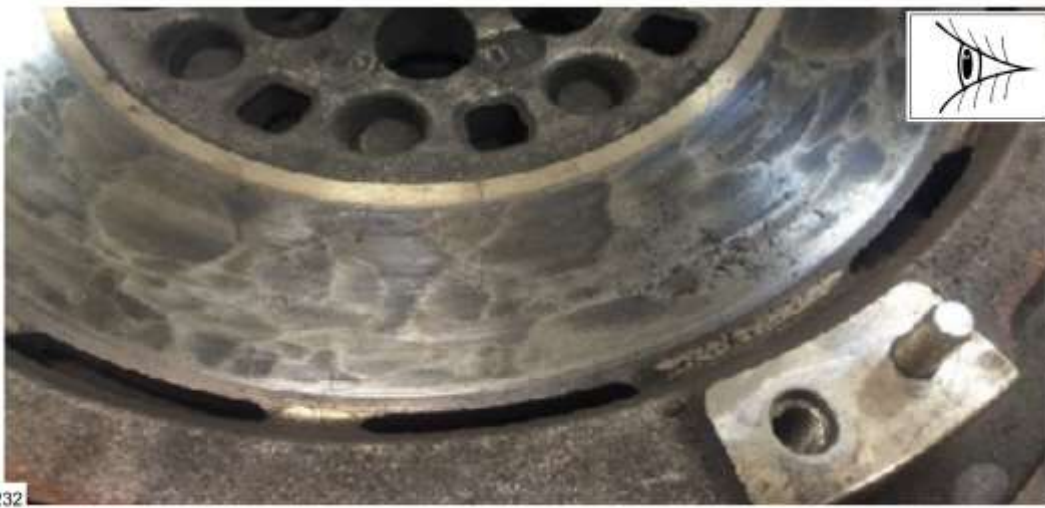
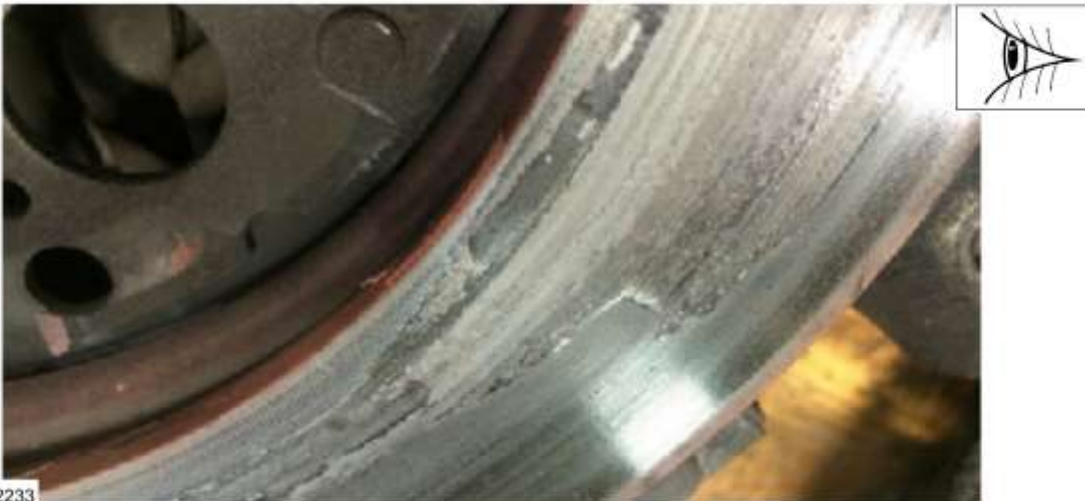
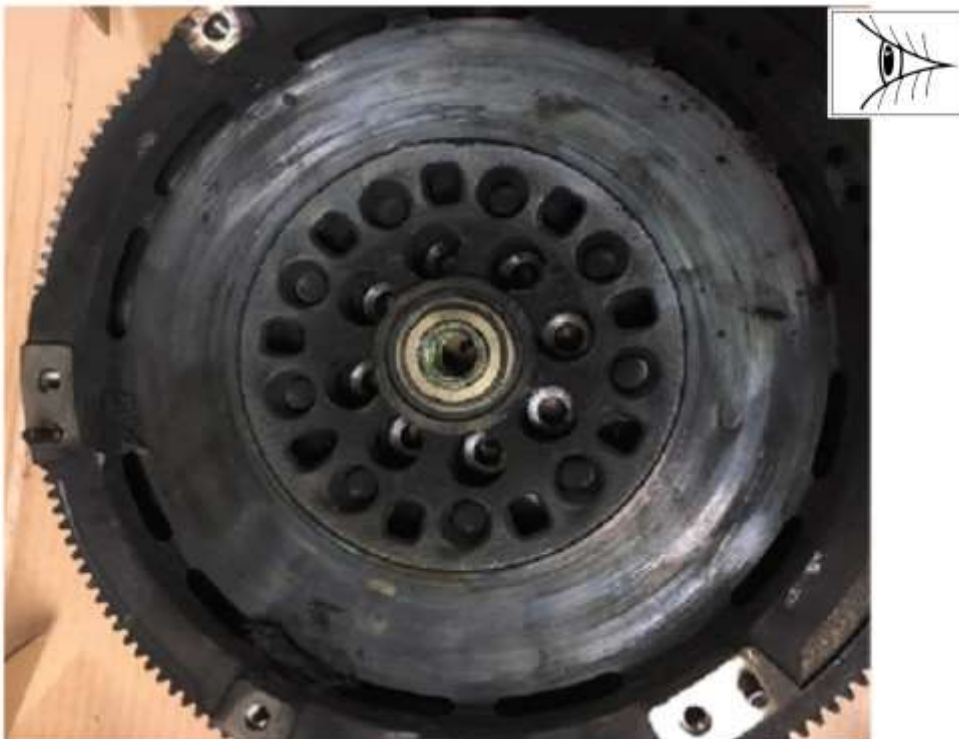
Not Reusable - Clutch flywheel showing material removed, blued, excessive lining dust. (Figure 40-42)
