**TECHNICAL SERVICE BULLETIN****Poor Air Conditioning (A/C) Performance - Evaporator Can Now Be Serviced Separately From The Climate Control Housing**

This bulletin supersedes 18-2166. Reason for update: Replace Awareness/Interim Message

Ford 2015-2017 Mustang

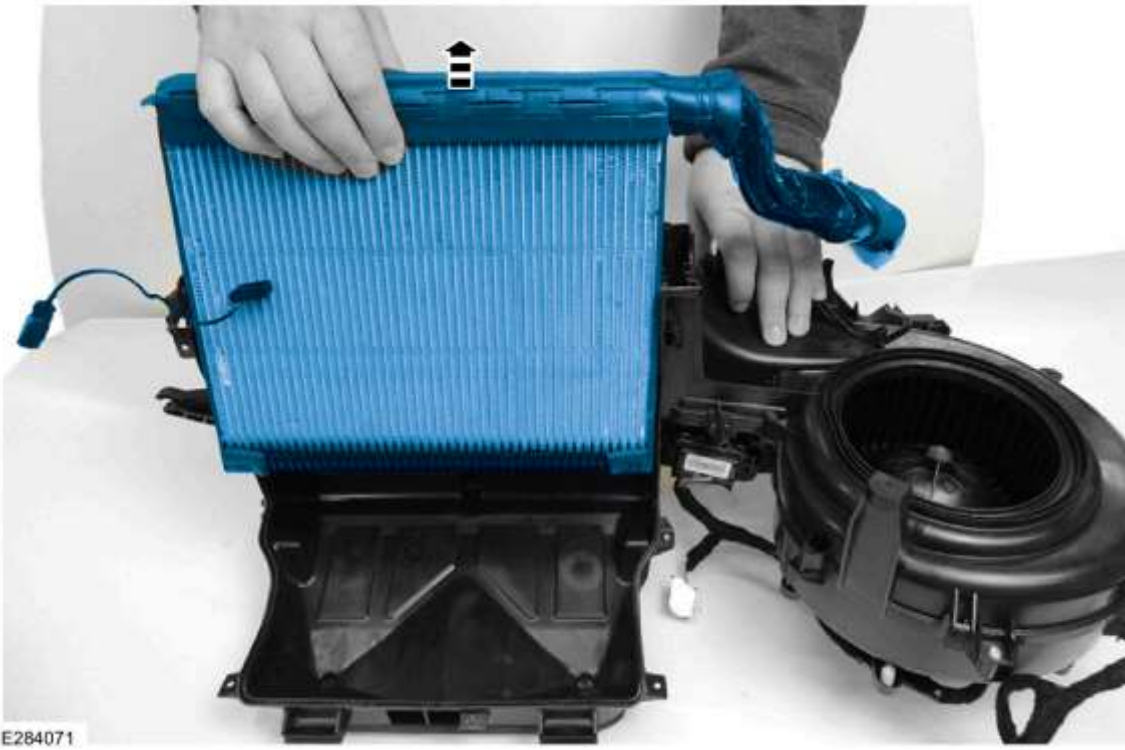
Figure 15

Issue: Some 2015-2017 Mustang vehicles may exhibit poor A/C performance. If the cause of this is found to be a refrigerant leak from the evaporator, it is recommended to replace only the evaporator as opposed to the entire climate control housing.

16. Remove the evaporator core from the climate control housing. (Figure 15)
