CARDONE ProTech

Failed Booster Seal Causes Master Cylinder Leaks

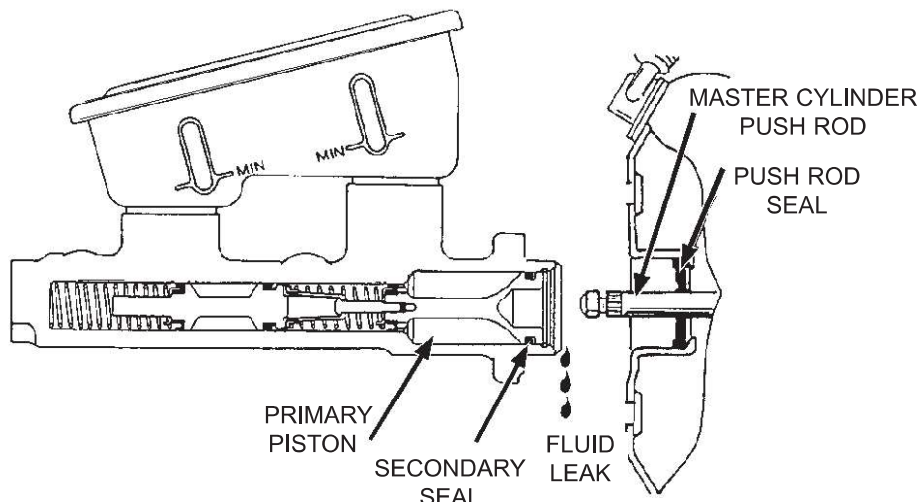
Problem Chronic master cylinder failure due to fluid leaking past secondary seal in the master cylinder bore.

Cause A defective master cylinder pushrod seal in the power brake booster allowing vacuum to draw fluid past secondary seal of the master cylinder.

Solution Replace both master cylinder and power brake unit.
