Door Panel Removal & Window Stop Adjustment

By: Jeff Wolford

Vehicle: 2006 Mustang GT Coupe.

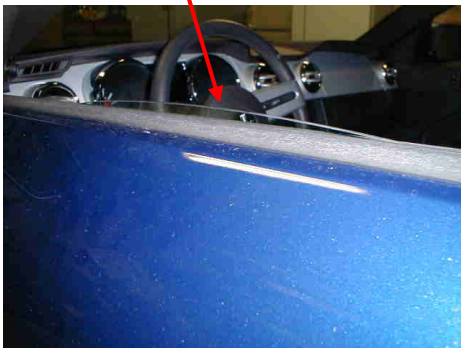
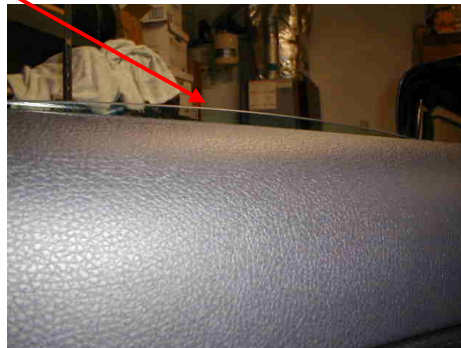
The Problem:

The driver side window did not lower enough. It stopped too high - leaving about $\frac{1}{2}$ inch. sticking up above the top of the door. The window was also catching on the plastic rain-drip trim (when window up) if I didn't open the door slow enough. This started after the car was repainted (75% of the vehicle's paint was damaged during a WA State wind storm in Mid Dec 2006).

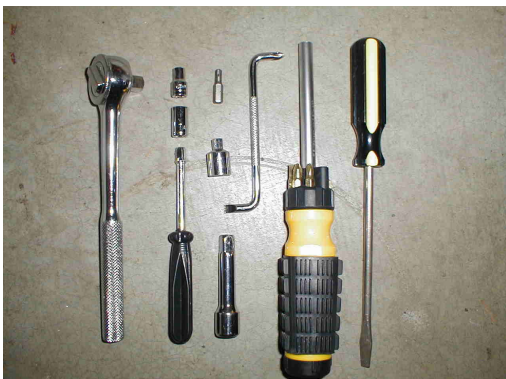
I Used the Following Tools:

- Plastic Putty Knife (not shown here)
- Ratchet
- 5mm Socket
- 7mm Socket
- Socket Handle Driver
- T30 Torx Socket
- Socket Adapter
- Short Socket Extension
- Philips Driver bent at a 90 degree angle
- Driver for Torx Bit
- Flat Head Screw Driver

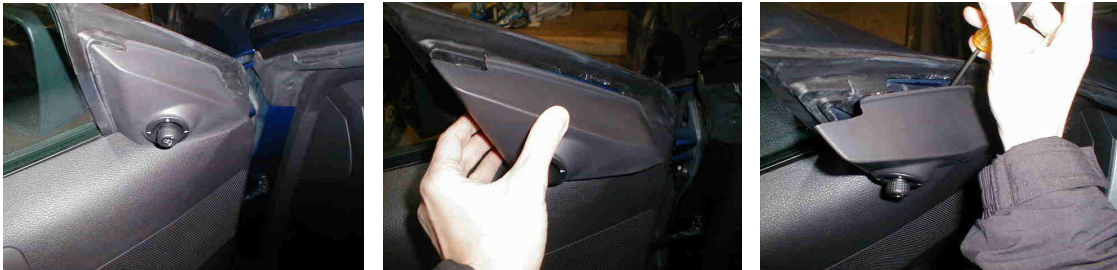
1. Sail Panel Removal:

This was pretty much Grip & Rip. The left (back) side came off very easy. It felt like it was binding a little on the right side (which is really the front side) so I eased it out with a flat-tip screw driver, being very careful not to mar the rubber around the mirror. In hindsight - I'm sure I could have skipped the screwdriver if I'd pulled a little harder. Better safe than sorry though.

The Sail Panel is held on by (2) spring clips. There are (3) plastic pins that go into guide holes, and... ..

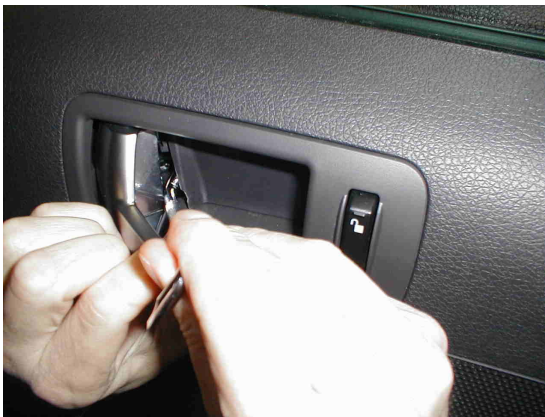
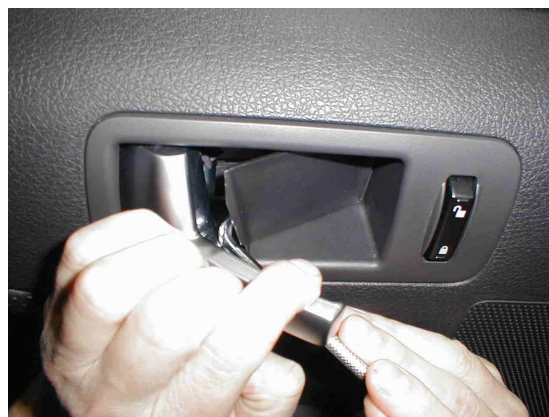
2. Door Handle Access Panel Removal:

I used a screwdriver that's bent at a 90-degree angle and carefully pried the back of the access door out. Then I carefully pulled the part out, being extra careful not to scratch the bottom of the door handle trim.

There are other parts back there can be damaged if you're not careful (like this one)..

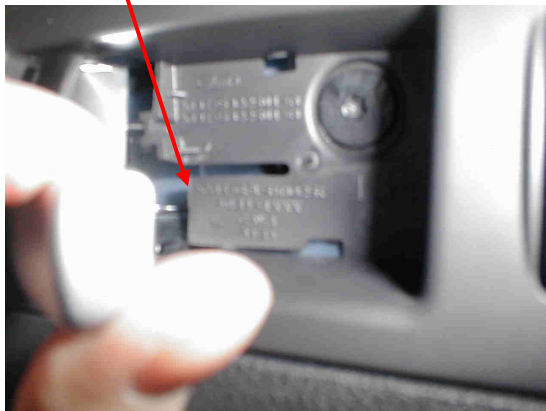
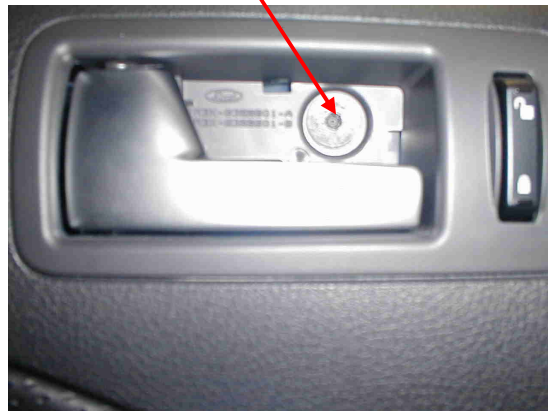
There's (1) T-30 torx screw.

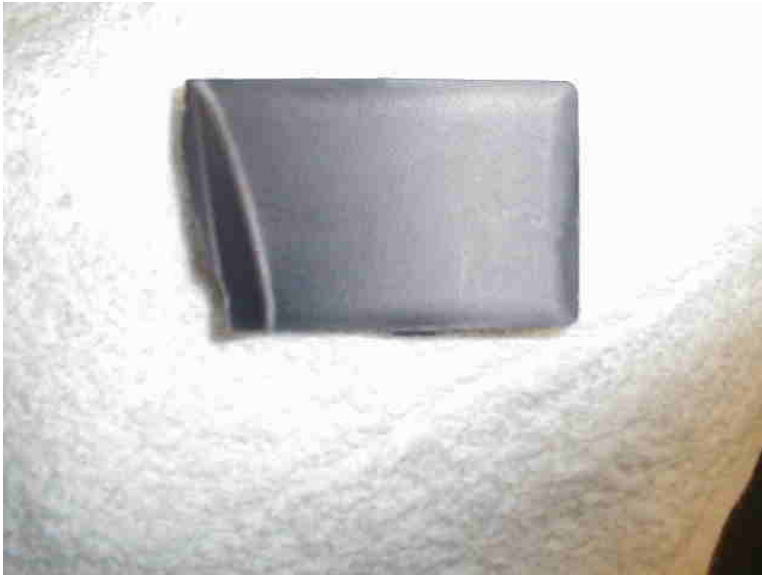
Additional Pictures of the Door Handle Access Panel:

Here's the little access door after I removed it.

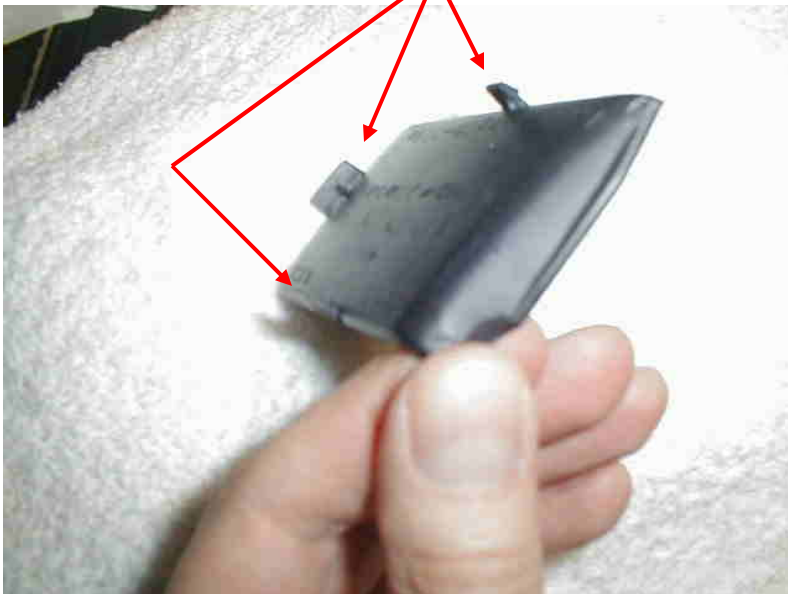
Notice the (3) tabs.

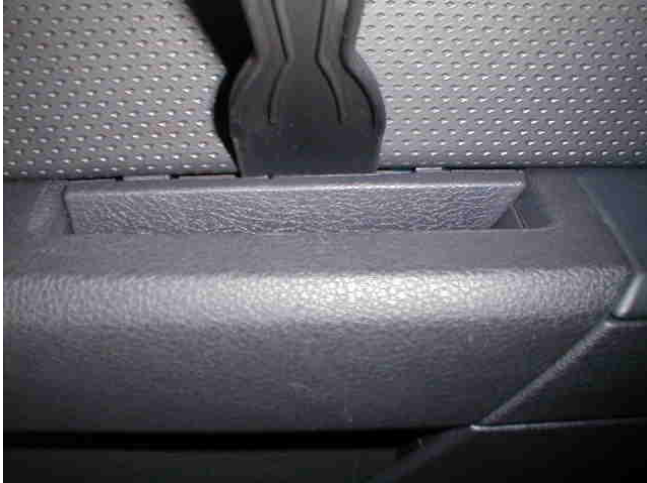
3. Arm Rest Access Panel Removal:

I used a plastic putty knife for this. I gently pried the top out, being careful not to damage the leather.

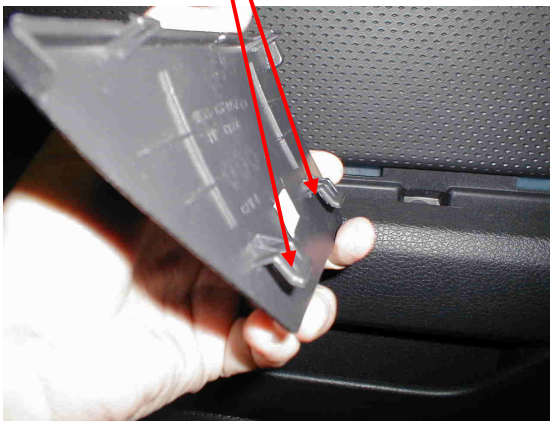
There are (2) tabs on the bottom that act as hinges. A slight angle was all it took, then I pulled it straight up.

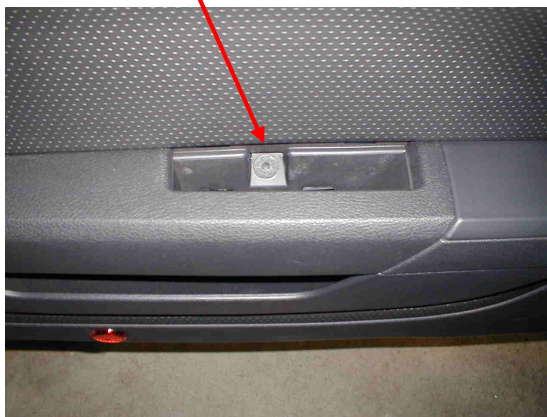
There's (1) T-30 torx screw behind it.

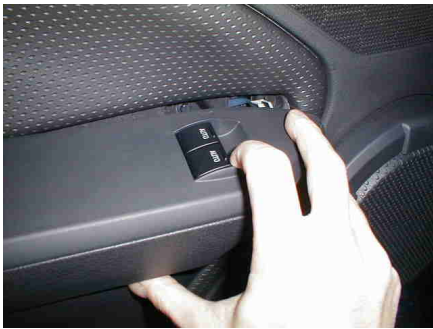
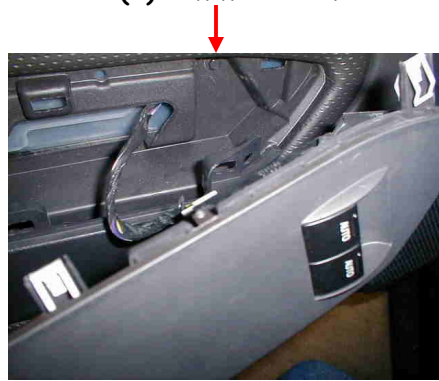
4. Power Window Switch Panel Removal:

This was pretty much Grip & Rip also. I grabbed the inside of the switch recess and pulled straight out. After the front was loosened I was able to pull out the back. There's (1) 7mm screw.

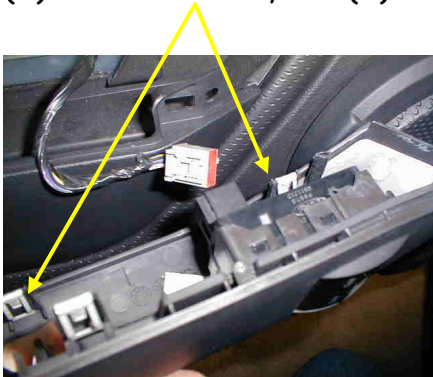
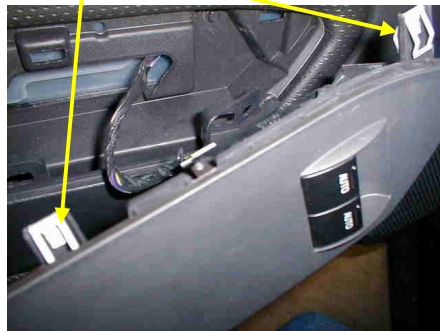
The upper switch housing and lower portion came off as one whole unit. There are (4) spring clips that hold it in place. (2) on the bottom, and (2) on the top.

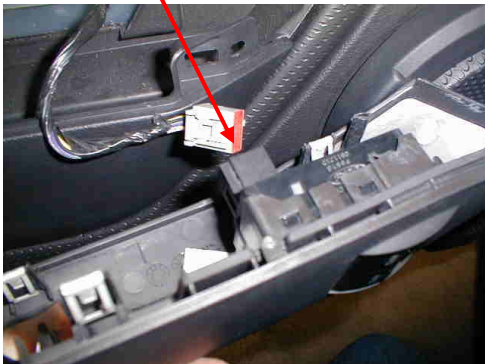
There's (1) electrical connection to the switches. It was really very simple.

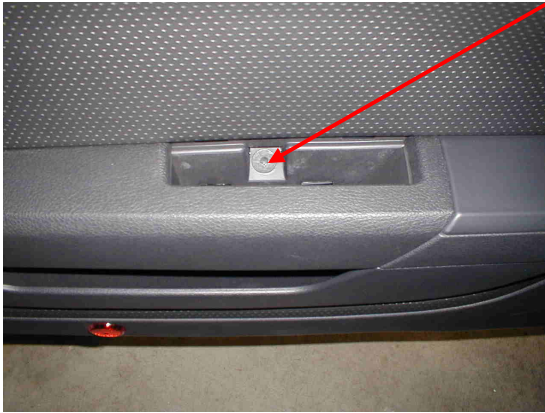
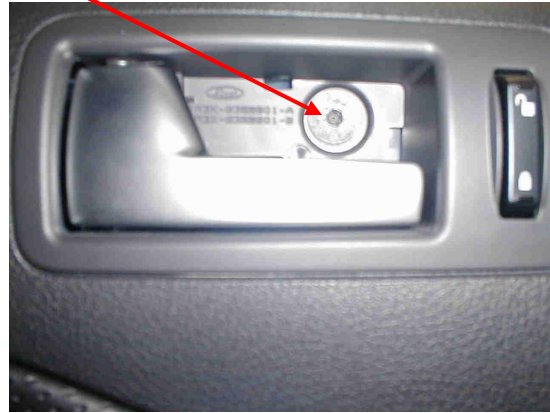
5. Remove Torx Screws:

I removed the 2 torx screws using a T-30 torx bit and driver.

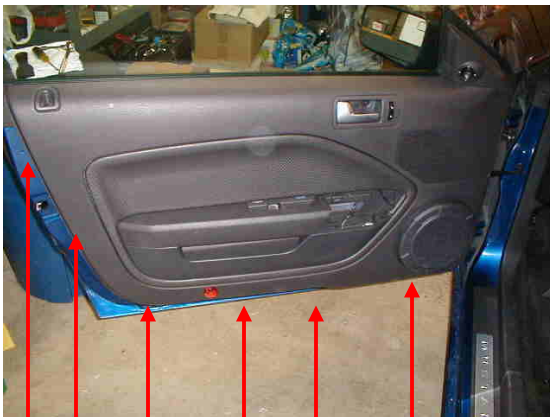
(1) (2) (3) (4) (5) (6)

I then removed the (9) 7mm screws that hold the door panel in place. The screws were all clearly visible around the edge of the panel (except screw 7).

** Note: The 2 pictures above show the sail panel in place because they were taken when I was putting everything back together. At this step in the process the sail panel was actually removed from my door. I just forgot to take a picture of this view when I was disassembling everything.

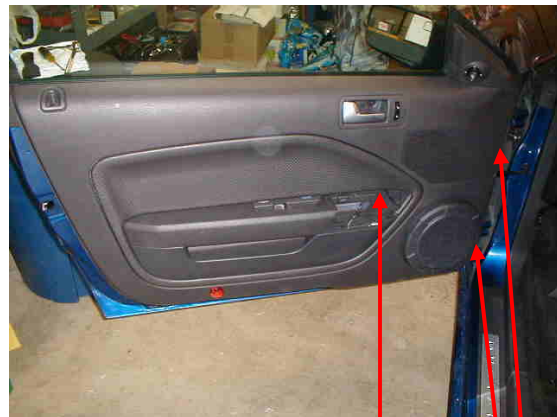
I almost missed this one (7) (8)(9)

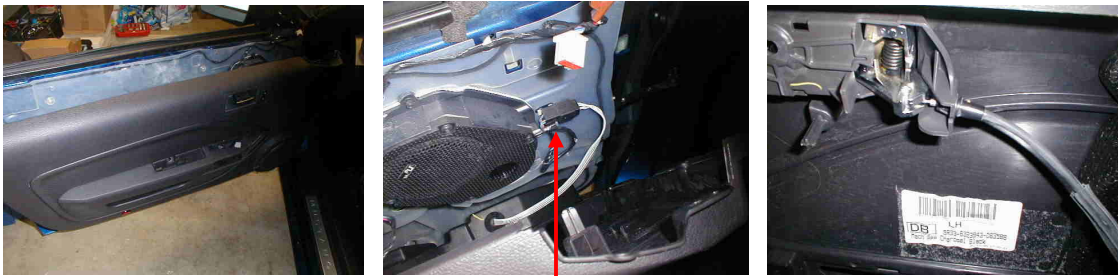
7. Remove The Door Panel:

While standing against the inside of the door I gripped the door panel from the bottom with my right hand and braced the top of the panel with my left. As I pulled up on the panel with my right hand I pulled the top lip toward me with my left, "unlatching" it from lip on top of the door. There are two large plastic tabs near the bottom of the panel that act as hinges. I was able to tilt the panel toward me and that gave me access to the speaker connection, power door lock connection, and door handle cable.

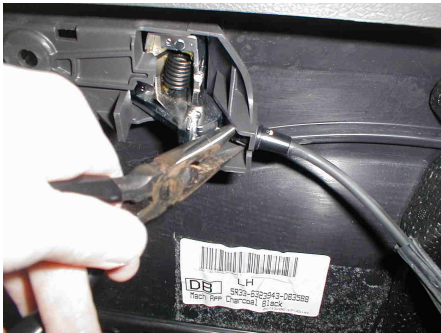
The speaker connection has a little button on the bottom that must be pushed in to disconnect the plug. There's also the power door lock (not pictured) that must be disconnected.

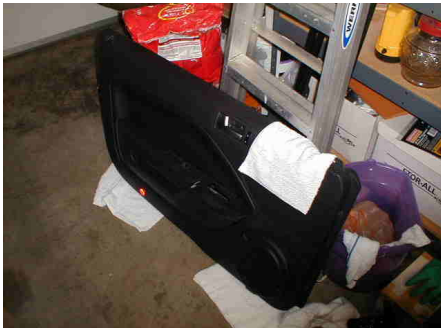
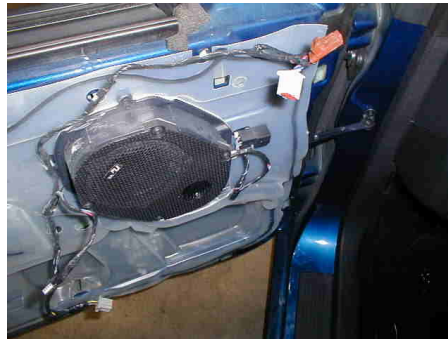
I released the door handle cable with a pair of needle-nose pliers. I squeezed the two plastic tabs in then pushed the cable back through the hole. The metal cable then slipped through the slot on the side of the bracket and I removed the end from the latch similar to a bicycle brake cable.

The subwoofer remained attached to the door panel. The other speaker remained on the door.

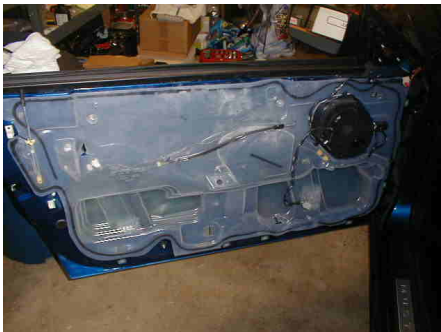
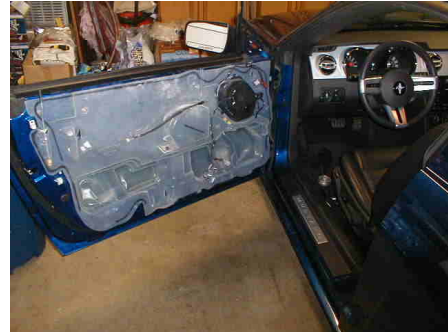
Here's what the door looks like without the panel.

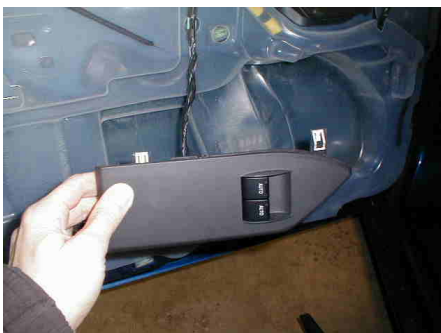
8. Getting Power Back to the Window:

I then reconnected the window switches so I could operate the window.

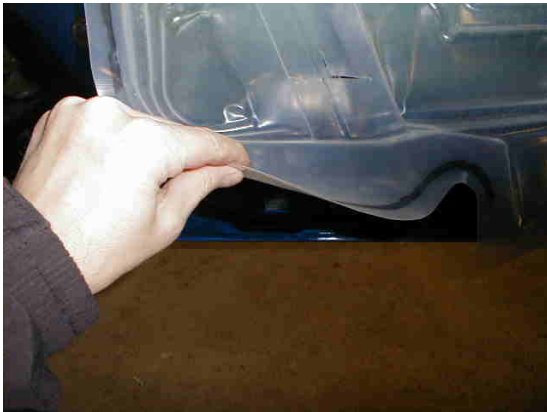
9. Getting Access to the Window Adjustment:

I then raised the window to a height that gave me access the window stop adjustment. I figured that was what I needed to adjust the window.

The water barrier on my door pulled away after some force. When I put it back I'm not sure if it's sealed as good as the factory but it seems to be ok.

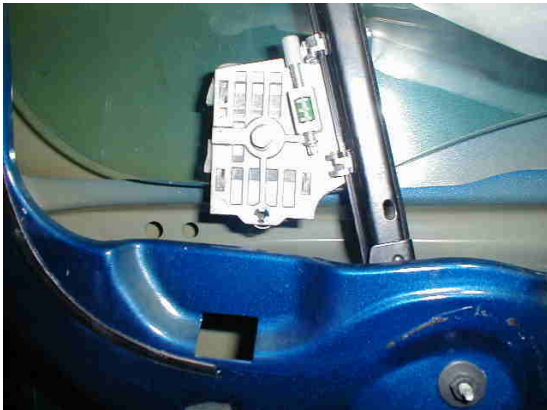
Back

These are the Window Adjusters and what actually holds the window in:

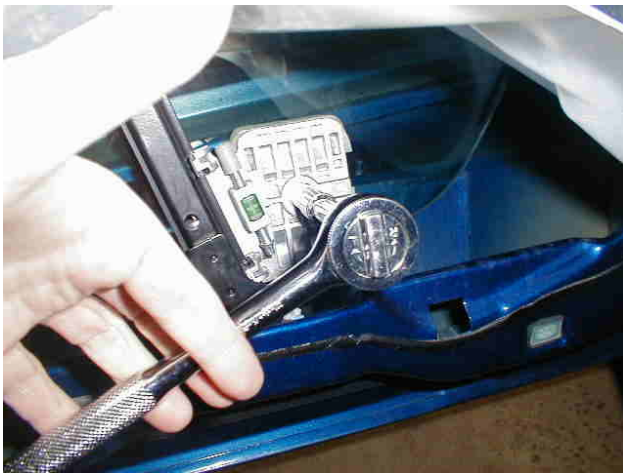
10. Adjusting the Window:

I tried to adjust the window using the adjustment screws, but it wasn't enough so I loosened the bolts that hold the window in place.

This was a little scary, but I loosened them just enough to allow the window to be pushed up and down. The window seems to fit like a "sandwich" between the nylon (plastic?) that squeezes closed with the bolt.

After I loosened the bolts I reached inside the door frame and raised or lowered the glass (on the brackets) just a little. Then I snugged the bolts back down and raised and lowered the window with the car's power to check the alignment. This required opening and closing the door several times to check the drop feather and sealing abilities, as well as checking to see that it was lowering into the door enough. I spent a good 45 minutes or so adjusting, checking, adjusting, checking, and so on.

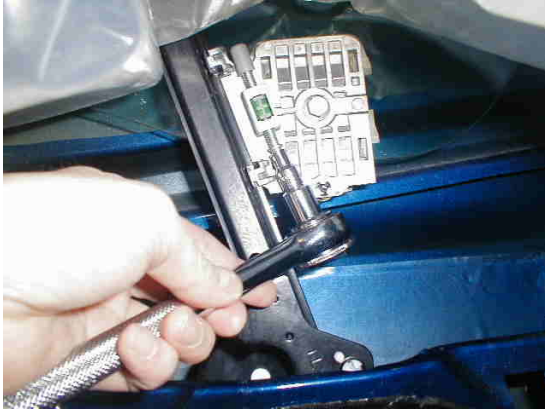
After I got the window as good as I could using the window mounting bolts I did some fine tuning with the front and back window stop adjustments. I used a 5mm socket for this.

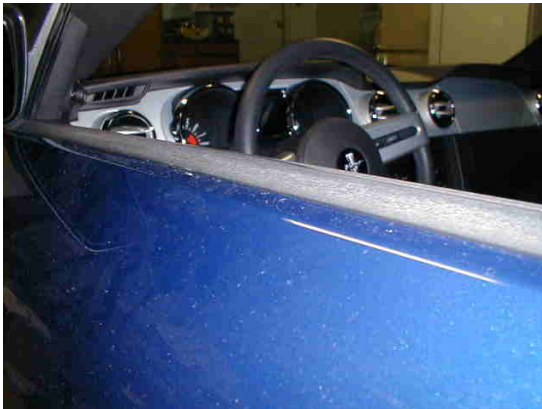
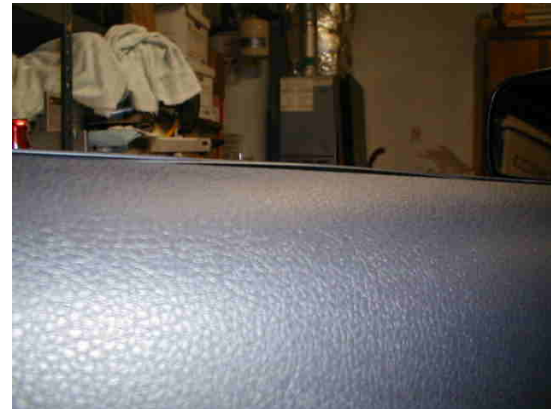
After

It seals good, doesn't pull up on the rubber mirror trim, doesn't catch on the plastic rain-drip trim when I open the door, and now the top of the window sits almost level with the top of the door when the window's down.
