TPMS Warranty

Examples of Non-Warrantable Damage on the New Valve-mounted sensor:

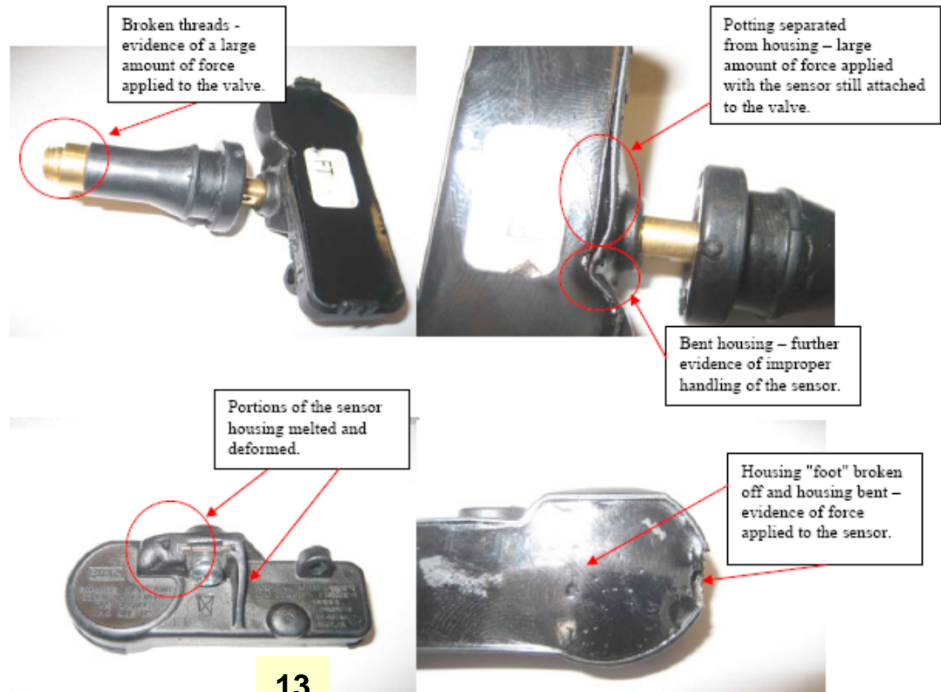
Examples of Non-Warrantable Damage on the New Valve-mounted sensor:

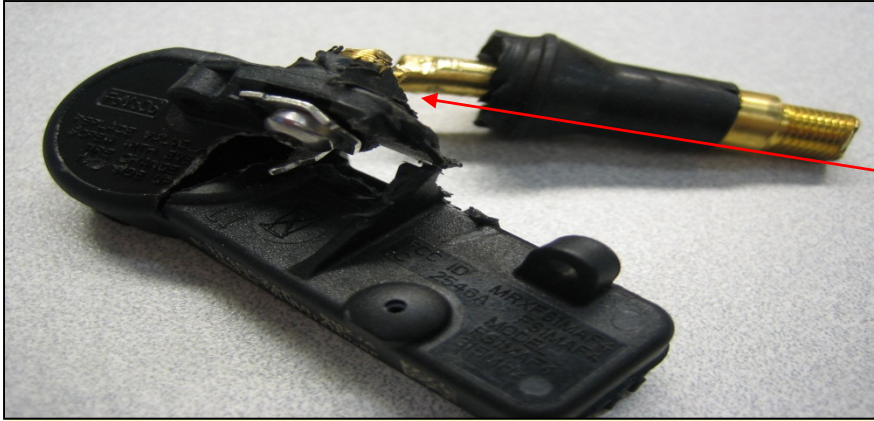
Examples of Non-Warrantable Damage on the New Valve-mounted sensor:

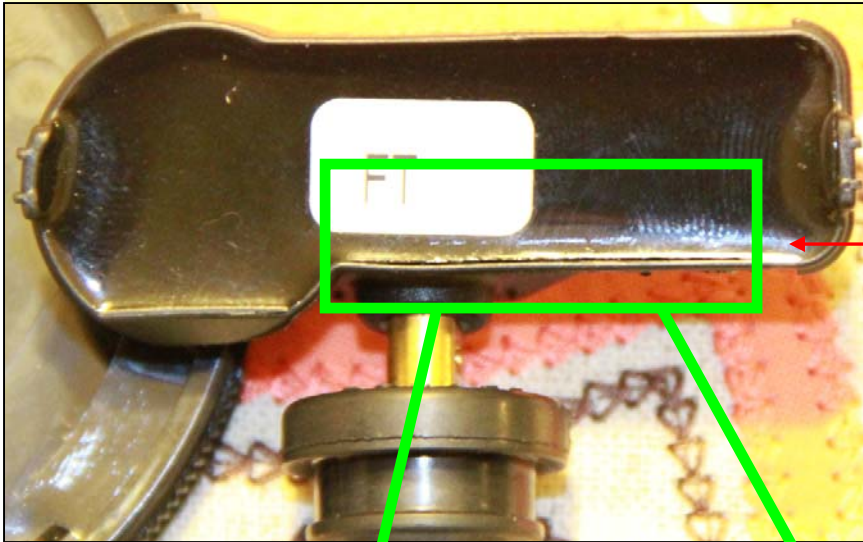
Severe chassis damage from attempting to pull the valve out with sensor attached

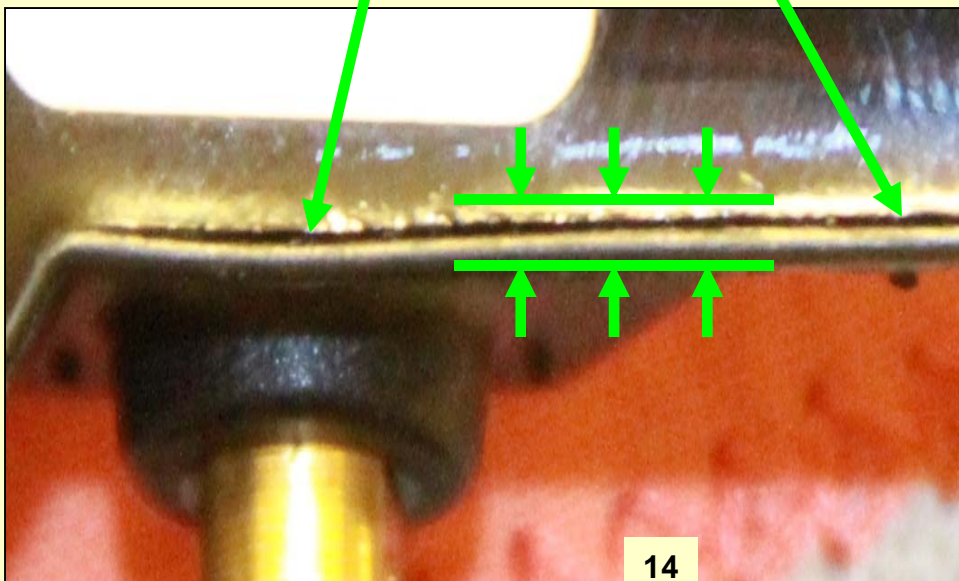
Detail of housing showing potting separation due to heavy force applied to the valve. If a finger nail or business card can be inserted between the TPMS sensor housing and potting, the TPMS sensor has been damaged. Damage of this nature is most often caused by improper tire removal or attempting to remove the valve stem like a conventional rubber valve stem.
