SPARK PLUG REMOVAL INSTRUCTIONS—4.6L 3V/5.4L 3V/6.8L 3V

Concern Tracking# 069-2008-1155

This article supersedes TSB **08-1-9** to update Vehicle Applications, Service Procedure and Part List.

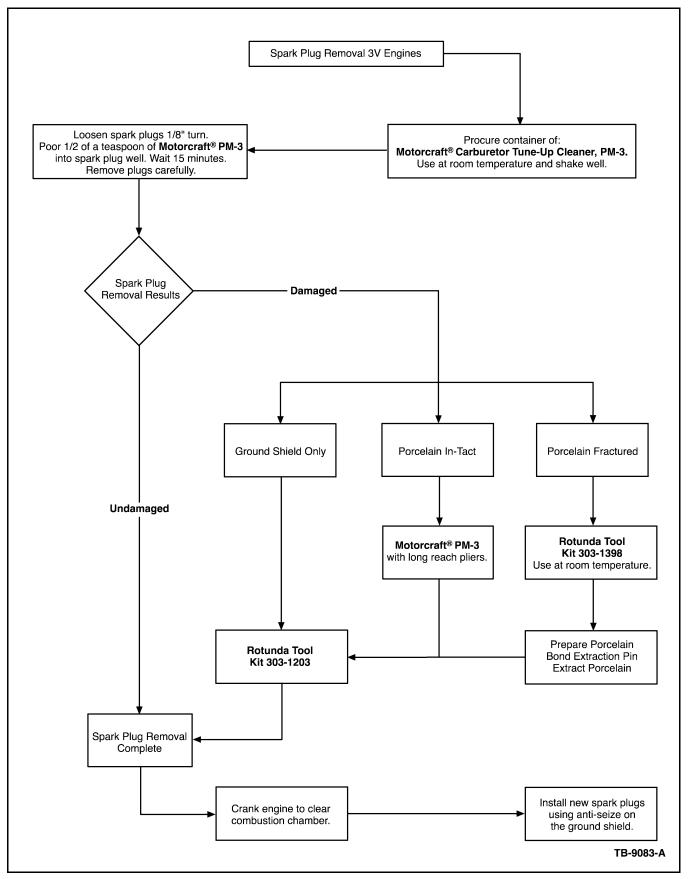
Figure 5 - Article 069-2008-1155

Flowchart of procedure. (Figure 5)

If the spark plug separates after following the Spark Plug Removal Procedure, it will fail in one of three modes. Refer to the appropriate removal procedure as required.

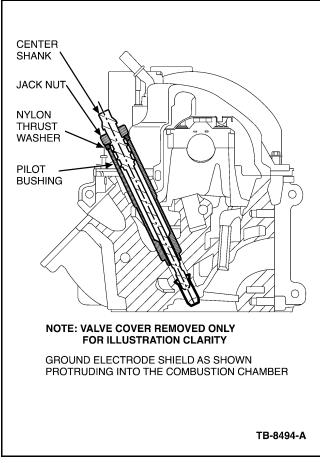
Figure 9 - Article 069-2008-1155

4. Thread Rotunda special service tool 303-1203 into the ground electrode shield. (Figure 9)

- a. Install the stepped end of the tool pilot bushing into the spark plug well ensuring it bottoms out.
- Screw the center shank into the ground electrode shield. Do not over tighten the shank, to prevent thread stripping.
- c. Install the nylon washer and jack nut until finger tight.
- d. Turn the jack nut until the ground electrode is freed from the cavity and withdraw the tool assembly.

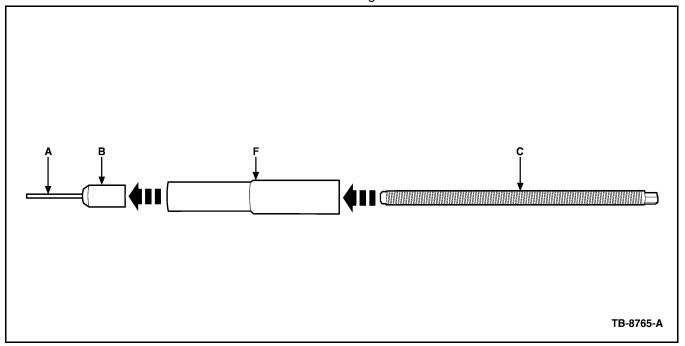
Figure 12 - Article 069-2008-1155

- 1. Remove any remaining electrode material from broken porcelain with long nose reach pliers.
- 2. Spray Motorcraft® Metal Brake Parts Cleaner into the porcelain hole for 2-4 seconds using the straw nozzle supplied with the brake cleaner can.
- 3. Insert a pin (A) into the collet (B). Screw the collet onto the threaded rod (C). Install the assembled collet, pin, and threaded rod into the steel tool pilot (F). (Figures 11 and 12)

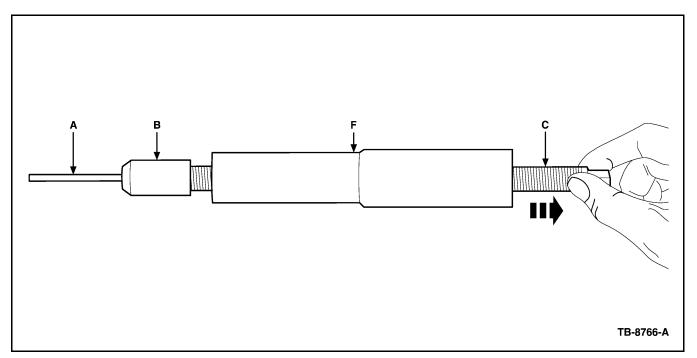
Figure 13 - Article 069-2008-1155

4. Retract the collet and pin into the steel tool pilot, protecting the pin. (Figures 13 and 14)

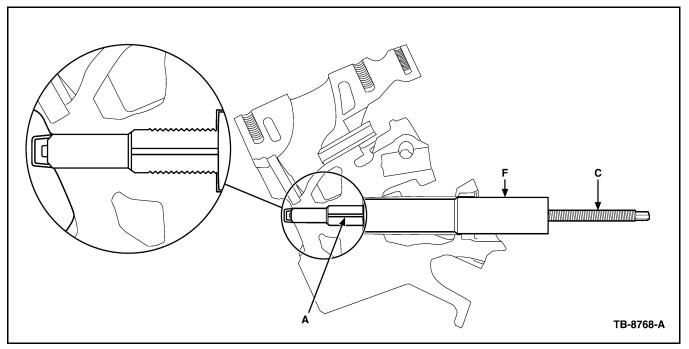
Figure 15 - Article 069-2008-1155

5. Insert the completed assembly into the spark plug well and fully engage the pin into the porcelain. (Figure 15)

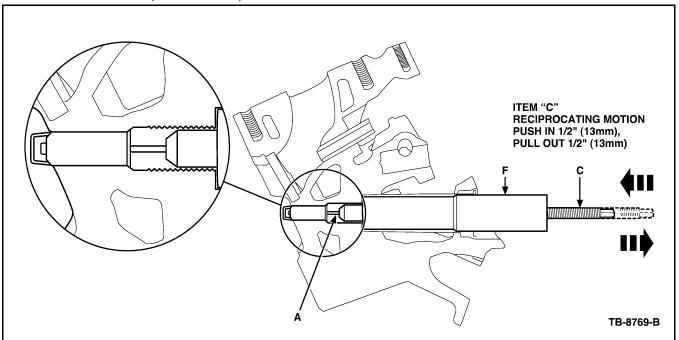
Figure 16 - Article 069-2008-1155

- 6. Spray Motorcraft® Metal Brake Parts Cleaner 2-4 seconds between the spark plug well and steel tool pilot. The steel tool pilot must be lifted up approximately 1/2" to allow brake cleaner to flood the porcelain and pin.
- Scrub the porcelain inside diameter by moving the threaded rod up and down vigorously. Take care making sure the pin does not disengage the porcelain. (Figure 16).

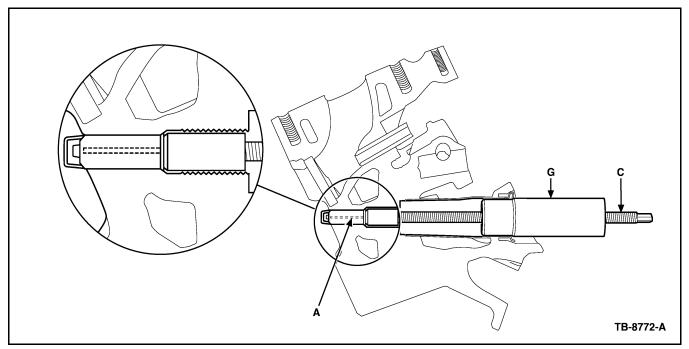
Figure 19 - Article 069-2008-1155

- Insert the completed assembly into spark plug well and fully engage the pin into the porcelain with a twisting motion to spread the bonding agent.
- Add additional Loctite® 638[™], repeating Steps 6-8.
- 10. Leave the pin fully inserted in the porcelain while the adhesive cures. Replace the steel tool pilot with the aluminum alignment sleeve (G), Figure 9, to support the threaded rod while the adhesive cures if additional porcelain fragments are present in other cylinders. (Figure 19).
