This article supersedes TSB **08-1-9** to update Vehicle Applications, Service Procedure and Part List.

ISSUE

Some 2004-2008 F-150, 2006-2008 Mark LT, 2005-2008 F-Super Duty, Expedition, and Navigator, with 5.4L 3-V engine; 2005-2008 Mustang, 2006-2008 Explorer, Mountaineer, and 2007-2008 Explorer Sport Trac with 4.6L 3-V engine; 2005-2008 F-Super Duty, 2006-2008 and F-Stripped Chassis, with 6.8L 3-V engine may experience difficulty with spark plug removal. This may cause damage to the spark plug and leave part of the spark plug in the cylinder head. Affected engine build dates are as follows: 5.4L 3-V and 6.8L 3-V before 10/9/07, 4.6L 3-V before 11/30/07.

Spark Plug Removal Procedure

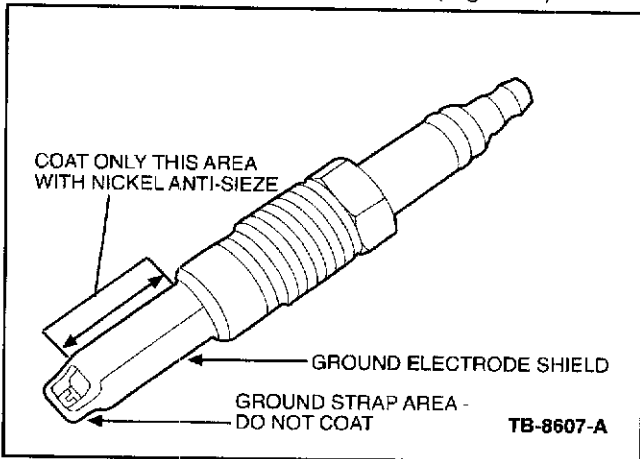
Figure 1 - Article 08-7-6

NEW PLUGS SHOULD BE INSTALLED USING A FILM COATING OF MOTORCRAFT HIGH TEMPERATURE NICKEL ANTI-SEIZE LUBRICANT ON THE GROUND ELECTRODE SHIELD. DO NOT COAT THE ELECTRODE STRAP. (Figure 1)

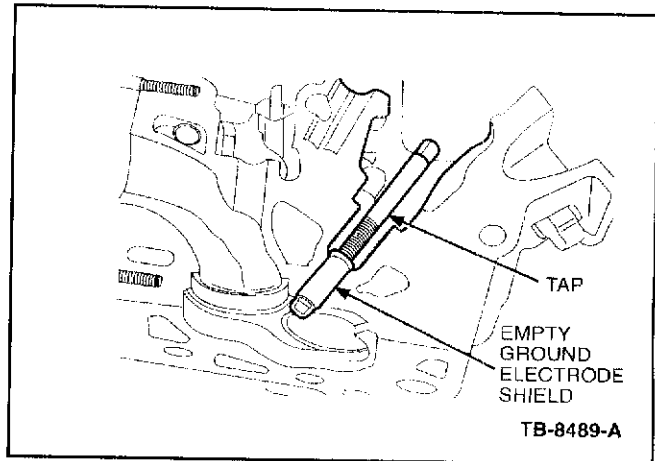
Figure 2 - Article 08-7-6

- a. Mode 1: The ground electrode shield is left behind as an empty shell. (Figure 2)

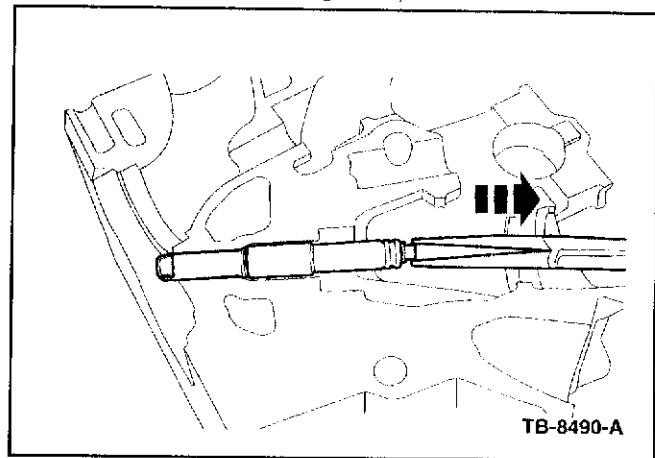
Figure 3 - Article 08-7-6

- b. Mode 2: The entire porcelain insulator and ground electrode shield remains in the cylinder head. (Figure 3)

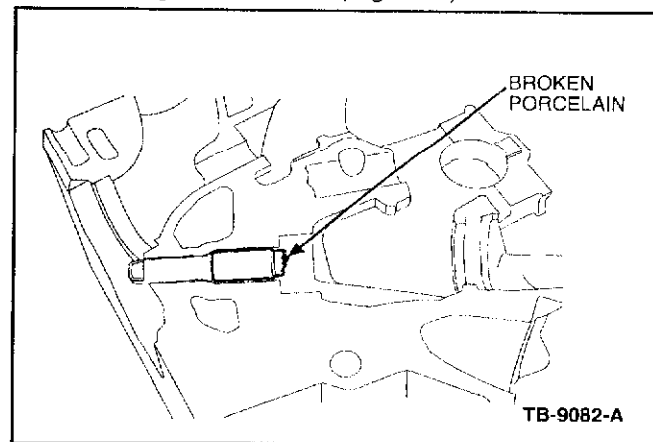
Figure 4 - Article 08-7-6

- c. Mode 3: The upper section of porcelain broke off with remaining porcelain left inside the ground shield. (Figure 4)

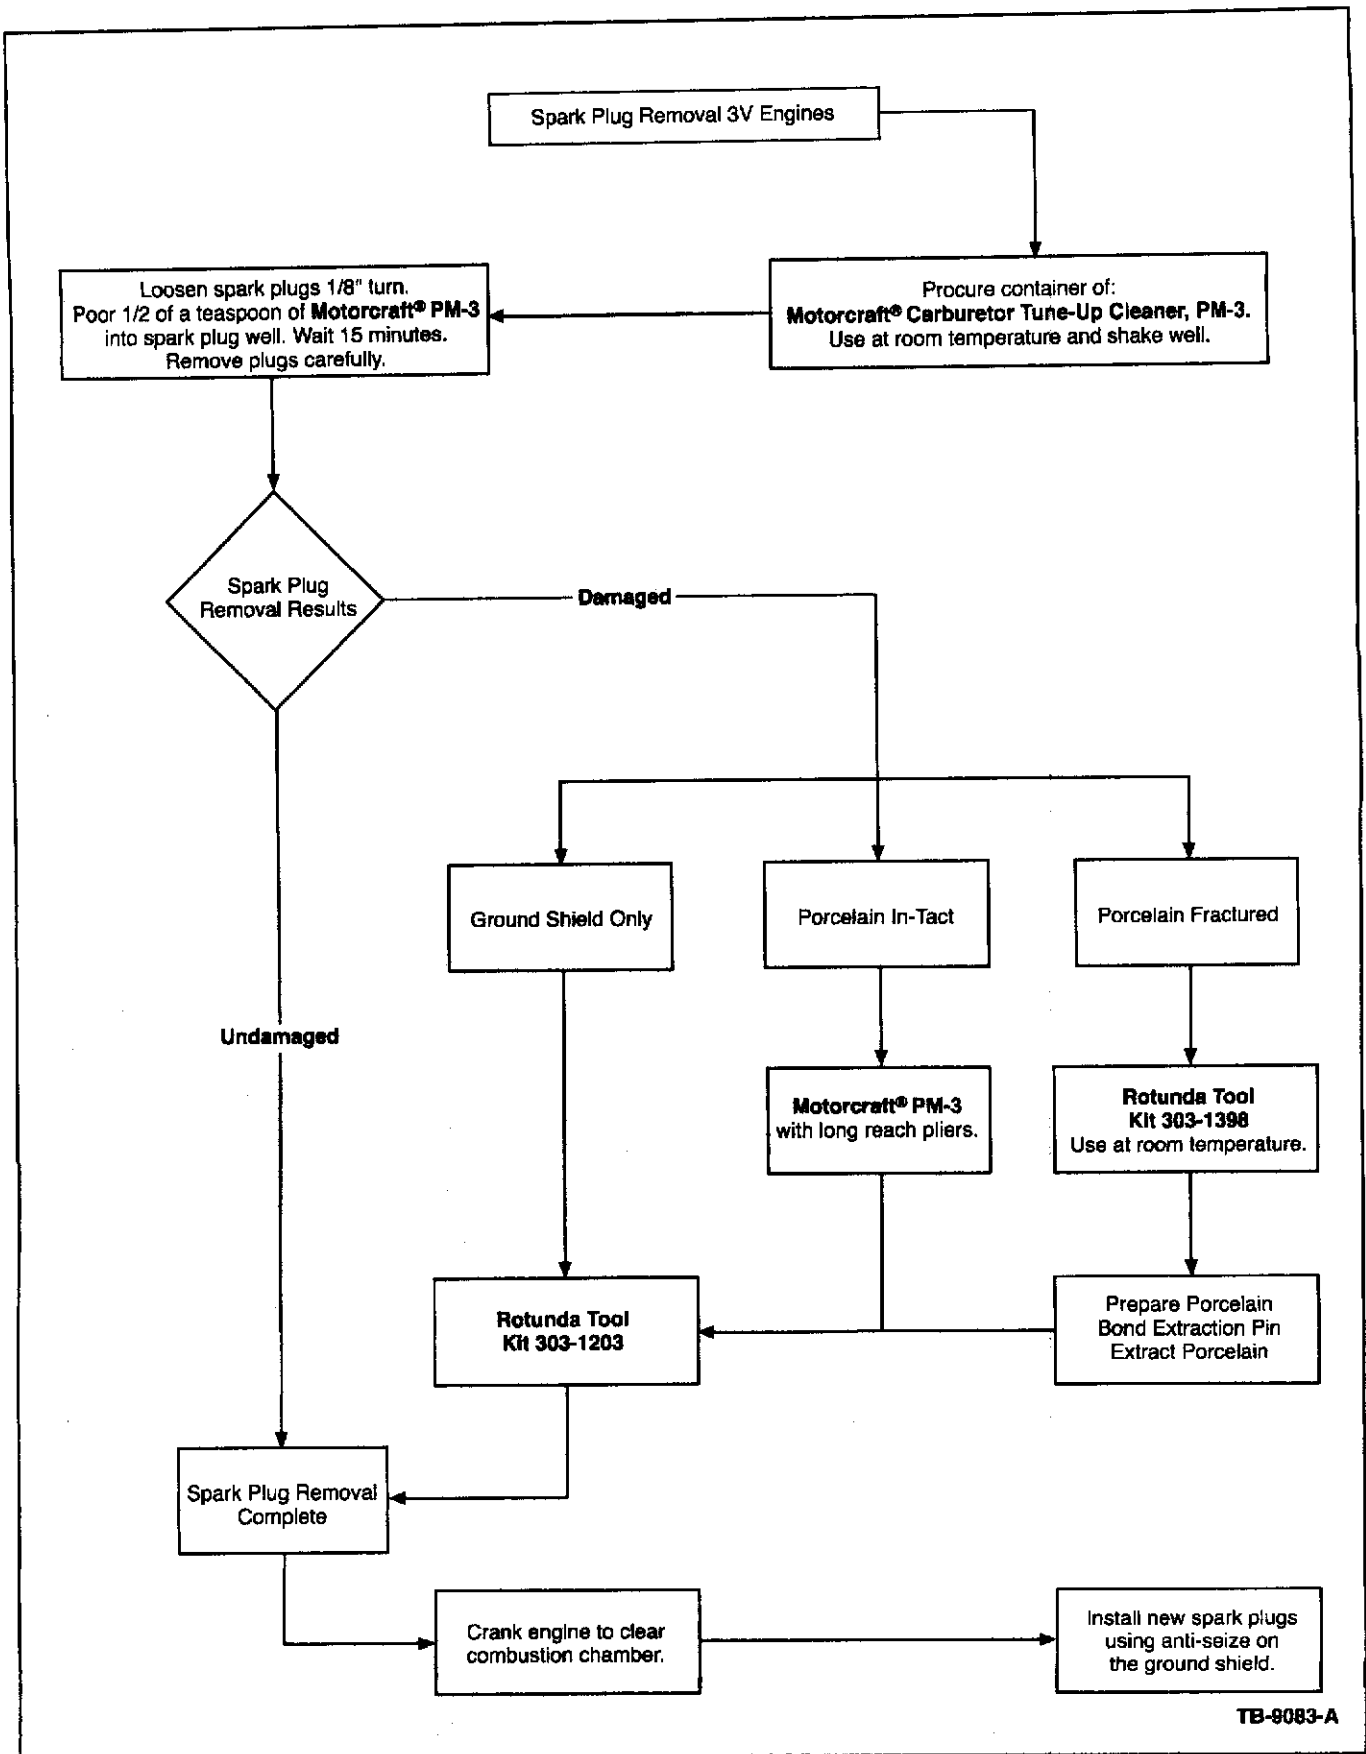
Figure 5 - Article 08-7-6

Flowchart of procedure. (Figure 5)

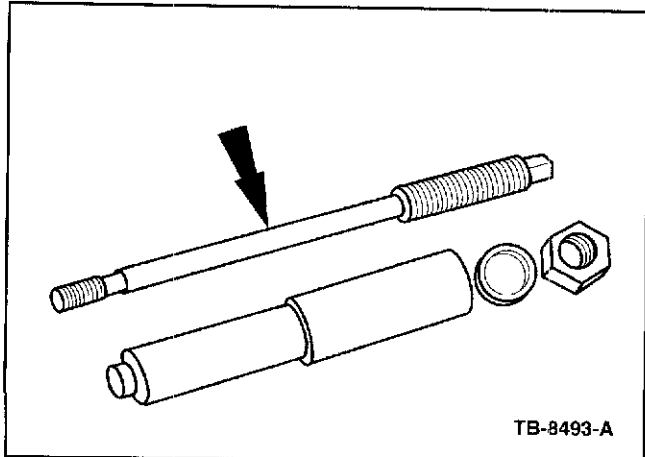
Figure 6 - Article 08-7-6

Use Rotunda special service tool 303-1203 to remove an empty ground electrode shield from the cylinder head. (Figure 6)

THIS TOOL IS ONLY DESIGNED TO WORK WITH AN EMPTY GROUND ELECTRODE SHIELD. IF PORCELAIN REMAINS, PROCEED TO MODE 2 OR 3 REMOVAL.

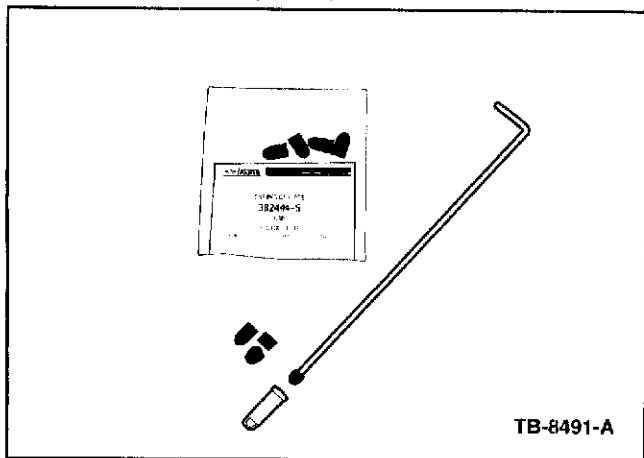
Figure 7 - Article 08-7-6

1. Modify vacuum cap to a 3/8" (10 mm) length for each ground electrode shield that needs to be removed. (Figure 7)

2. Use the installation rod (J) provided with service tool 303-1203 update to install the modified vacuum cap. Push the cap into the ground shield down to the electrode strap. This will plug and protect the combustion chamber from contamination. (Figure 7)

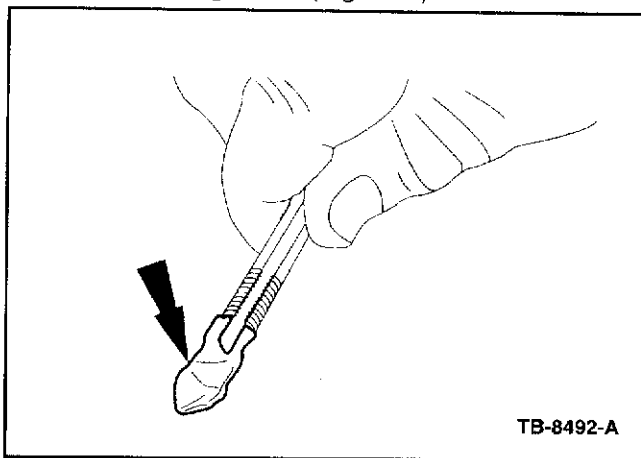
Figure 8 - Article 08-7-6

3. Thread-tap the ground electrode shield using a 9.0 x 1.0 mm plug tap (tap profile is about 3-4 reduced diameter threads on the tip end).
 - a. Coat the end of the tap with general purpose grease. (Figure 8)

- b. Turn the tap about 3 to 4 turns into the ground electrode shield. Back the tap up frequently to break chips and avoid cut material from coiling-up in the spark plug well. A tap socket adaptor (K) is provided with service tool 303-1203 update to connect the tap to a 3/8" socket drive.

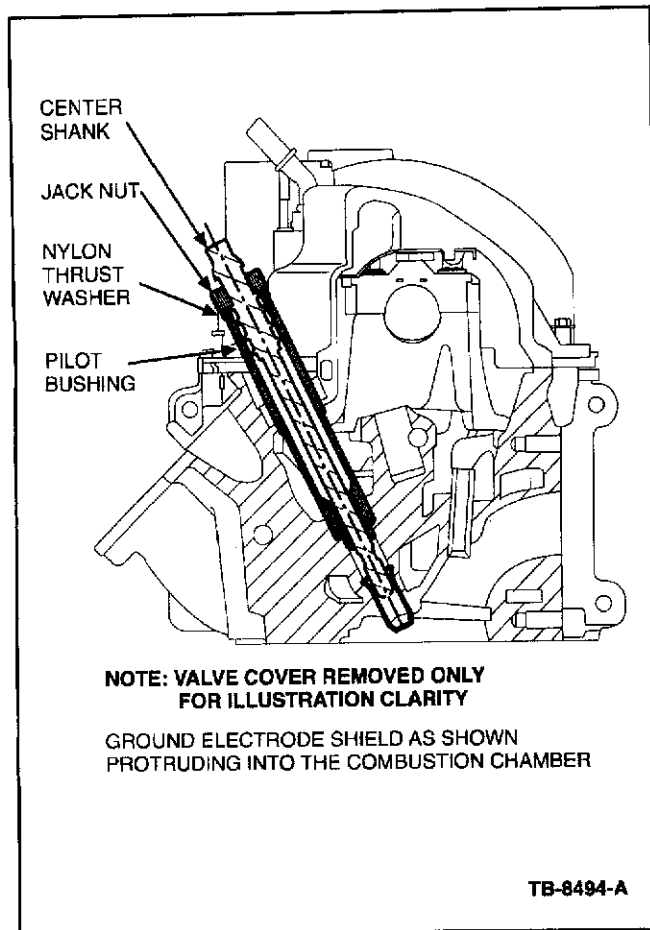
Figure 9 - Article 08-7-6

4. Thread Rotunda special service tool 303-1203 into the ground electrode shield. (Figure 9)

- a. Install the stepped end of the tool pilot bushing into the spark plug well ensuring it bottoms out.
- b. Screw the center shank into the ground electrode shield. Do not over tighten the shank, to prevent thread stripping.
- c. Install the nylon washer and jack nut until finger tight.
- d. Turn the jack nut until the ground electrode is freed from the cavity and withdraw the tool assembly.

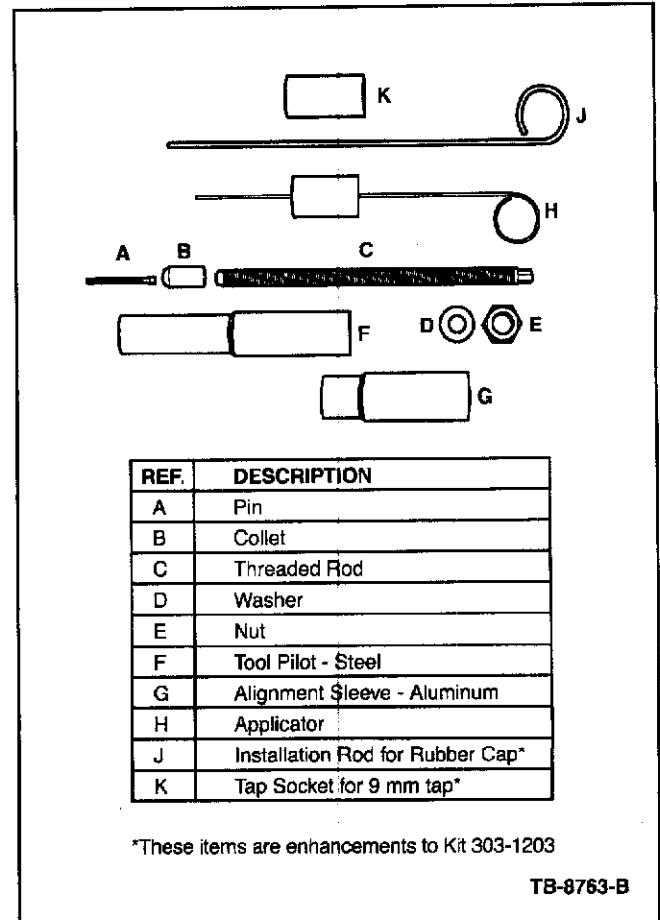
Figure 10 - Article 08-7-6

Use Rotunda special service tool kit 303-1398 to remove porcelain broken inside the ground electrode shield. (FIGURE 10)

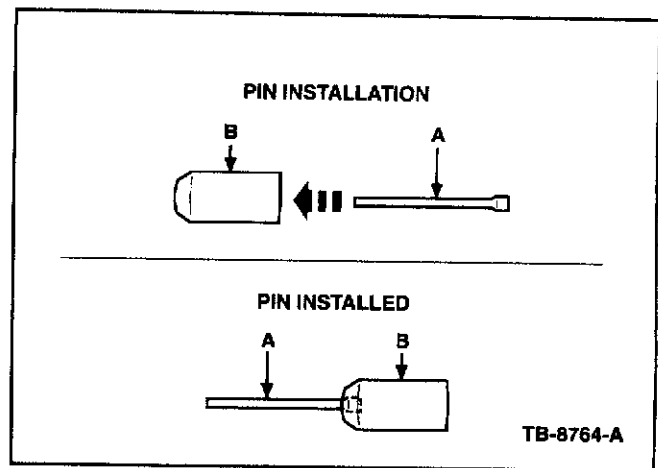
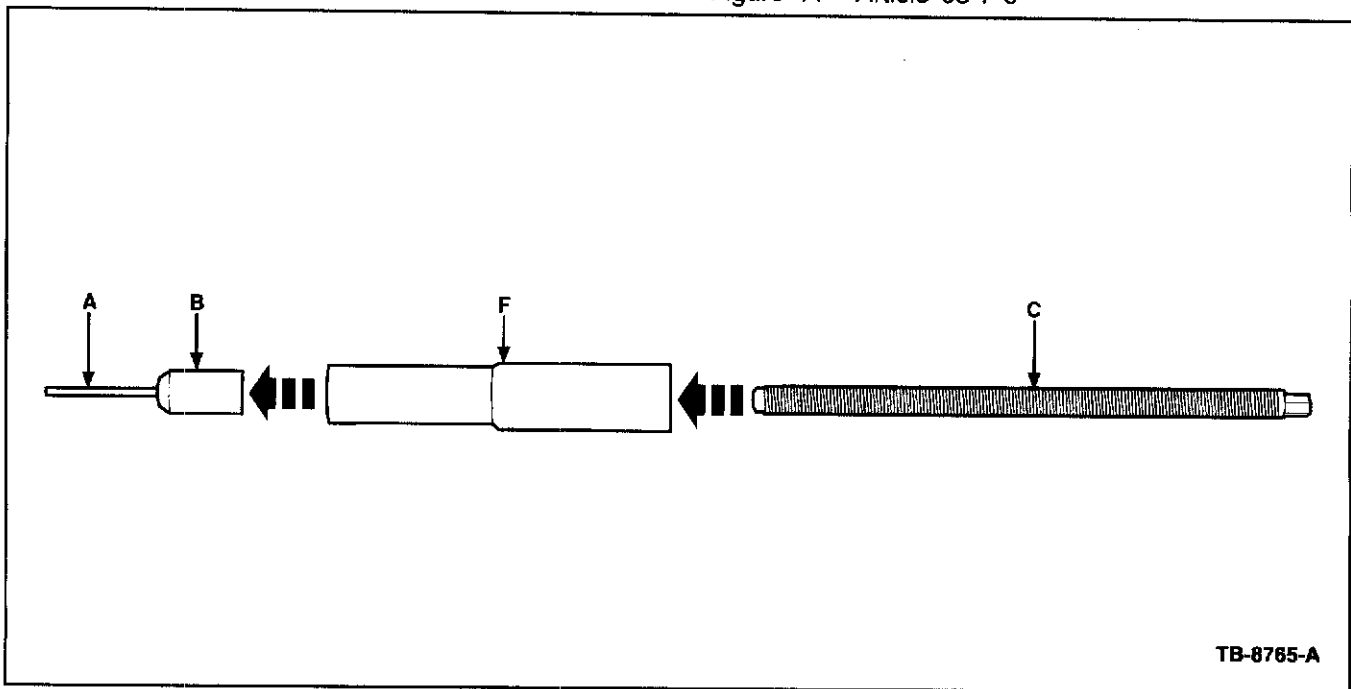
1. Remove any remaining electrode material from broken porcelain with long nose reach pliers.
2. Spray Motorcraft® Metal Brake Parts Cleaner into the porcelain hole for 2-4 seconds using the straw nozzle supplied with the brake cleaner can.
3. Insert a pin (A) into the collet (B). Screw the collet onto the threaded rod (C). Install the assembled collet, pin, and threaded rod into the steel tool pilot (F). (Figures 11 and 12)

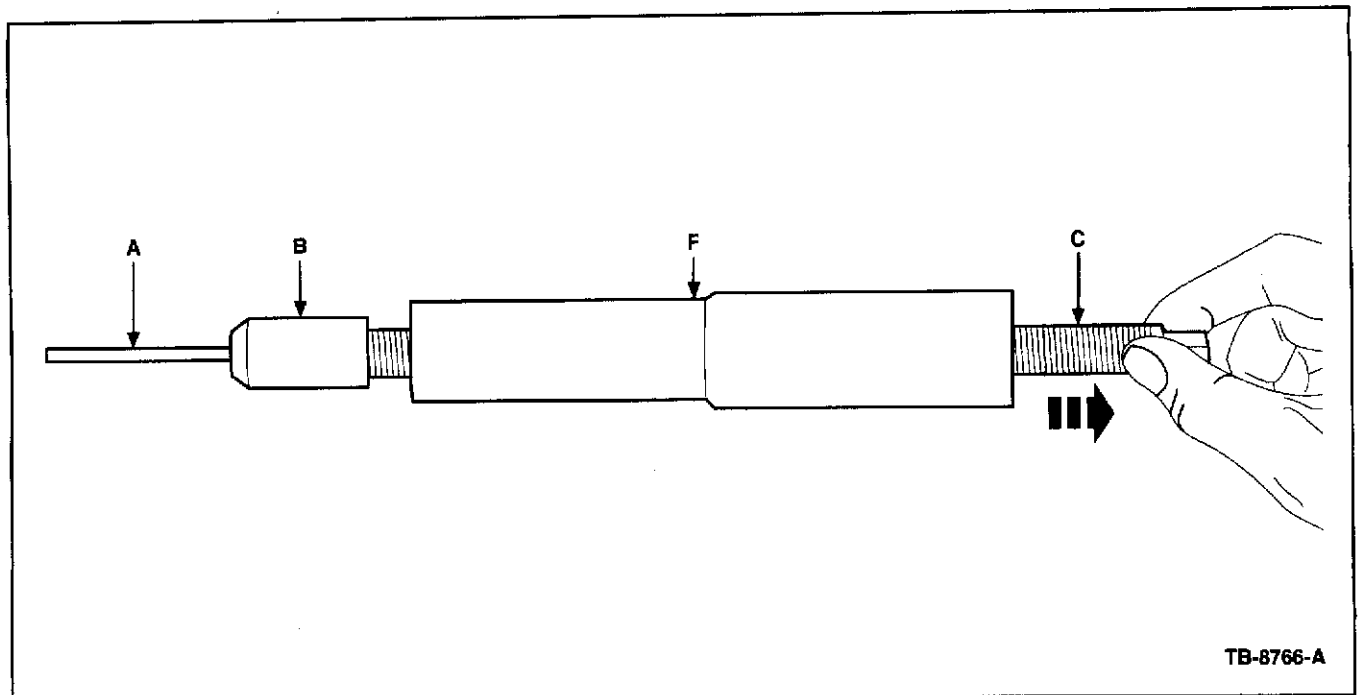
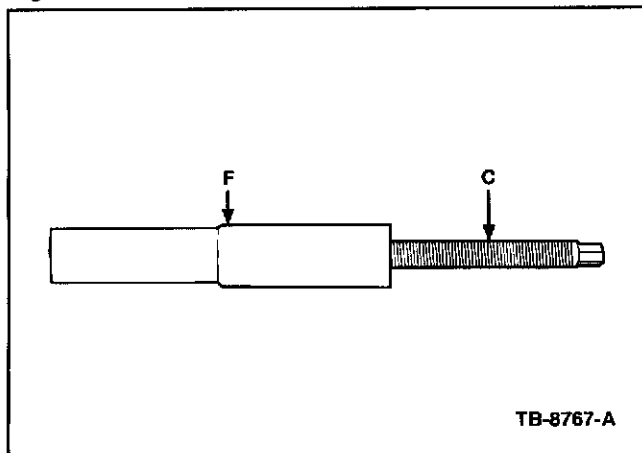
4. Retract the collet and pin into the steel tool pilot, protecting the pin. (Figures 13 and 14)

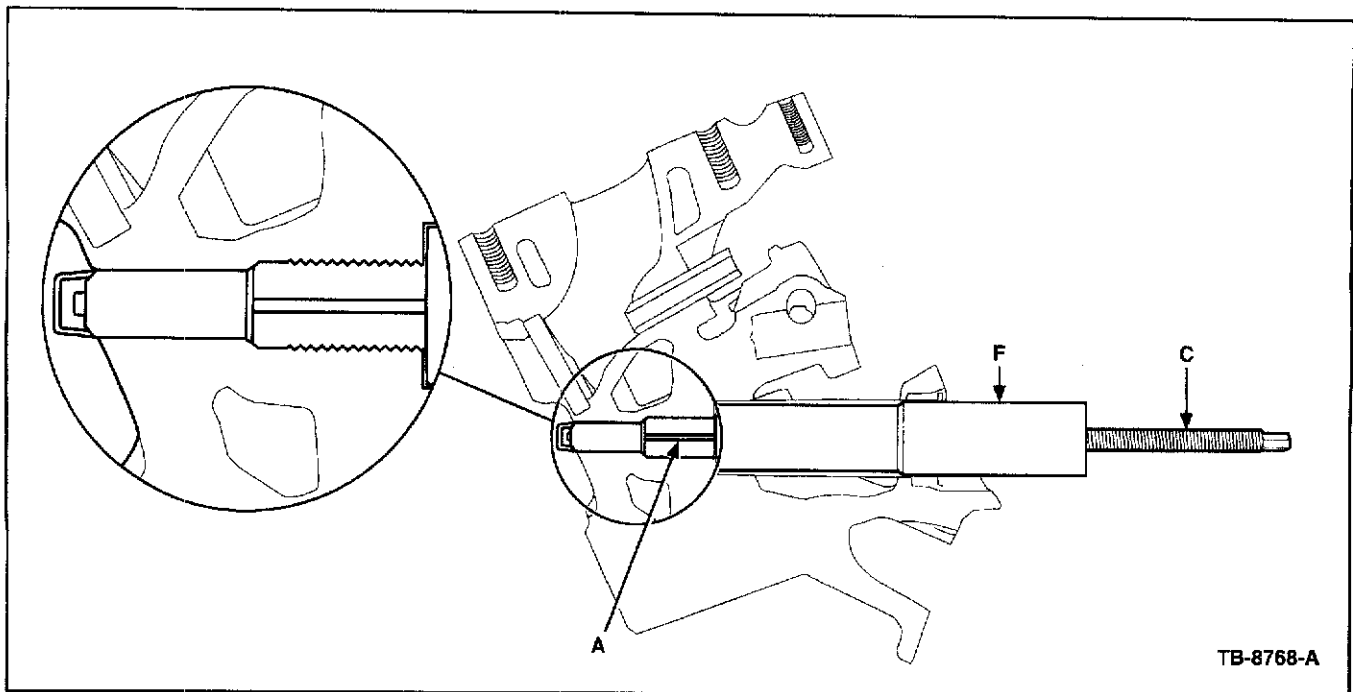
Figure 15 - Article 08-7-6

5. Insert the completed assembly into the spark plug well and fully engage the pin into the porcelain. (Figure 15)

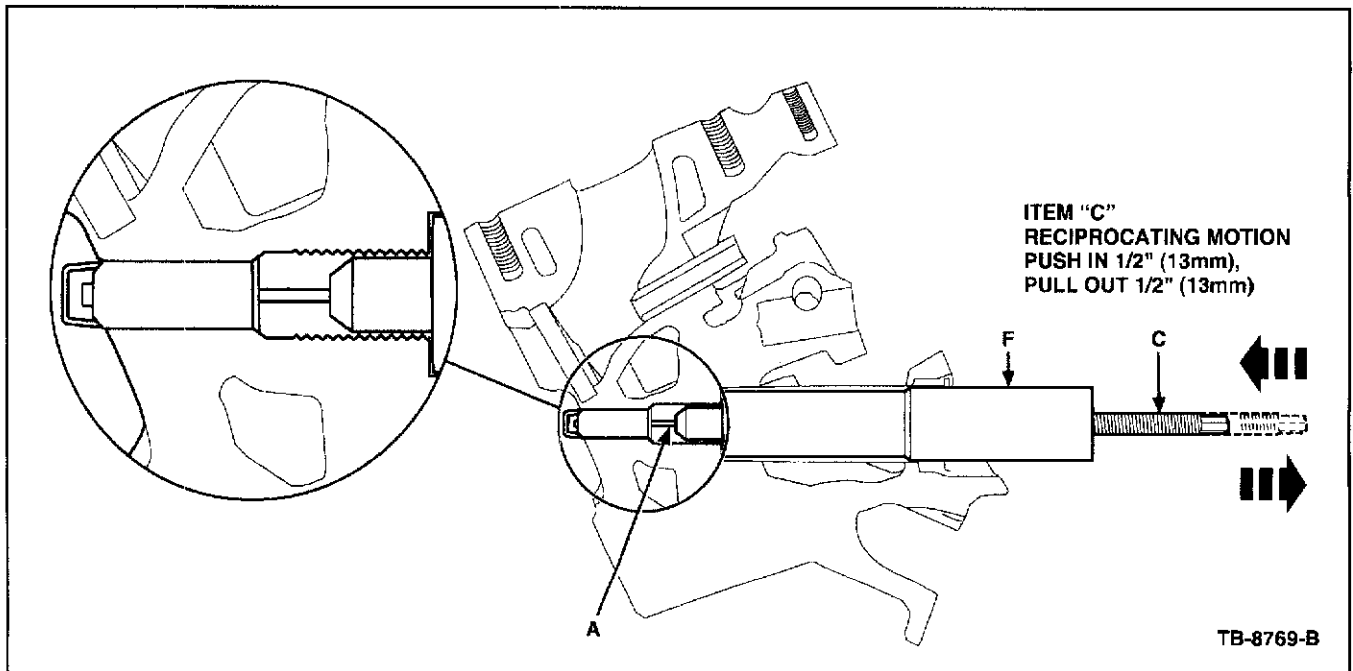
Figure 16 - Article 08-7-6

6. Spray Motorcraft® Metal Brake Parts Cleaner 2-4 seconds between the spark plug well and steel tool pilot. The steel tool pilot must be lifted up approximately 1/2" to allow brake cleaner to flood the porcelain and pin.
7. Scrub the porcelain inside diameter by moving the threaded rod up and down vigorously. Take care making sure the pin does not disengage the porcelain. (Figure 16).

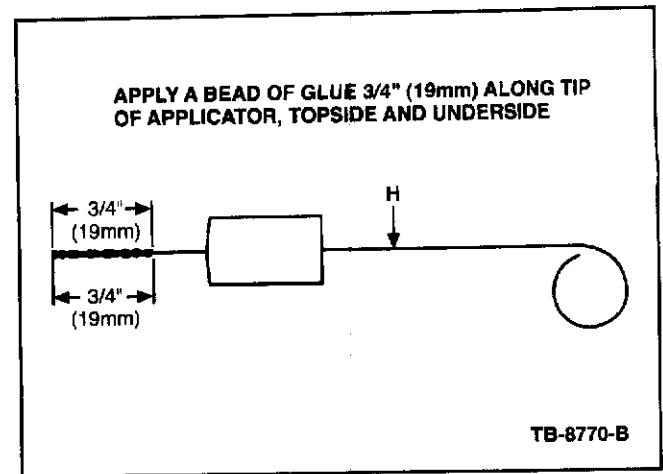
Figure 17 - Article 08-7-6

- Apply two 3/4" (19 mm) long stripes of Loctite® 638™ to opposite sides of a clean and dry applicator (H). Excessive amounts of Loctite® 638™ are being used if it drips off the applicator. (Figure 17)

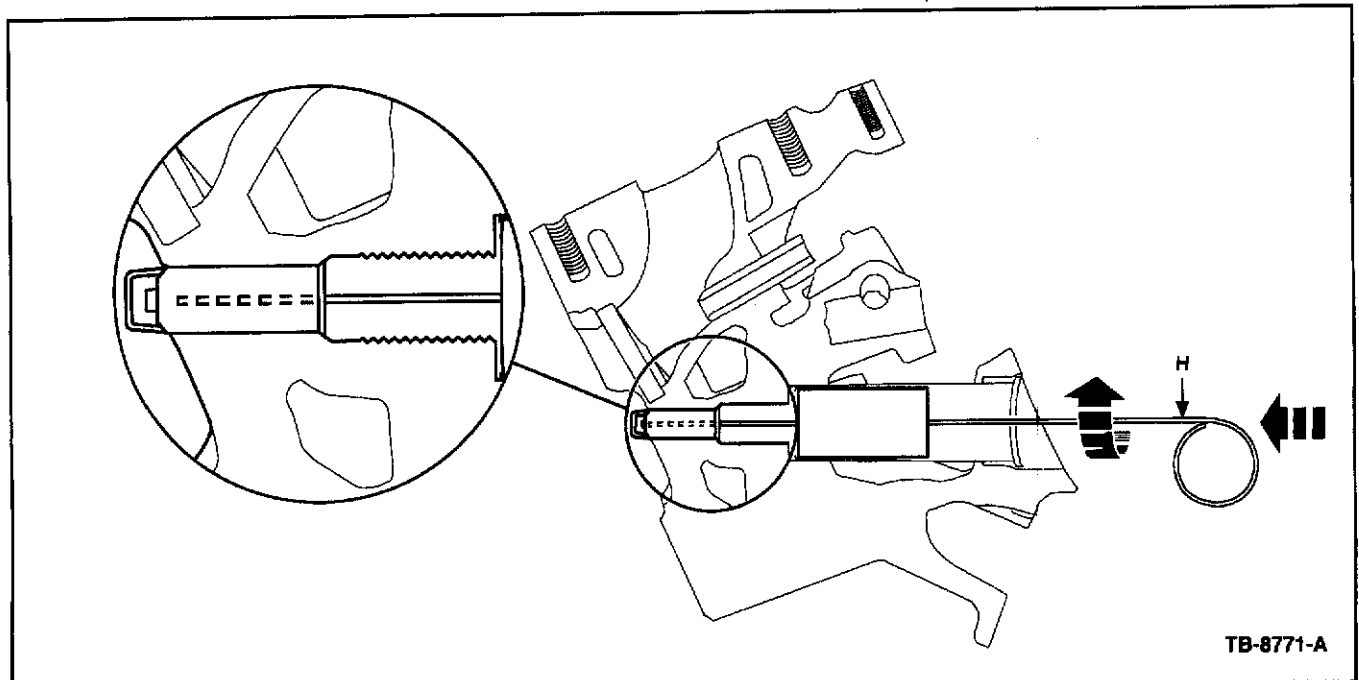
Figure 18 - Article 08-7-6

- Insert applicator into the porcelain and move applicator up and down 1/2" (13 mm) while turning to spread the Loctite® 638™ on the inside of the porcelain. (Figure 18).

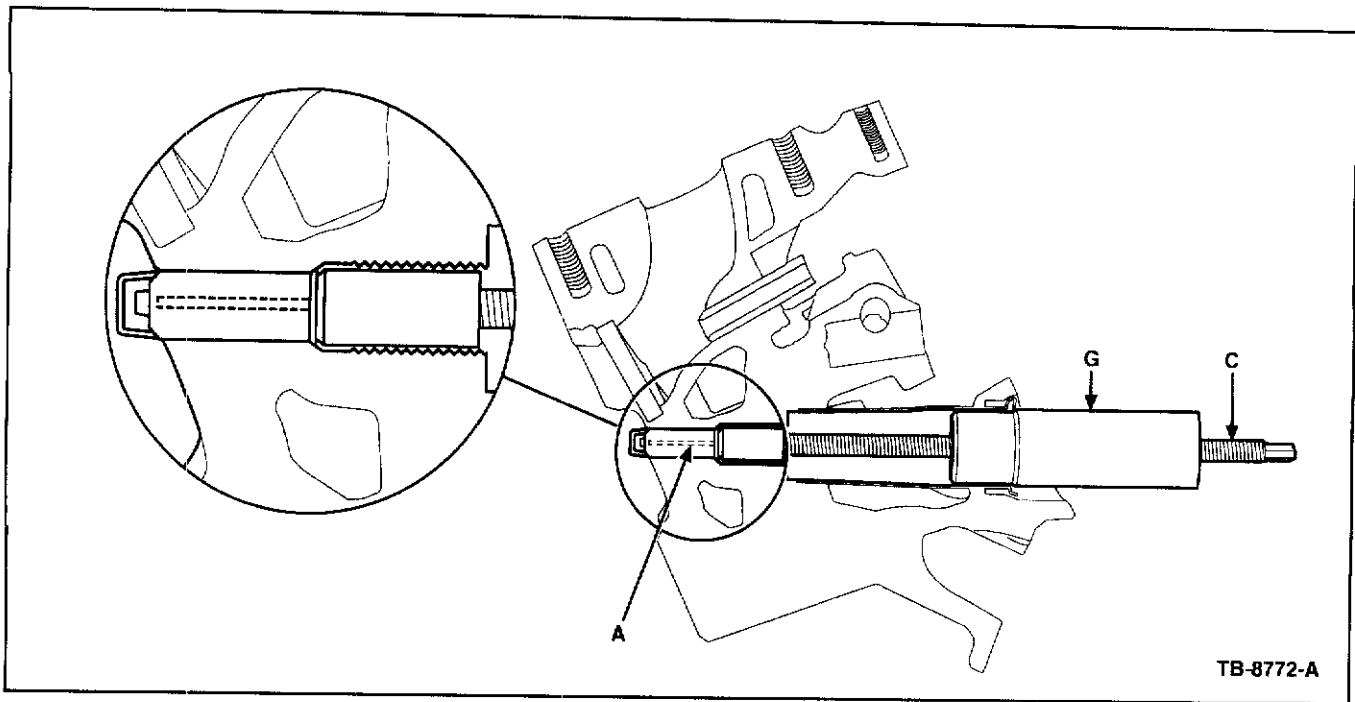
Figure 19 - Article 08-7-6

- Add additional Loctite® 638™, repeating Steps 6-8.
- Leave the pin fully inserted in the porcelain while the adhesive cures. Replace the steel tool pilot with the aluminum alignment sleeve (G), Figure 9, to support the threaded rod while the adhesive cures if additional porcelain fragments are present in other cylinders. (Figure 19).
