This article supersedes TSB **08-1-9** to update Vehicle Applications, Service Procedure and Part List.

Spark Plug Removal Procedure

TSB 08-7-6 (Continued)

Separated/Broken Spark Plug Removal

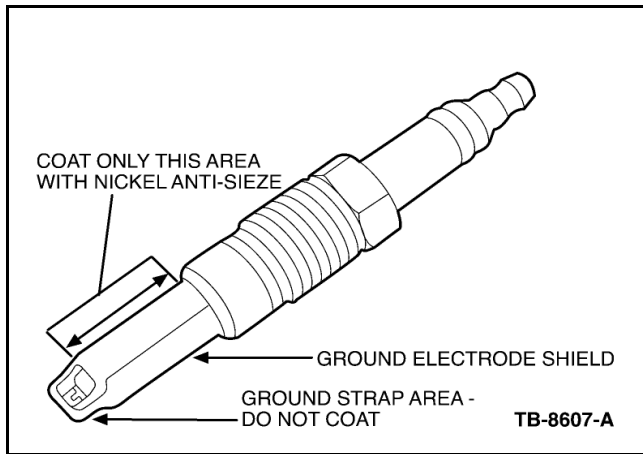
Figure 1 - Article 08-7-6

NEW PLUGS SHOULD BE INSTALLED USING A FILM COATING OF MOTORCRAFT HIGH TEMPERATURE NICKEL ANTI-SEIZE LUBRICANT ON THE GROUND ELECTRODE SHIELD. DO NOT COAT THE ELECTRODE STRAP. (Figure 1)

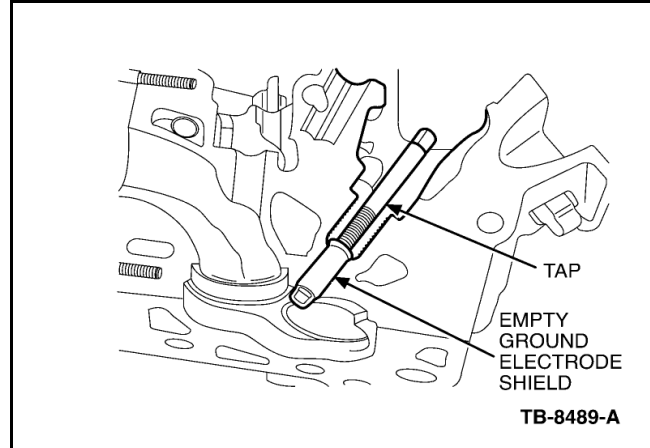
Figure 2 - Article 08-7-6

- a. Mode 1: The ground electrode shield is left behind as an empty shell. (Figure 2)

Use Rotunda special service tool 303-1203 to remove an empty ground electrode shield from the cylinder head. (Figure 6)

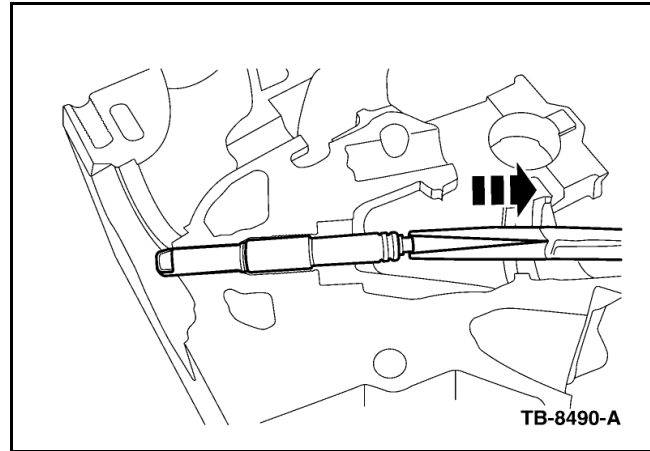
Figure 3 - Article 08-7-6

- b. Mode 2: The entire porcelain insulator and ground electrode shield remains in the cylinder head. (Figure 3)

1. Add an additional 1/2 teaspoon Motorcraft® Carburetor Tune-Up Cleaner fluid into spark plug well and allow 15 minutes of soak time.
2. Using long-reach nose pliers grasp and remove the porcelain with an up and down motion taking care not to fracture the porcelain.

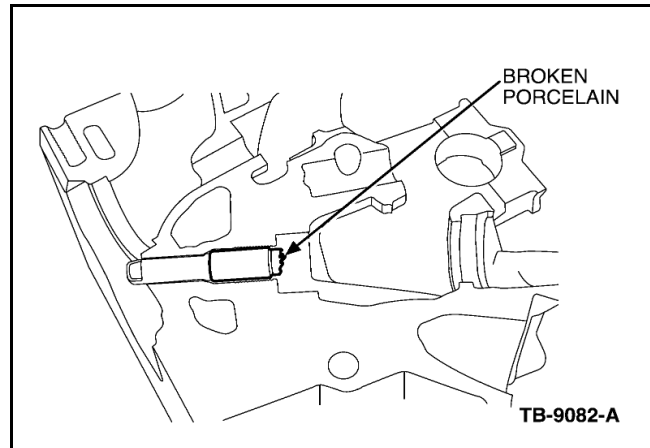
Figure 4 - Article 08-7-6

- c. Mode 3: The upper section of porcelain broke off with remaining porcelain left inside the ground shield. (Figure 4)

Use Rotunda special service tool kit 303-1398 to remove porcelain broken inside the ground electrode shield. (FIGURE 10)

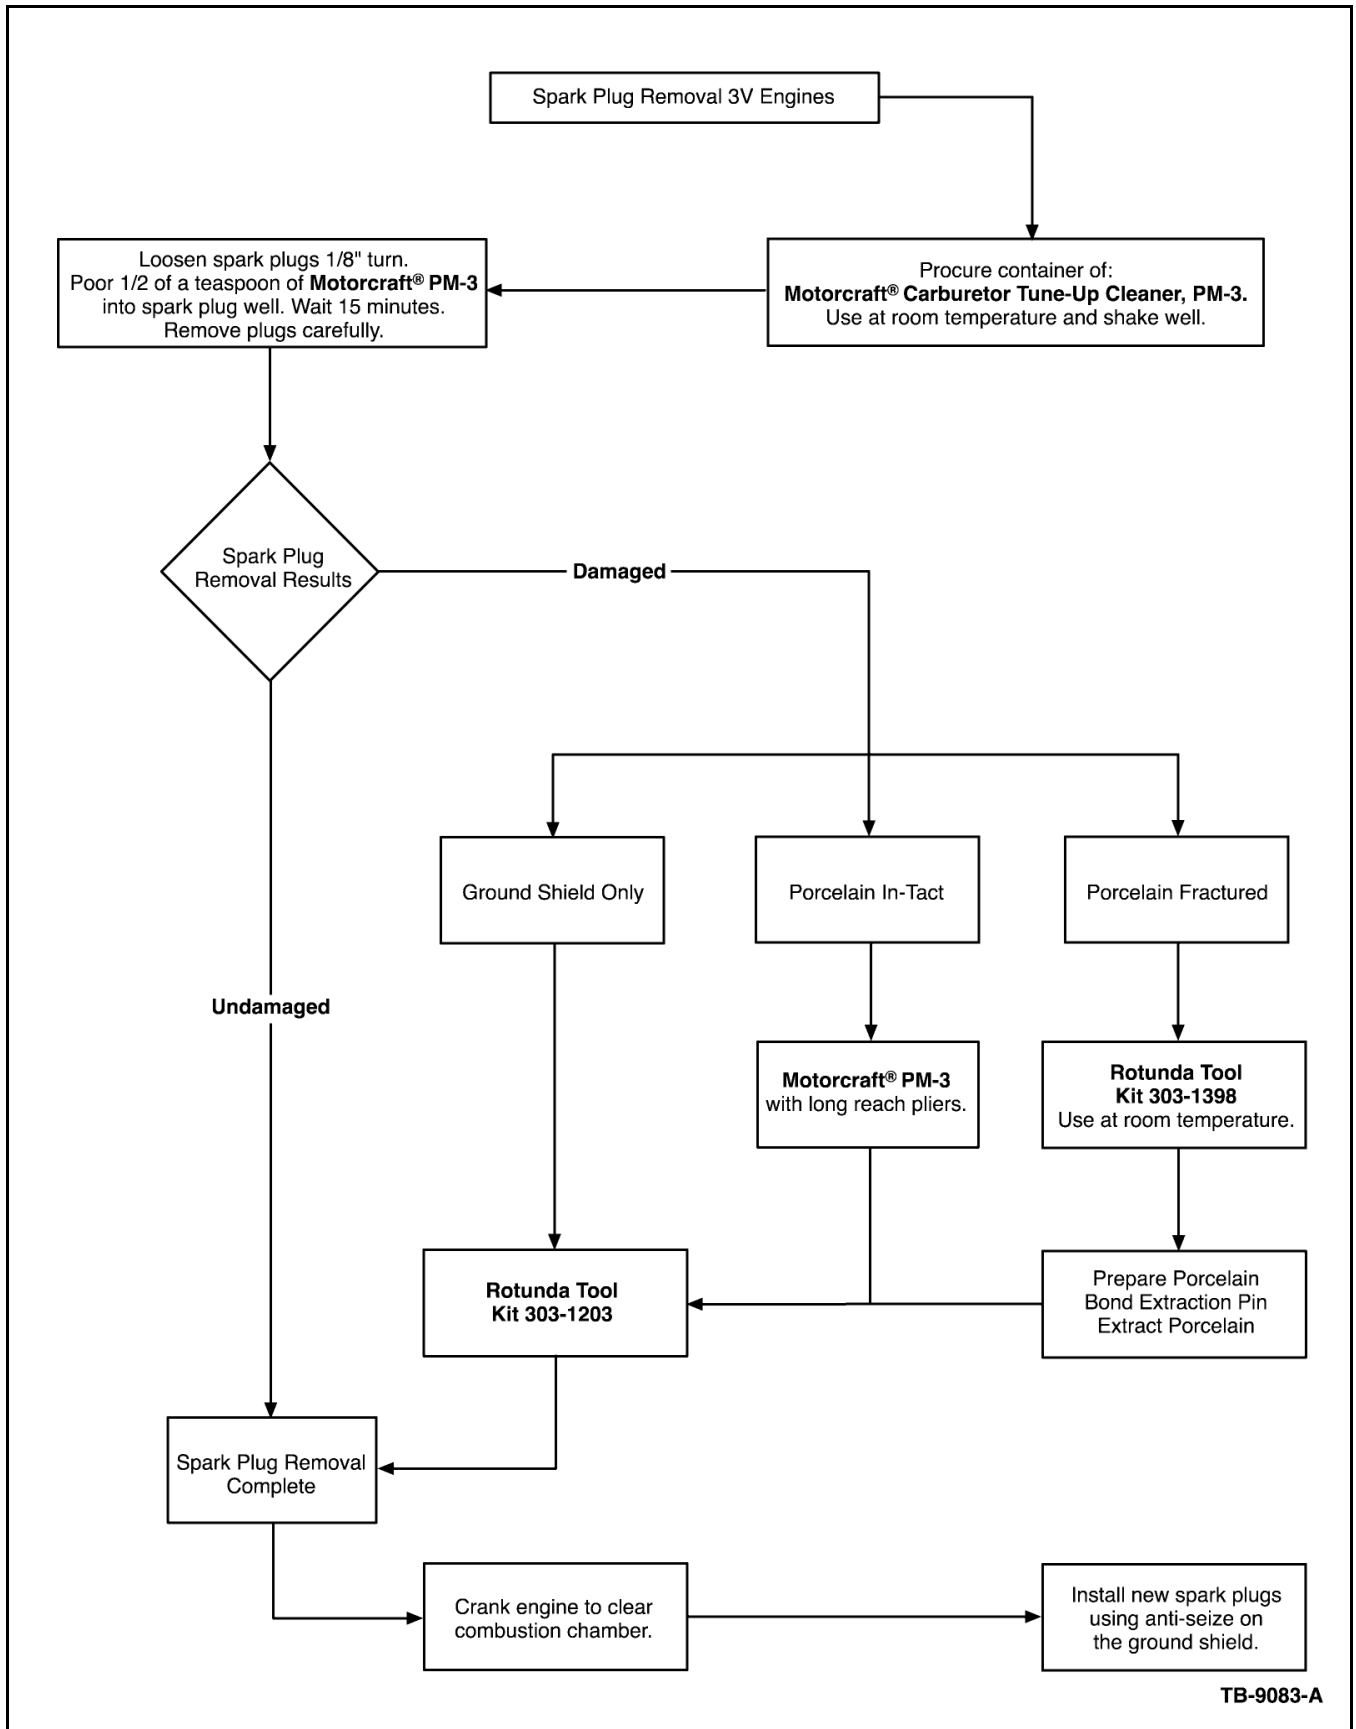
Figure 5 - Article 08-7-6

Flowchart of procedure. (Figure 5)

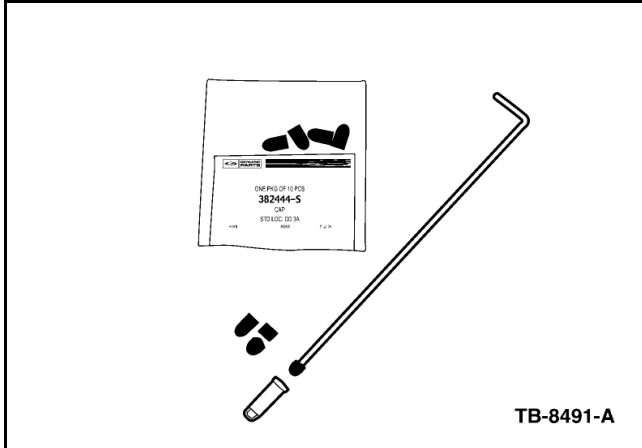
Figure 7 - Article 08-7-6

1. Modify vacuum cap to a 3/8" (10 mm) length for each ground electrode shield that needs to be removed. (Figure 7)

2. Use the installation rod (J) provided with service tool 303-1203 update to install the modified vacuum cap. Push the cap into the ground shield down to the electrode strap. This will plug and protect the combustion chamber from contamination. (Figure 7)
3. Thread-tap the ground electrode shield using a 9.0 x 1.0 mm plug tap (tap profile is about 3-4 reduced diameter threads on the tip end).
 - a. Coat the end of the tap with general purpose grease. (Figure 8)

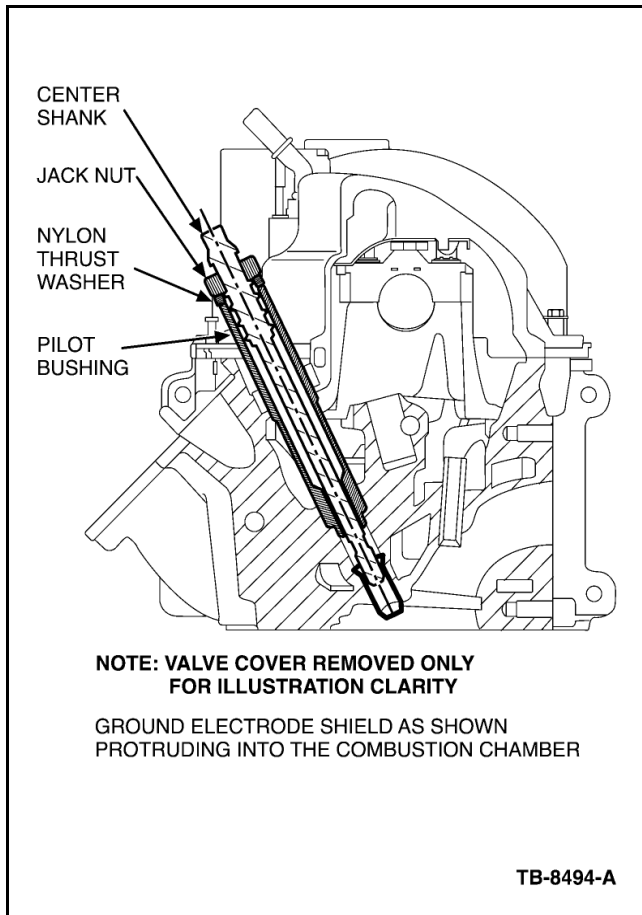
Figure 9 - Article 08-7-6

4. Thread Rotunda special service tool 303-1203 into the ground electrode shield. (Figure 9)

- a. Install the stepped end of the tool pilot bushing into the spark plug well ensuring it bottoms out.
- b. Screw the center shank into the ground electrode shield. Do not over tighten the shank, to prevent thread stripping.
- c. Install the nylon washer and jack nut until finger tight.
- d. Turn the jack nut until the ground electrode is freed from the cavity and withdraw the tool assembly.

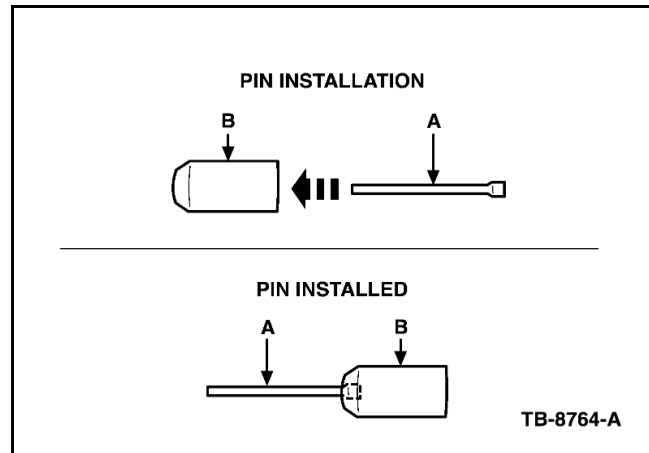
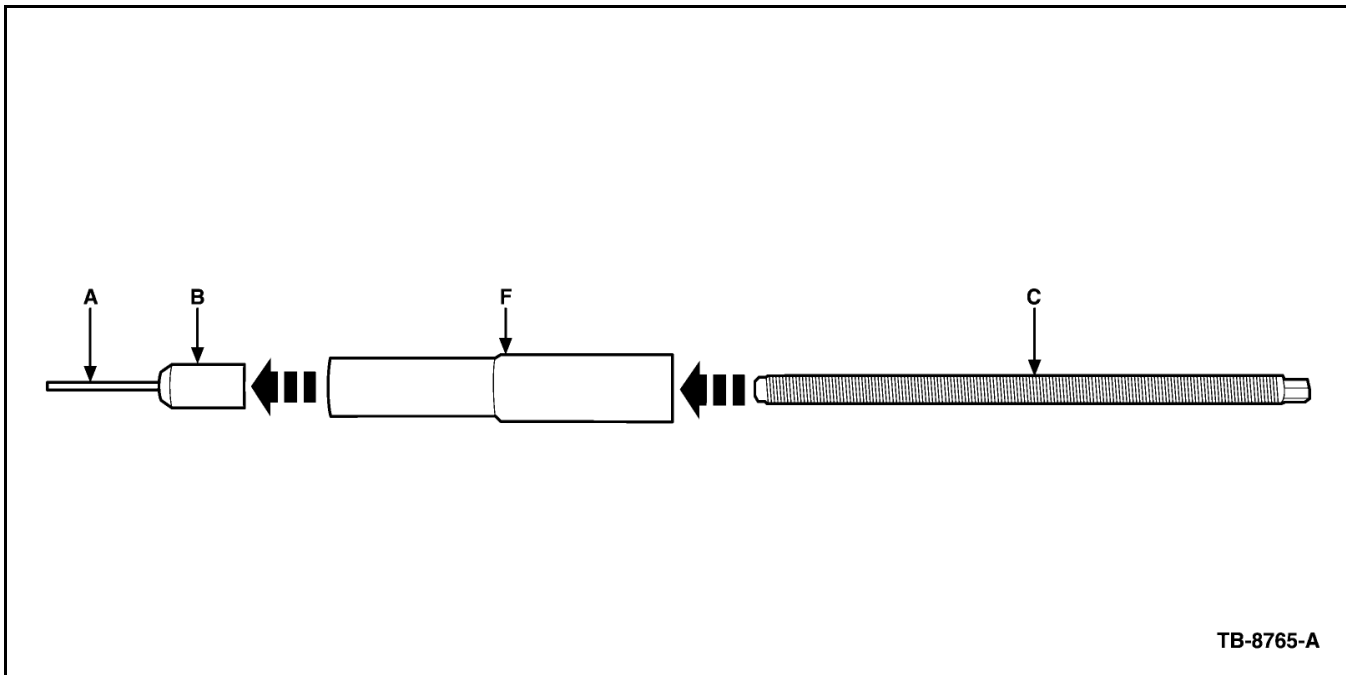
Figure 11 - Article 08-7-6

1. Remove any remaining electrode material from broken porcelain with long nose reach pliers.
2. Spray Motorcraft® Metal Brake Parts Cleaner into the porcelain hole for 2-4 seconds using the straw nozzle supplied with the brake cleaner can.
3. Insert a pin (A) into the collet (B). Screw the collet onto the threaded rod (C). Install the assembled collet, pin, and threaded rod into the steel tool pilot (F). (Figures 11 and 12)

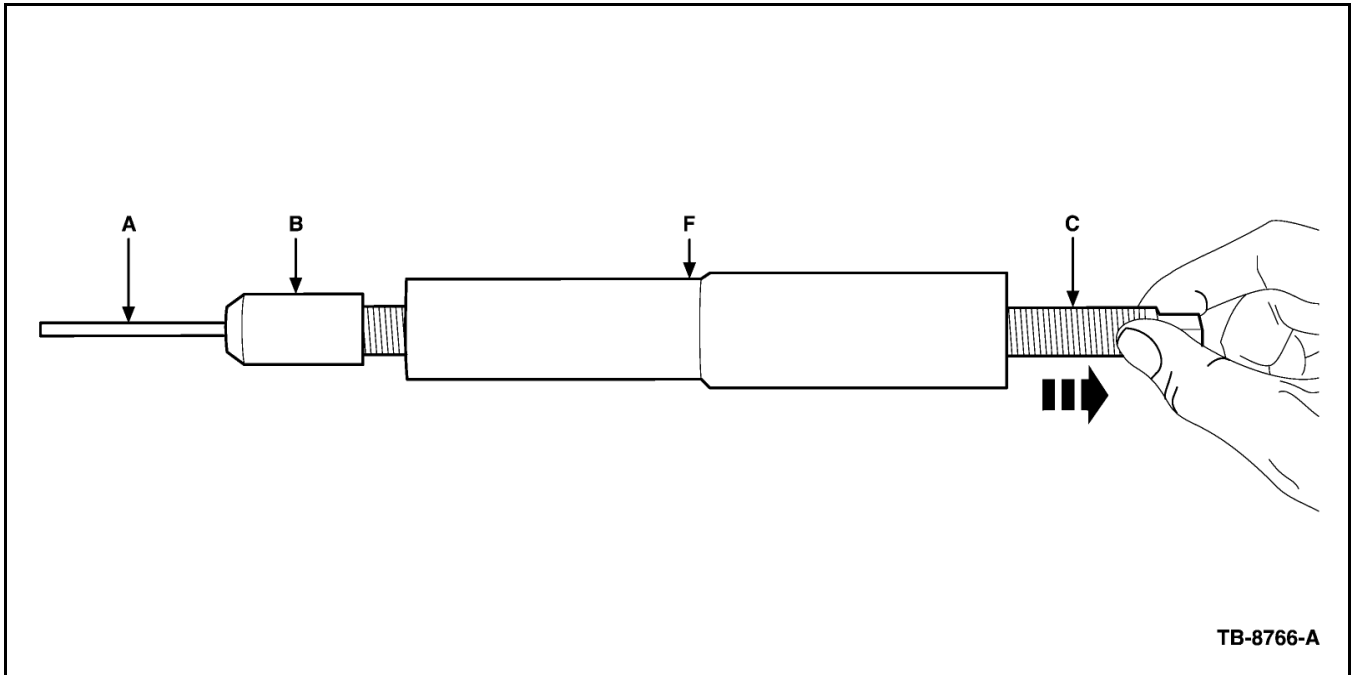
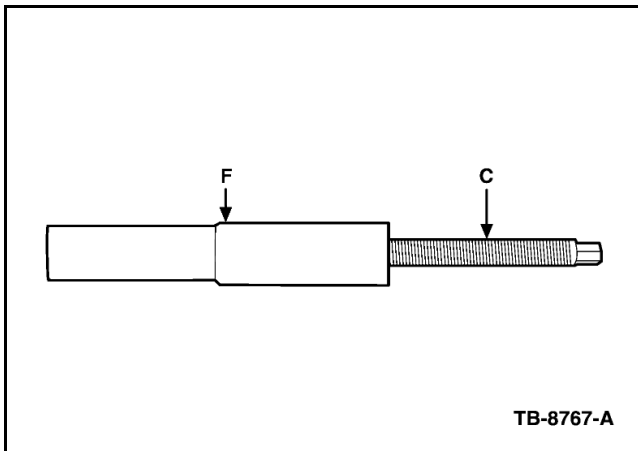
Figure 13 - Article 08-7-6

4. Retract the collet and pin into the steel tool pilot, protecting the pin. (Figures 13 and 14)

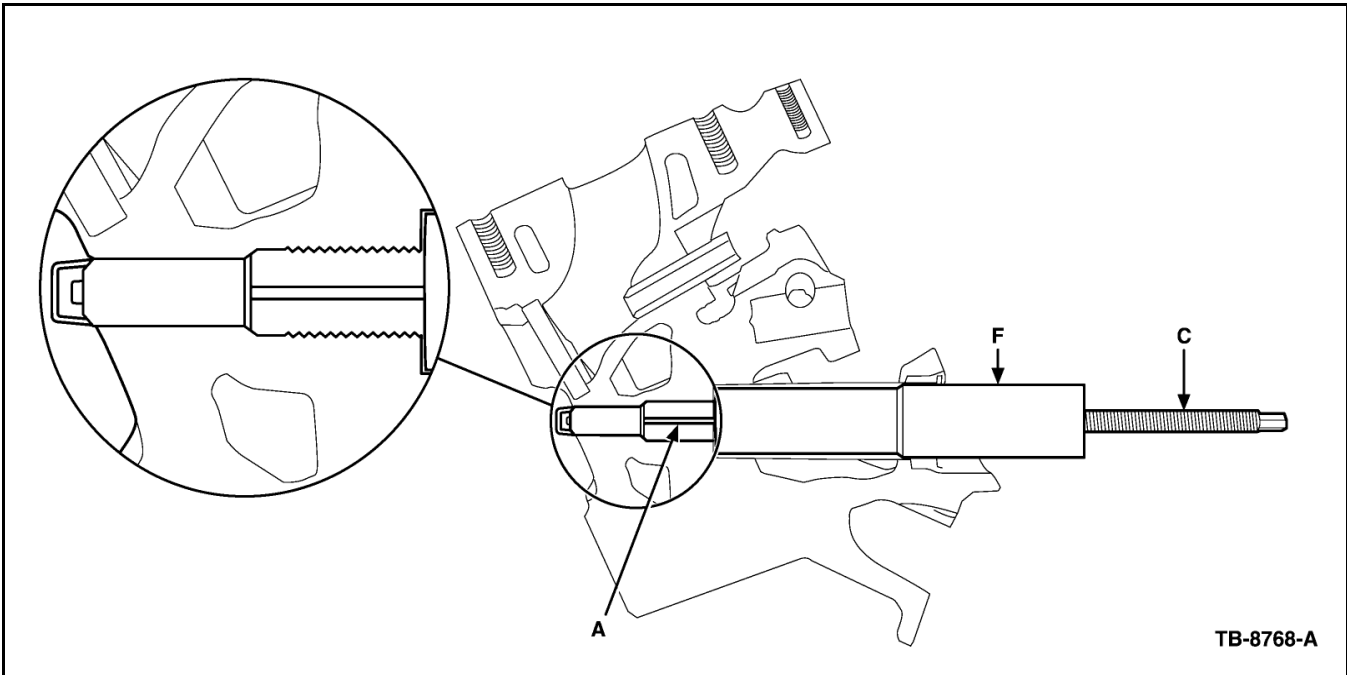
Figure 15 - Article 08-7-6

5. Insert the completed assembly into the spark plug well and fully engage the pin into the porcelain. (Figure 15)

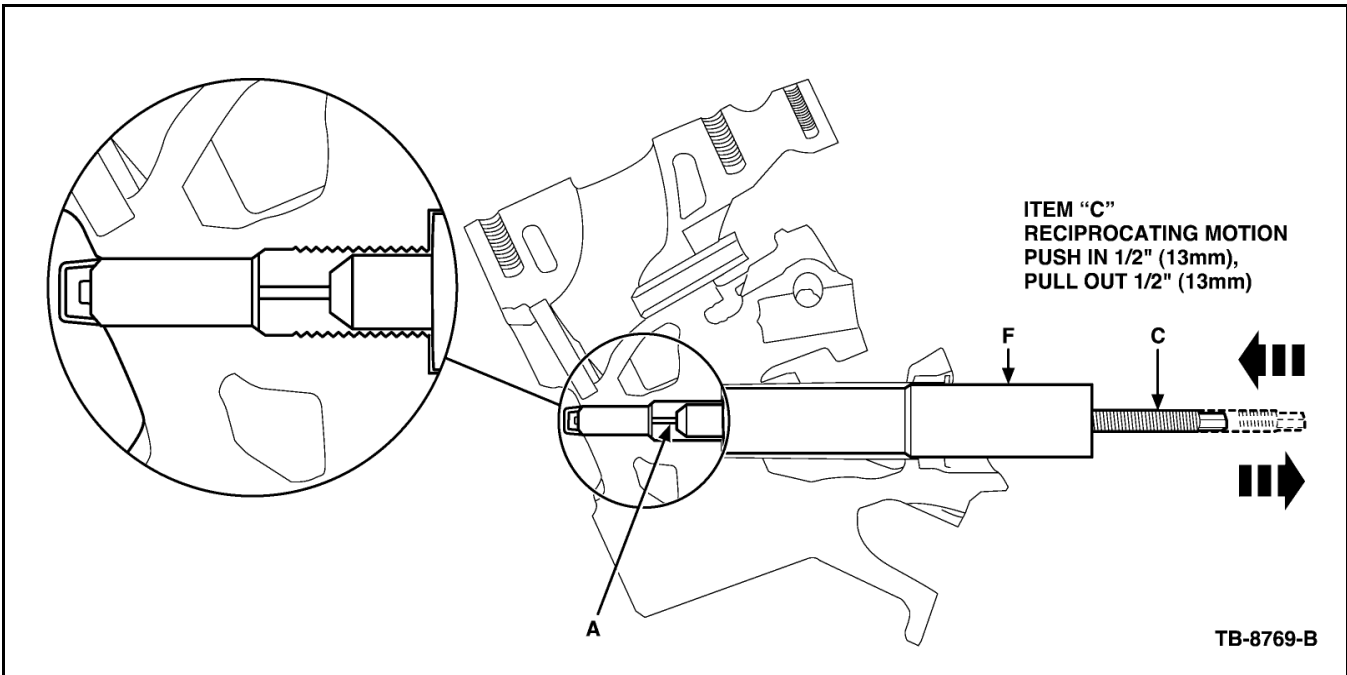
Figure 16 - Article 08-7-6

6. Spray Motorcraft® Metal Brake Parts Cleaner 2-4 seconds between the spark plug well and steel tool pilot. The steel tool pilot must be lifted up approximately 1/2" to allow brake cleaner to flood the porcelain and pin.
7. Scrub the porcelain inside diameter by moving the threaded rod up and down vigorously. Take care making sure the pin does not disengage the porcelain. (Figure 16).

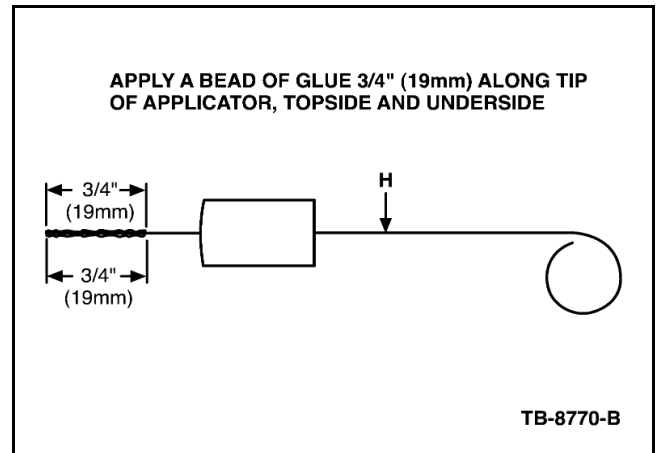
Figure 17 - Article 08-7-6

- Apply two 3/4" (19 mm) long stripes of Loctite® 638™ to opposite sides of a clean and dry applicator (H). Excessive amounts of Loctite® 638™ are being used if it drips off the applicator. (Figure 17)

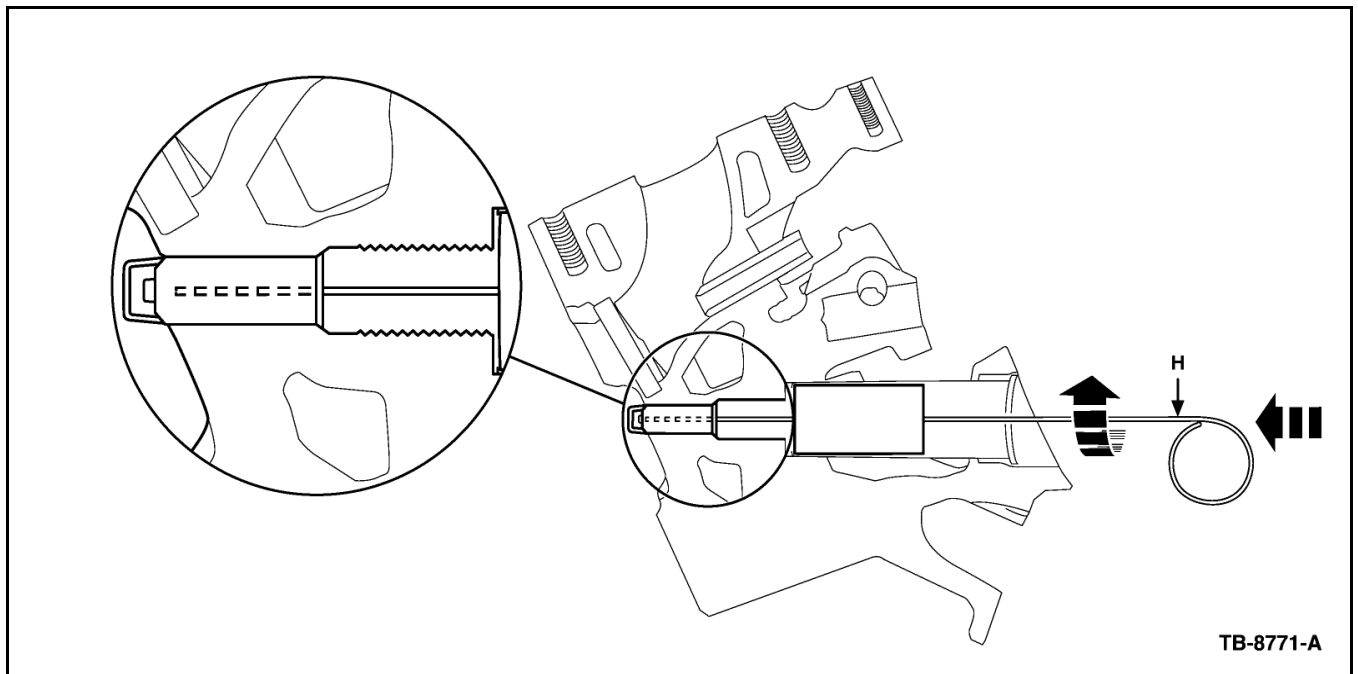
Figure 18 - Article 08-7-6

- Insert applicator into the porcelain and move applicator up and down 1/2" (13 mm) while turning to spread the Loctite® 638™ on the inside of the porcelain. (Figure 18).

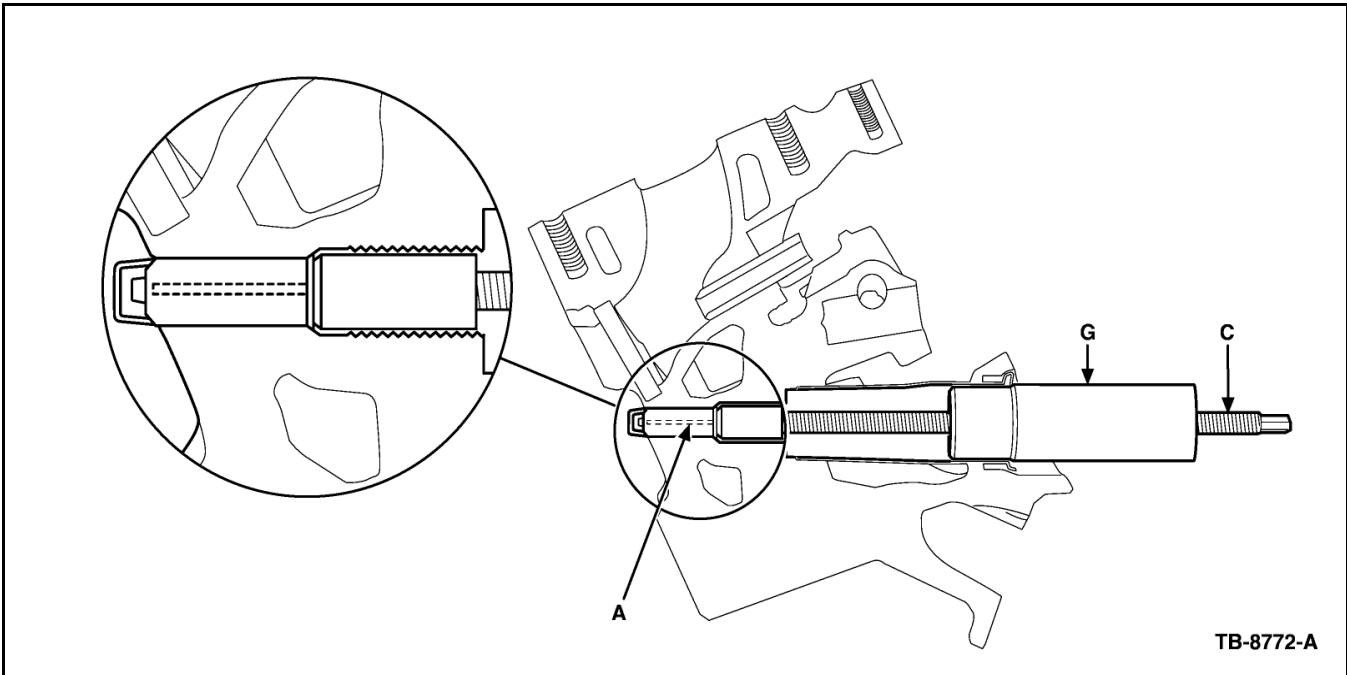
Figure 19 - Article 08-7-6

- Add additional Loctite® 638™, repeating Steps 6-8.
- Leave the pin fully inserted in the porcelain while the adhesive cures. Replace the steel tool pilot with the aluminum alignment sleeve (G), Figure 9, to support the threaded rod while the adhesive cures if additional porcelain fragments are present in other cylinders. (Figure 19).
