This article supersedes TSB **08-1-9** to update Vehicle Applications, Service Procedure and Part List.

ISSUE

ACTION

Spark Plug Removal Procedure

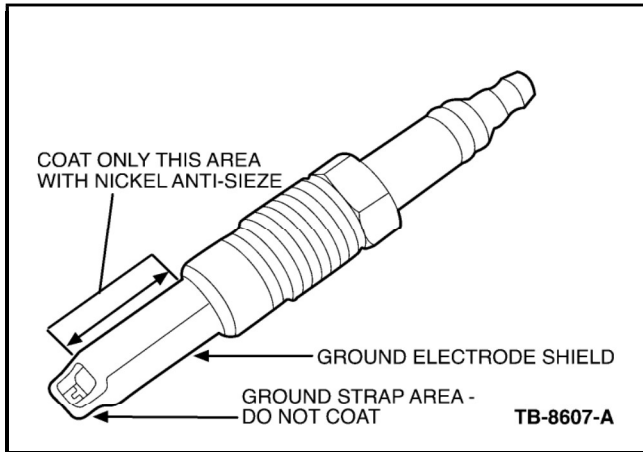
Figure 1 - Article 08-7-6

NEW PLUGS SHOULD BE INSTALLED USING A FILM COATING OF MOTORCRAFT HIGH TEMPERATURE NICKEL ANTI-SEIZE LUBRICANT ON THE GROUND ELECTRODE SHIELD. DO NOT COAT THE ELECTRODE STRAP. (Figure 1)

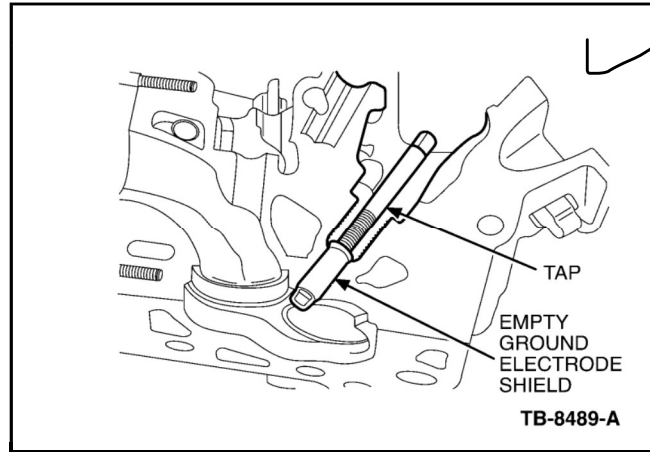
Figure 2 - Article 08-7-6

- a. Mode 1: The ground electrode shield is left behind as an empty shell. (Figure 2)

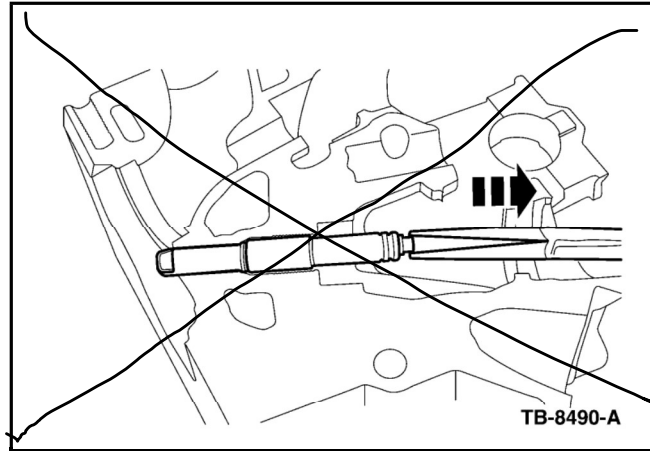
Figure 3 - Article 08-7-6

- b. Mode 2: The entire porcelain insulator and ground electrode shield remains in the cylinder head. (Figure 3)

1. Add an additional 1/2 teaspoon Motorcraft® Carburetor Tune-Up Cleaner fluid into spark plug well and allow 15 minutes of soak time.
2. Using long-reach nose pliers grasp and remove the porcelain with an up and down motion taking care not to fracture the porcelain.

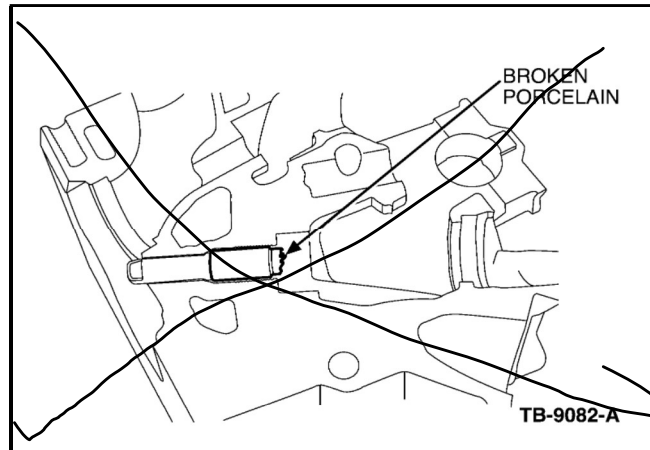
Figure 4 - Article 08-7-6

- c. Mode 3: The upper section of porcelain broke off with remaining porcelain left inside the ground shield. (Figure 4)

Use Rotunda special service tool kit 303-1398 to remove porcelain broken inside the ground electrode shield. (FIGURE 10)

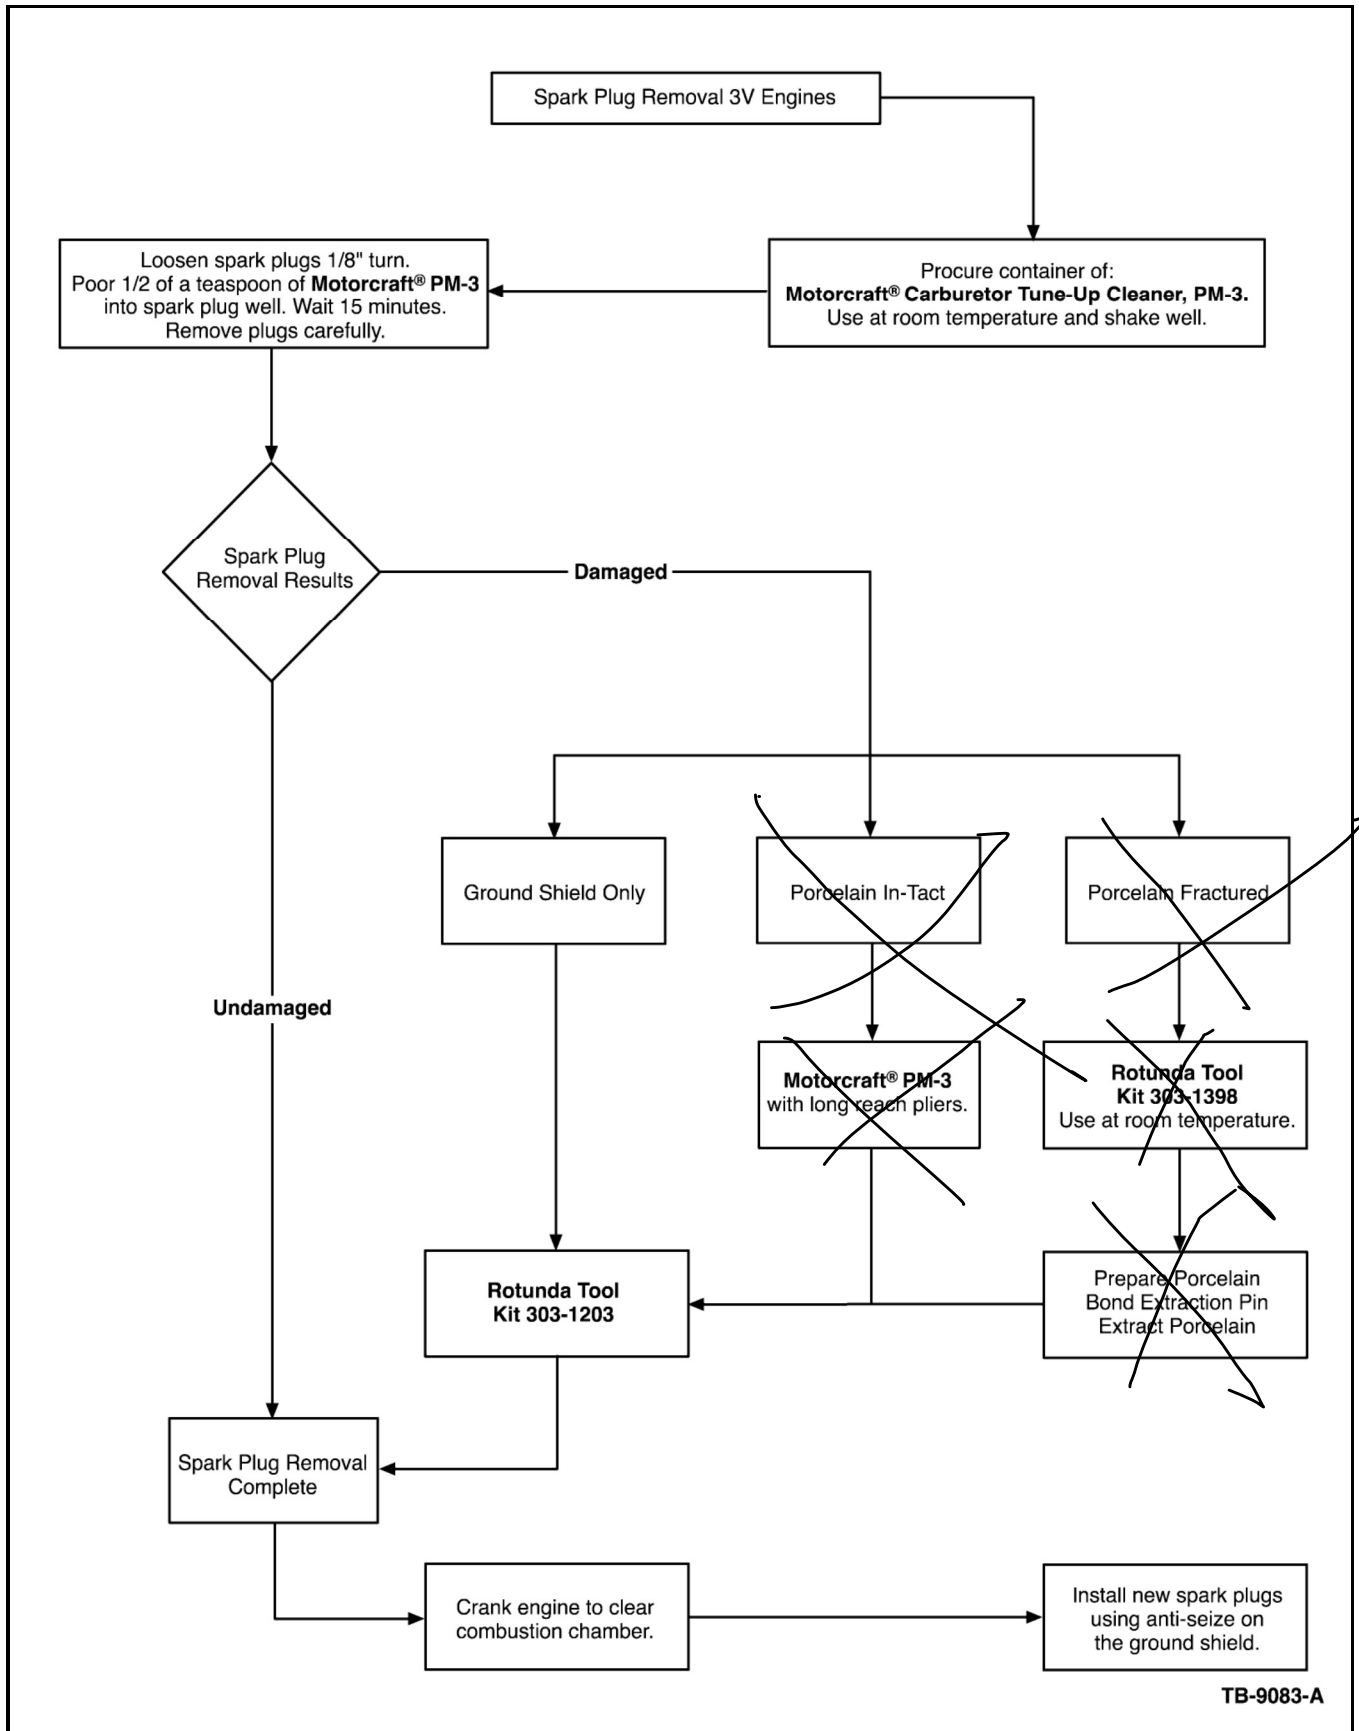
Figure 5 - Article 08-7-6

Flowchart of procedure. (Figure 5)

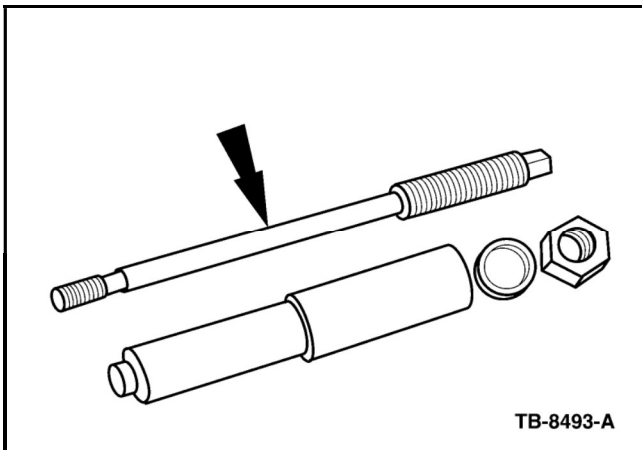
Figure 6 - Article 08-7-6

Use Rotunda special service tool 303-1203 to remove an empty ground electrode shield from the cylinder head. (Figure 6)

THIS TOOL IS ONLY DESIGNED TO WORK WITH AN EMPTY GROUND ELECTRODE SHIELD. IF PORCELAIN REMAINS, PROCEED TO MODE 2 OR 3 REMOVAL.

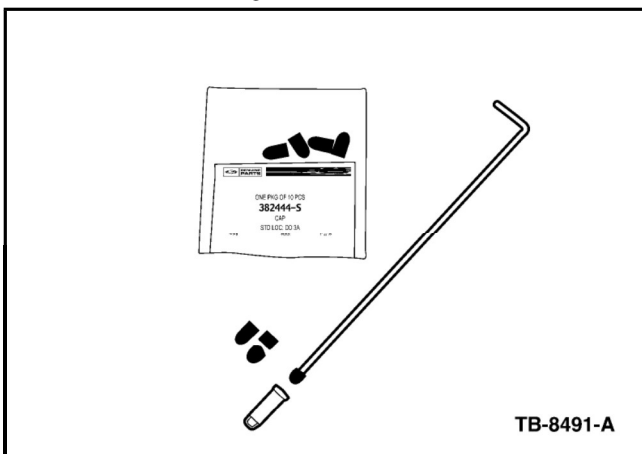
Figure 7 - Article 08-7-6

1. Modify vacuum cap to a 3/8" (10 mm) length for each ground electrode shield that needs to be removed. (Figure 7)

2. Use the installation rod (J) provided with service tool 303-1203 update to install the modified vacuum cap. Push the cap into the ground shield down to the electrode strap. This will plug and protect the combustion chamber from contamination. (Figure 7)
3. Thread-tap the ground electrode shield using a 9.0 x 1.0 mm plug tap (tap profile is about 3-4 reduced diameter threads on the tip end).
 - a. Coat the end of the tap with general purpose grease. (Figure 8)

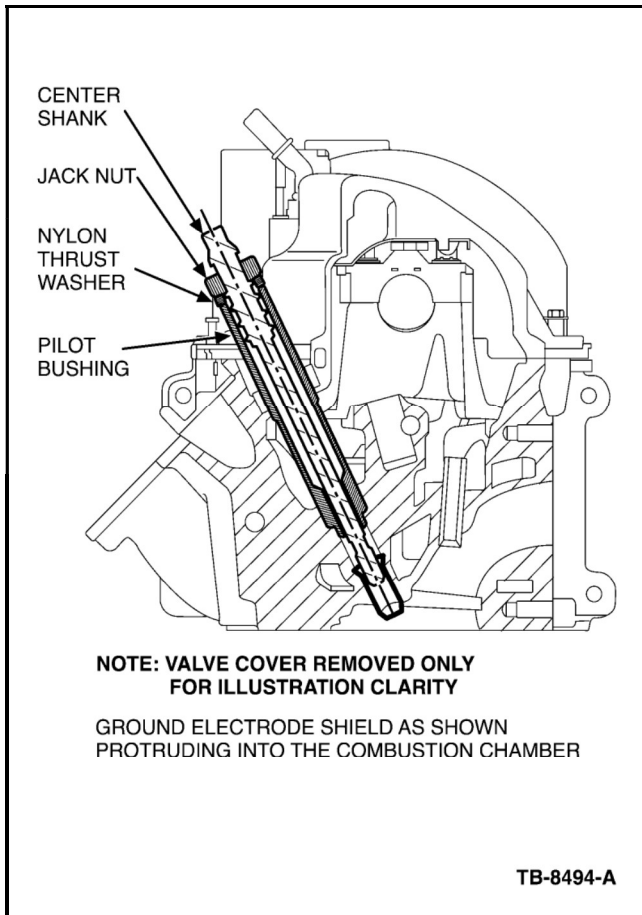
Figure 9 - Article 08-7-6

4. Thread Rotunda special service tool 303-1203 into the ground electrode shield. (Figure 9)

- a. Install the stepped end of the tool pilot bushing into the spark plug well ensuring it bottoms out.
- b. Screw the center shank into the ground electrode shield. Do not over tighten the shank, to prevent thread stripping.
- c. Install the nylon washer and jack nut until finger tight.
- d. Turn the jack nut until the ground electrode is freed from the cavity and withdraw the tool assembly.

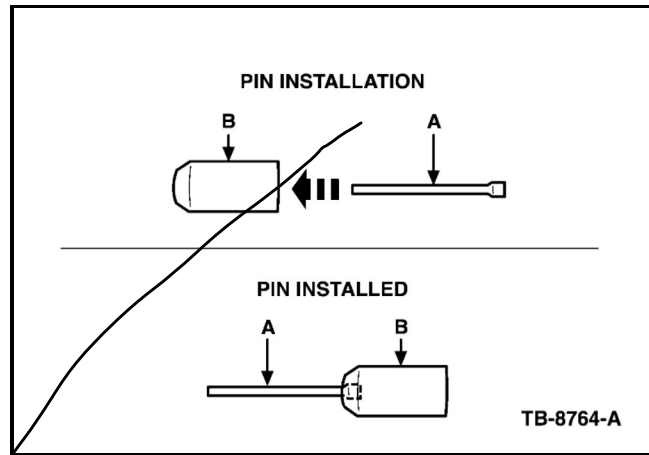
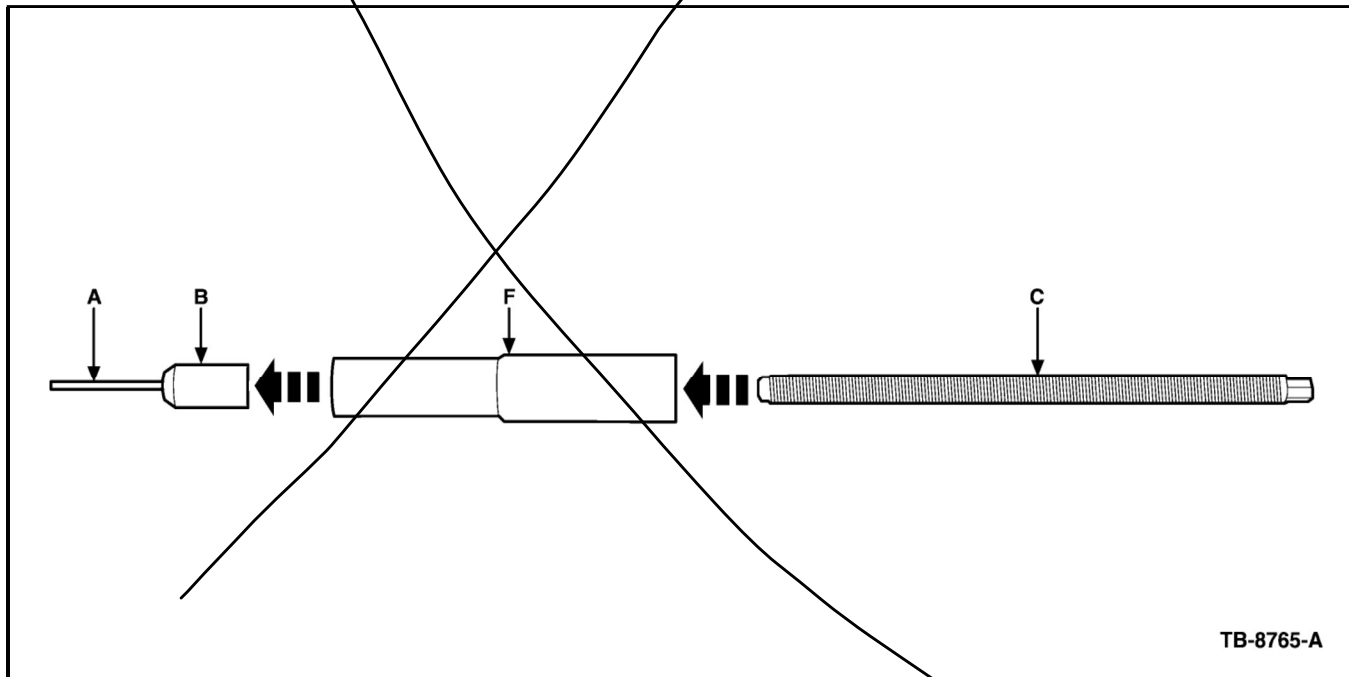
1. Remove any remaining electrode material from broken porcelain with long nose reach pliers.
2. Spray Motorcraft® Metal Brake Parts Cleaner into the porcelain hole for 2-4 seconds using the straw nozzle supplied with the brake cleaner can.
3. Insert a pin (A) into the collet (B). Screw the collet onto the threaded rod (C). Install the assembled collet, pin, and threaded rod into the steel tool pilot (F). (Figures 11 and 12)

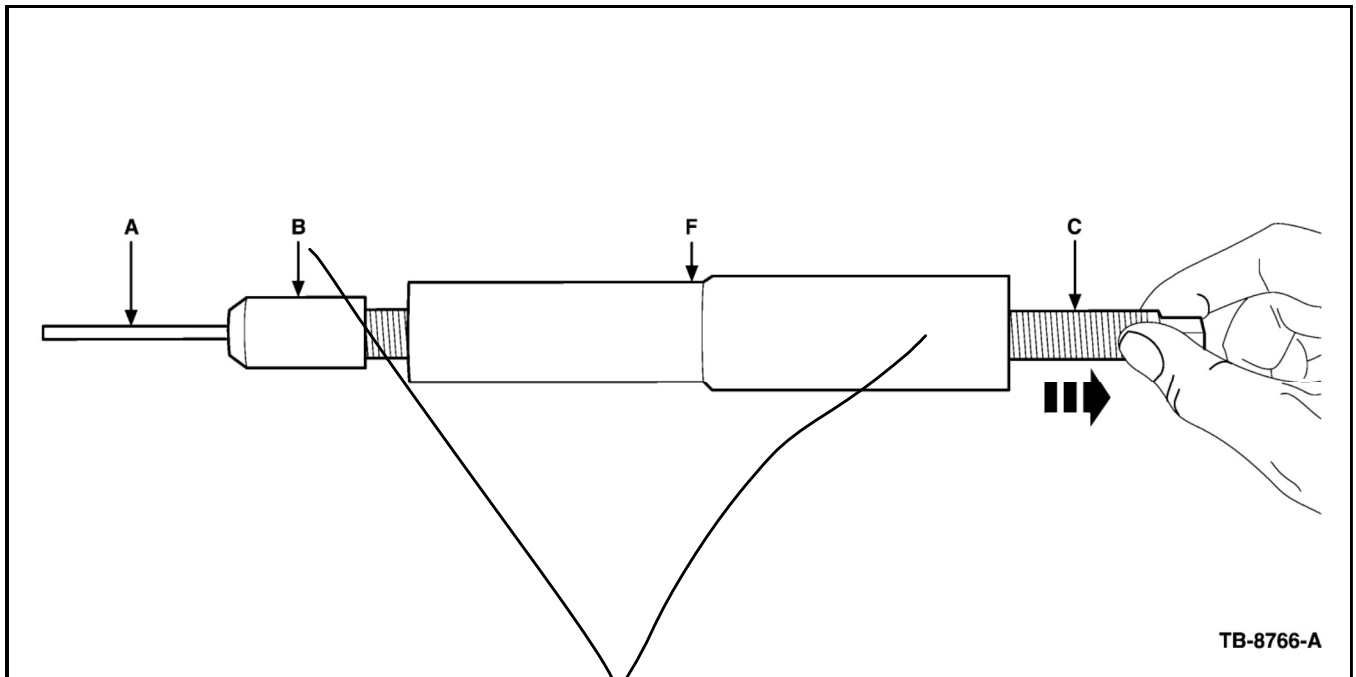
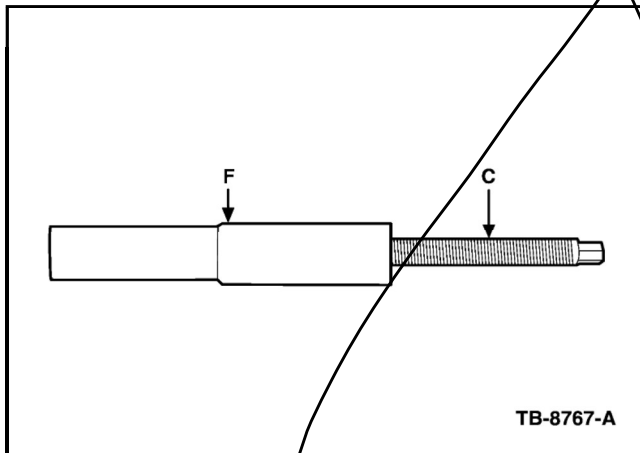
4. Retract the collet and pin into the steel tool pilot, protecting the pin. (Figures 13 and 14)

PIN TIP DAMAGE OR BENT PINS WILL PREVENT INSERTION INTO THE PORCELAIN.

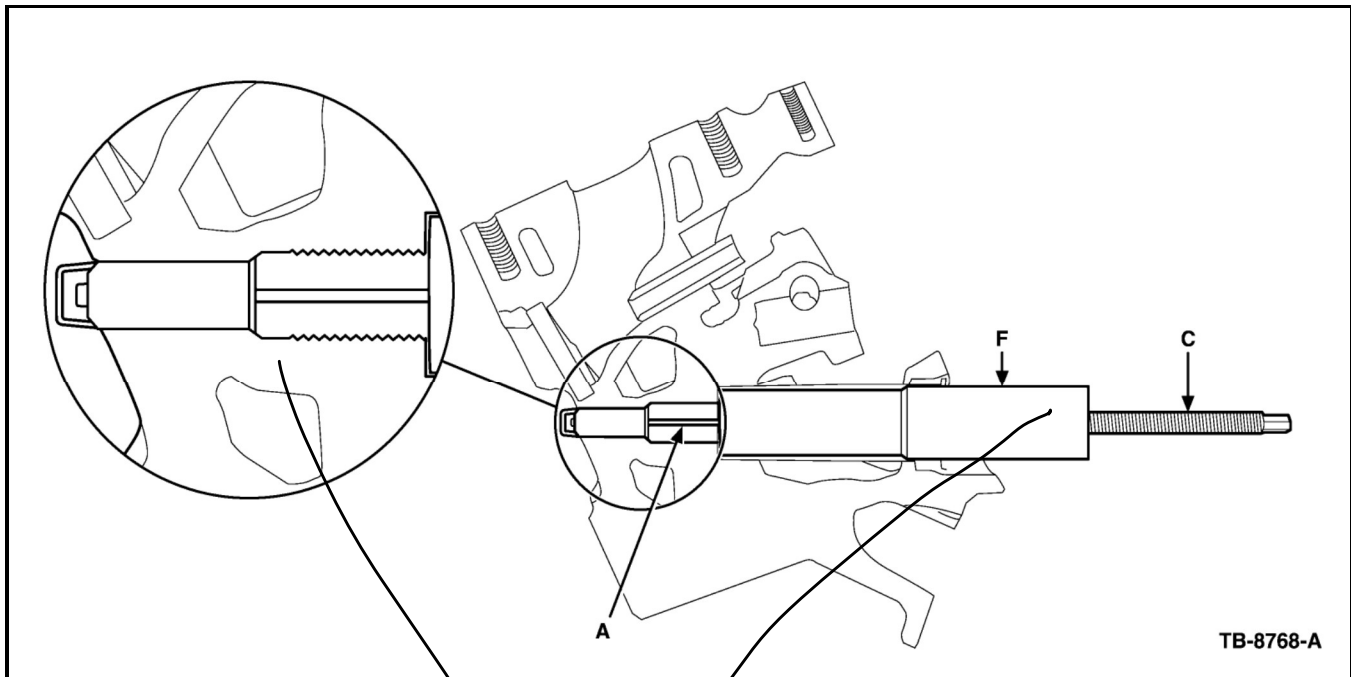
Figure 15 - Article 08-7-6

5. Insert the completed assembly into the spark plug well and fully engage the pin into the porcelain. (Figure 15)

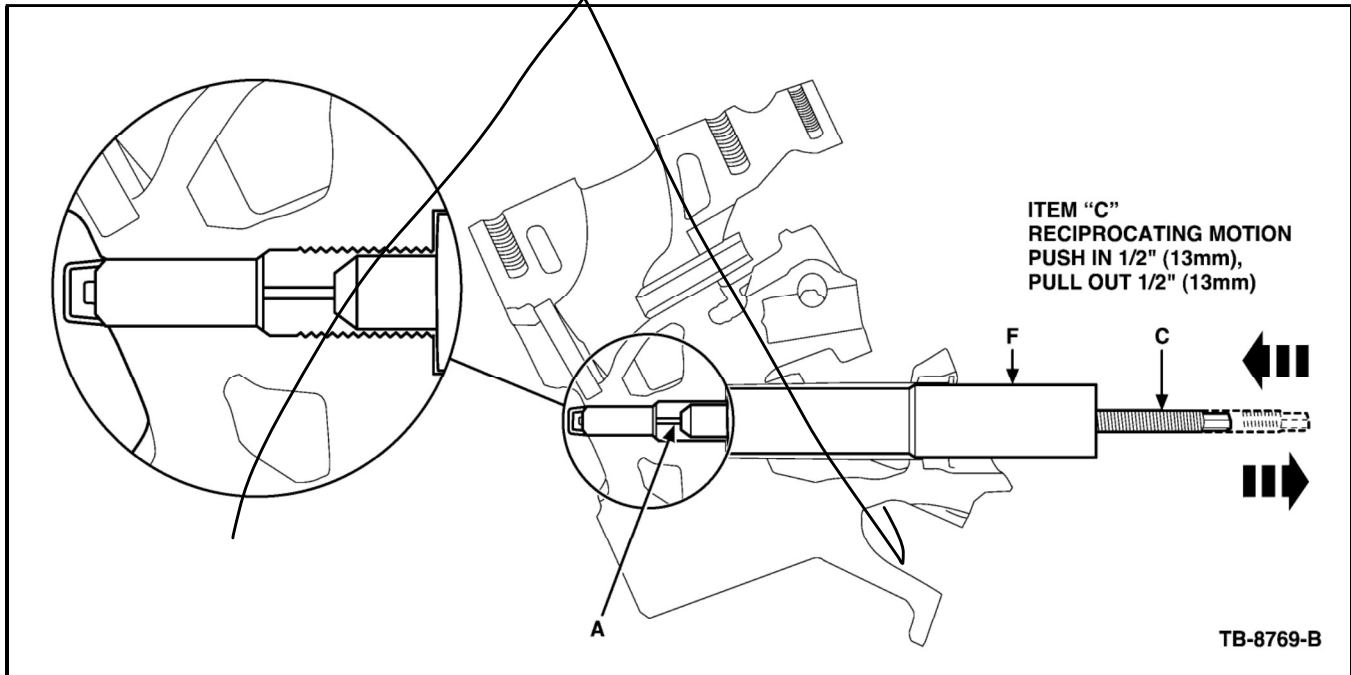
Figure 16 - Article 08-7-6

6. Spray Motorcraft® Metal Brake Parts Cleaner 2-4 seconds between the spark plug well and steel tool pilot. The steel tool pilot must be lifted up approximately 1/2" to allow brake cleaner to flood the porcelain and pin.
7. Scrub the porcelain inside diameter by moving the threaded rod up and down vigorously. Take care making sure the pin does not disengage the porcelain. (Figure 16).

8. Repeat Steps 6 and 7.
 9. Remove the tool assembly. Again flood the porcelain with Motorcraft® Metal Brake Parts Cleaner for 2-4 seconds, then blow out the entire spark plug well and porcelain with dry compressed air.
- NOTE**
 CLEAN AND DRY COMPONENTS ARE KEY TO BONDING THE PIN TO THE PORCELAIN.
10. Repeat Steps 1-9 to prepare remaining porcelain fragments as needed.

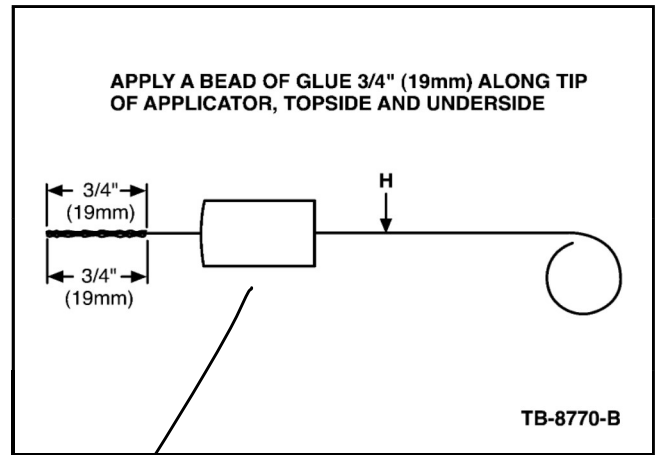
Figure 17 - Article 08-7-6

- Apply two 3/4" (19 mm) long stripes of Loctite® 638™ to opposite sides of a clean and dry applicator (H). Excessive amounts of Loctite® 638™ are being used if it drips off the applicator. (Figure 17)

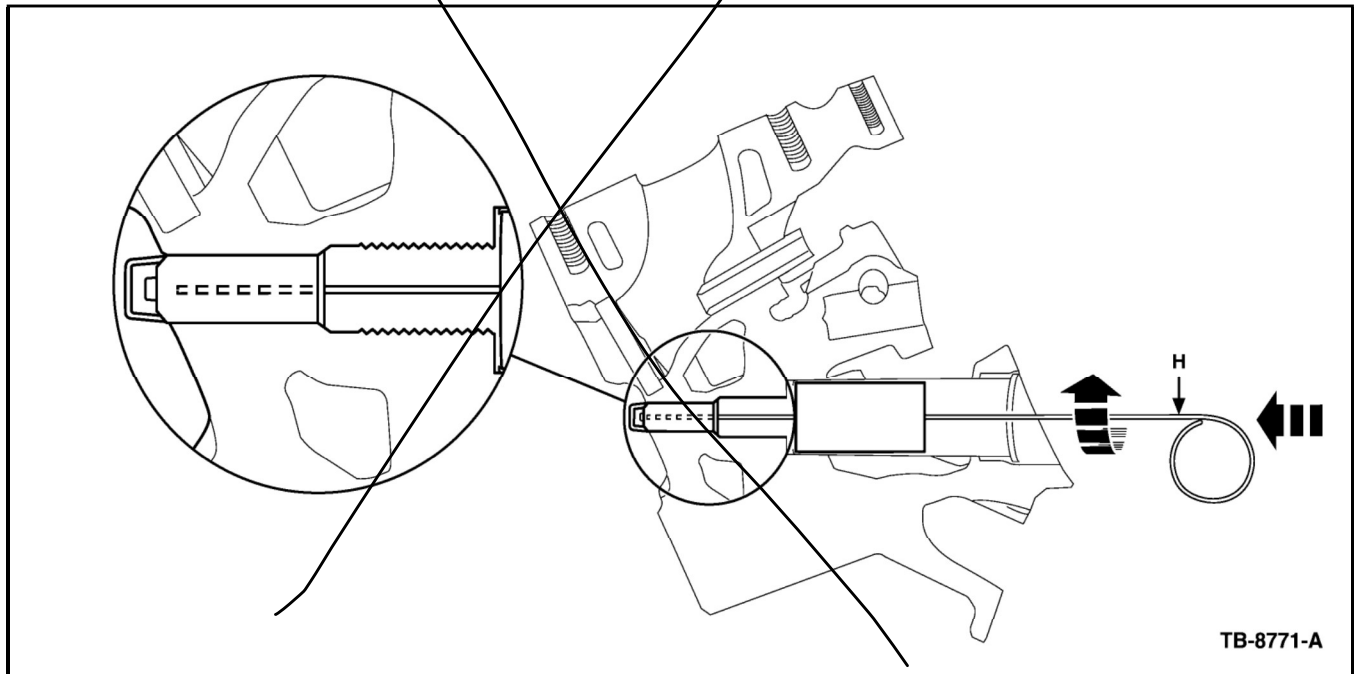
Figure 18 - Article 08-7-6

- Insert applicator into the porcelain and move applicator up and down 1/2" (13 mm) while turning to spread the Loctite® 638™ on the inside of the porcelain. (Figure 18).

- Add additional Loctite® 638™, repeating Steps 1 and 2.
- Clean the applicator with Motorcraft® Metal Brake Parts Cleaner before the bonding agent starts to cure.

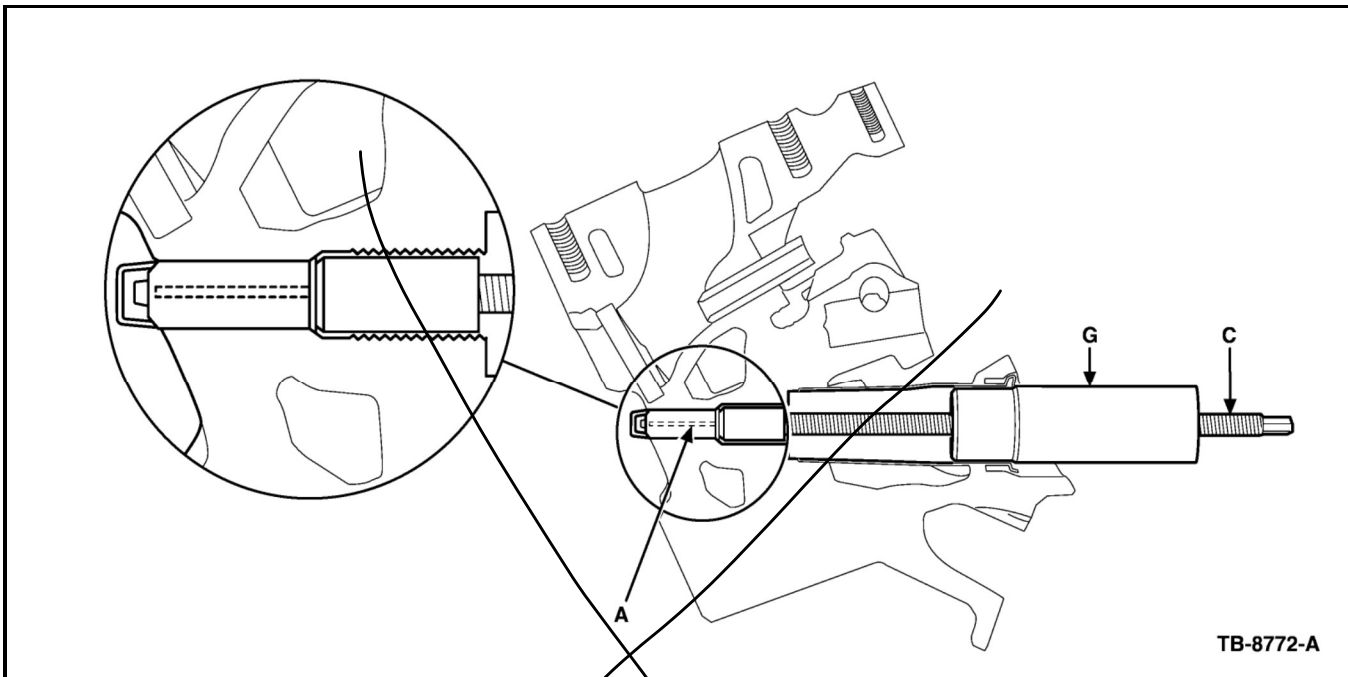
Figure 19 - Article 08-7-6

- Add additional Loctite® 638™, repeating Steps 6-8.
- Leave the pin fully inserted in the porcelain while the adhesive cures. Replace the steel tool pilot with the aluminum alignment sleeve (G), Figure 9, to support the threaded rod while the adhesive cures if additional porcelain fragments are present in other cylinders. (Figure 19).

A MINIMUM 1 HOUR CURING TIME AT 70 °F (21 °C) DEGREES IS REQUIRED BEFORE EXTRACTION IS ATTEMPTED.

11. Allow the Loctite® 638™ to cure for a minimum of one hour at 70 °F (21 °C).
12. Repeat the bonding process for remaining cylinders as needed.
